**National TAB
1329 E. KEMPER ROAD
SUITE 4210
CINCINNATI, OH 45246**

**Report: TAB REPORT
Function: Test, Adjust, & Balance
Date: 01/27/2023**

**01-23-23 SWEETGREEN (CHI276) -
NORTHBROOK, IL (TAB)**

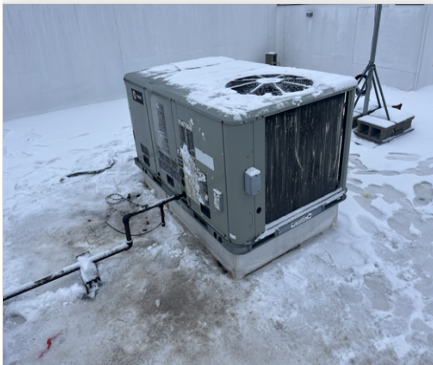
RTU-1.jpeg

Issue Name : 01. RTU-1 is Not Operational.

Description : RTU-1 is not operational. The unit is not currently running and is not capable of heat. Unit was jumpered to FAN ONLY in high speed for the purpose of the balance but requires further service to be operational.

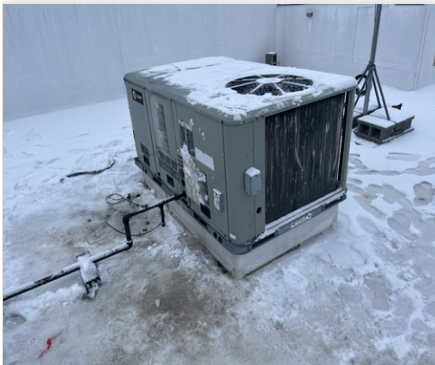
RTU-1.jpeg

Issue Name : 02. RTU-1 Unit Tonnage.

Description : RTU-1 is scheduled to be replaced with an 8.5 ton unit. Currently a 5 ton unit is installed. Airflow proportionally reduced for unit performance and capability.

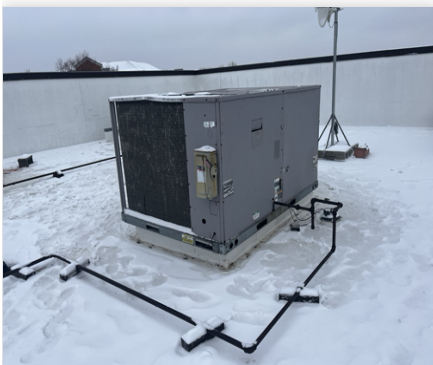
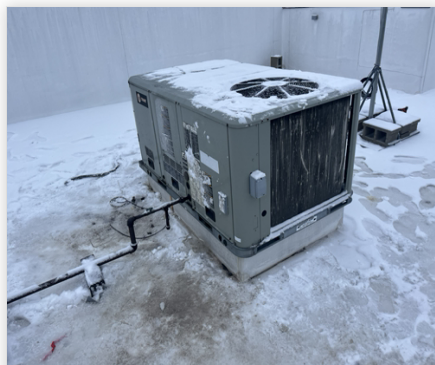
Issue Name : 03. RTUs are in a State of Disrepair.

Description : Both RTU-1 and RTU-2 have several issues and are need of repair. Units are scheduled to be replaced with new units in March 2023.

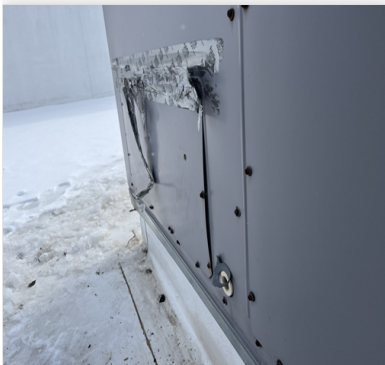
Dischargeleaknocondensate.jpeg

- RTU-2 Issues: Economizer not functional (OA manually set), Discharge panel leaking air, No OA filter installed, No condensate drain installed. RTU-1 is not operational, is not currently capable of heat, and needs service.

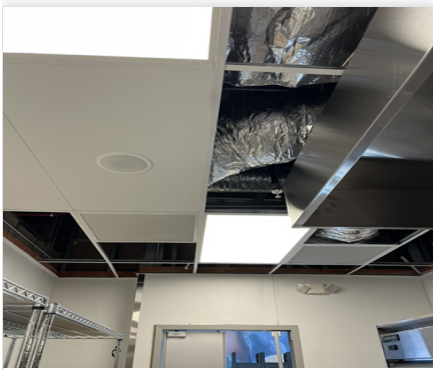
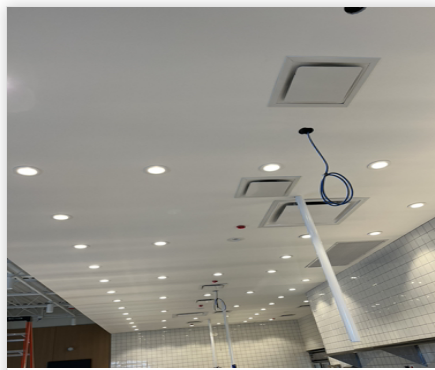
Issue Name : 04. RTU-1 Diffusers 1-3, 1-4, and 1-14 not installed.

Description : Diffusers 1-3, 1-4, and 1-14 are not installed. Recommend diffusers are installed per plans. Scheduled airflow for these diffusers was proportionally distributed across installed diffusers.

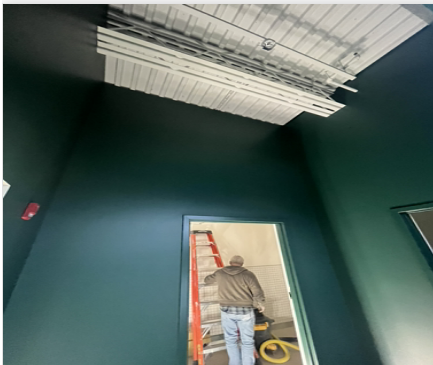
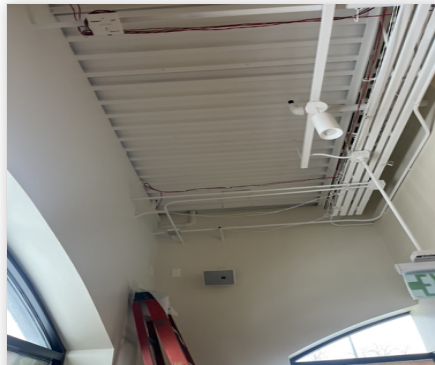
Issue Name : 05. RTU-2 Diffusers 2-1 and 2-9 Not Installed.

Description : Diffusers 2-1 and 2-9 are not installed. Diffusers scheduled for combined 100 cfm supply airflow. Scheduled airflow was proportionally distributed across installed diffusers.

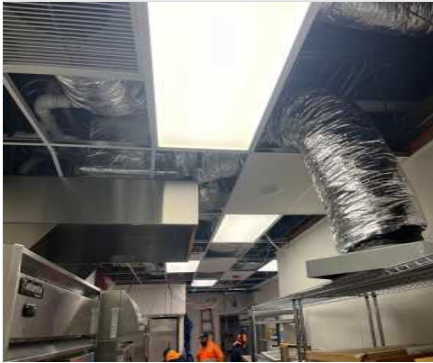
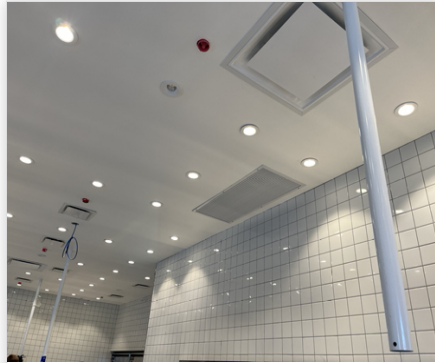
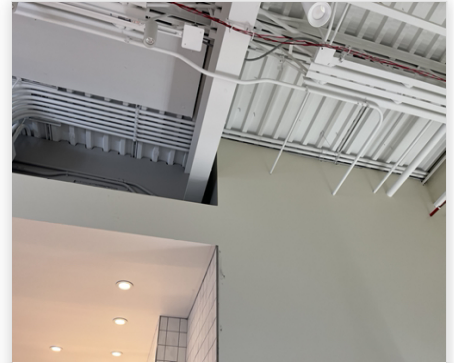
Issue Name : 06. RTU-1 AND RTU-2 Returns Relocated.

Description : RTU-1 and RTU-2 returns relocated due to space constraints and location of drops. RTU-1 return was relocated to hood area, near oven. Hood capture did not appear impacted by proximity of returns, but this may cause cooking exhaust to be pulled into the unit. RTU-2 was relocated to behind front counter area. Units are achieving correct airflow.

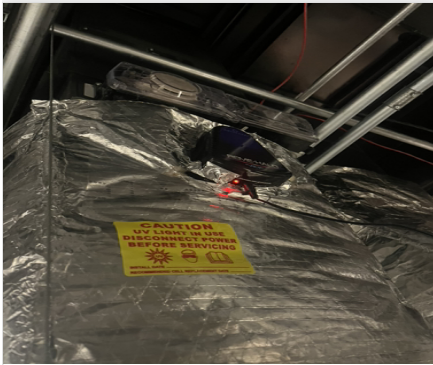
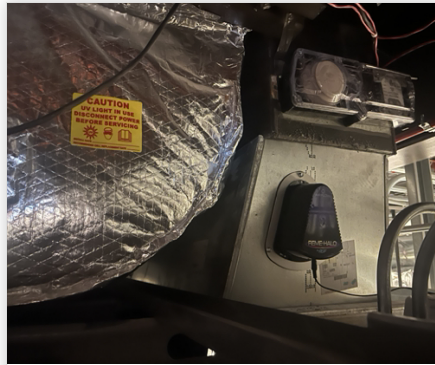
Issue Name : 07. Reme Halo Air Purifiers.

Description : Reme Halo air purifiers are installed in the return ducts of both units. Recommend air purifiers are installed after the evaporator coil or in the supply duct for optimum performance. Additionally, RTU-2 air purifier does not appear to be powered. Recommend service.

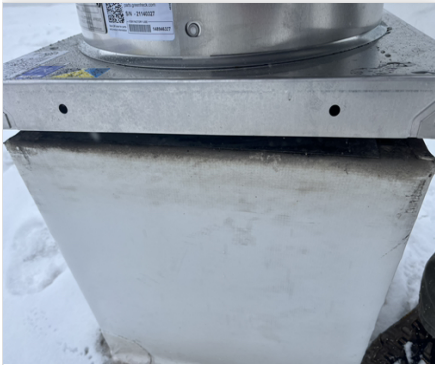
EF-1.jpeg

Issue Name : 08. EF-1 and EF-2 are Not Secured to Curbs

Description : EF-1 and EF-2 are not secured to their curbs. Recommend fans are secured.

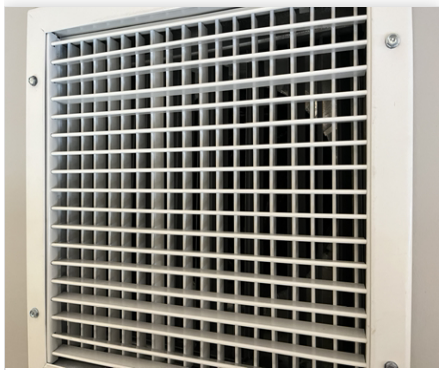
Girlle.jpeg

Issue Name : 09. RTU-2 Face Dampers are Not Secure.

Description : RTU-2 sidewall grille OBD's are not secured and rattling. This is creating noise in the dining area. Recommend dampers are secured.

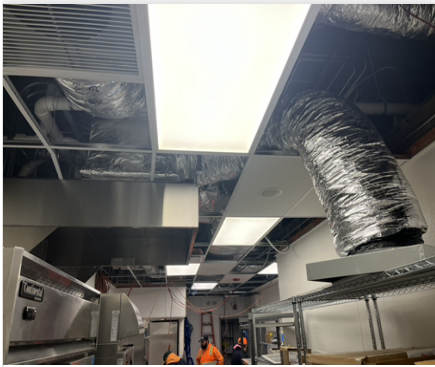
BOH.jpeg

Issue Name : 10. Dropped Ceiling Not Completely Installed.

Description : Most dropped ceiling tiles in BOH were not installed at the time of the balance. Building pressure measurements impacted.
