**Report: Pre-TAB Report**  
**Function: Test, Adjust, & Balance**  
**Date: 03/03/2026**  
**Completed By: National TAB**

## 03-23-26 WAWA #8245 YEAGERTOWN, PA

Project: 03-23-26 WAWA #8245 YEAGERTOWN, PA

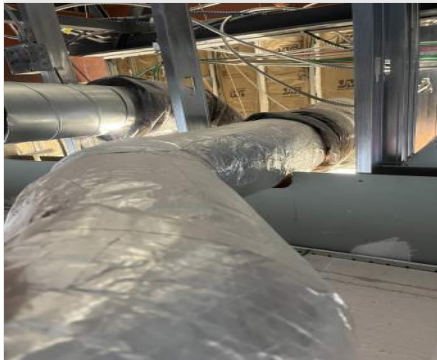
**Issue Name :** 1. Missing damper -office  
**Description :** Office diffuser does not have a damper installed. Add prior to TAB  
**Created By :** National TAB                      **Assigned To :** National TAB - Tyler Youells  
**Status :** Open  
**Priority :** High                                      **Asset Tag :**  
**Originated Date :** 03/03/2026 - Tyler Youells - National TAB

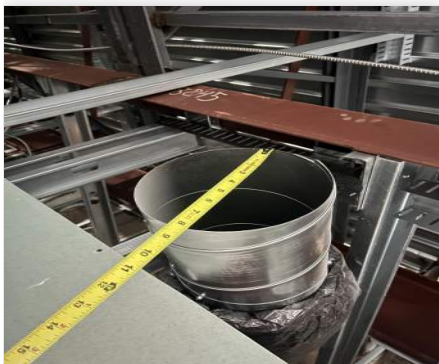
**Issue Name :** 2. Transfer Duct- Vestibule  
**Description :** Transfer duct for the vestibule is installed as an 8" but is designed as a 10". Upsize the duct.  
**Created By :** National TAB                      **Assigned To :** National TAB - Tyler Youells  
**Status :** Open  
**Priority :** Medium                                      **Asset Tag :**  
**Originated Date :** 03/03/2026 - Tyler Youells - National TAB

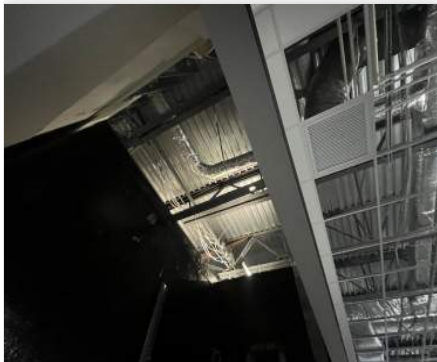
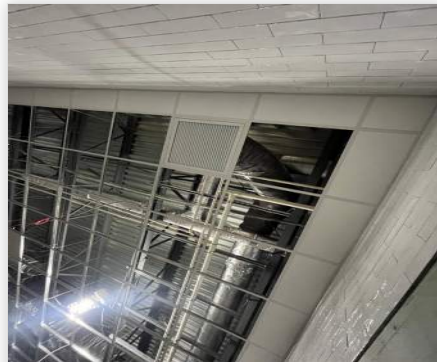
**Issue Name :** 3. RTU-3 Return Grille location  
**Description :** Relocate Return grille to ice chest and ice cream cooler alcove ceiling once the grid is installed.  
**Created By :** National TAB                      **Assigned To :** National TAB - Tyler Youells  
**Status :** Open  
**Priority :** **Medium**                                      **Asset Tag :**  
**Originated Date :** 03/03/2026 - Tyler Youells - National TAB

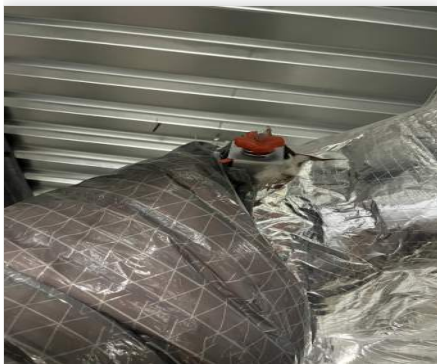
**Issue Name :** 4. Stuck Damper on RTU-3 Return  
**Description :** correct damper so that it can open and close freely. Damper is jammed up halfway closed. Repair prior to TAB.  
**Created By :** National TAB                      **Assigned To :** National TAB - Tyler Youells  
**Status :** Open  
**Priority :** Medium                                      **Asset Tag :**  
**Originated Date :** 03/03/2026 - Tyler Youells - National TAB

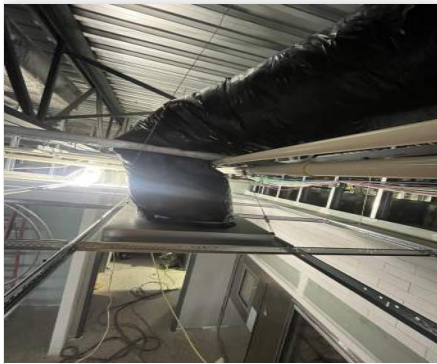
**Issue Name :** 5. Adjust Flexible duct- RTU-3 Return  
**Description :** Adjust the Flexible duct for RTU-3 return, Also recommend adjusting the plumbing support bracket to allow a better flex connection that is less impeded.  
**Created By :** National TAB                      **Assigned To :** National TAB - Tyler Youells  
**Status :** Open  
**Priority :** Medium                                      **Asset Tag :**  
**Originated Date :** 03/03/2026 - Tyler Youells - National TAB

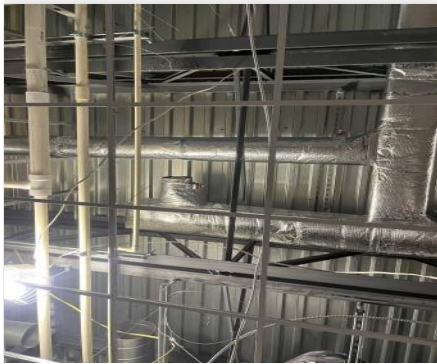
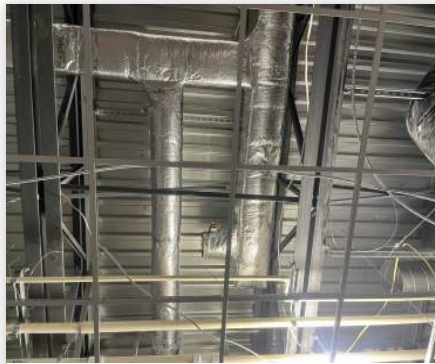
**Issue Name :** 6. Relocate supply takeoff- Delivery RM  
**Description :** Relocate the supply takeoff for the delivery room, current location will cause a tight duct connection. relocate to other side of the supply trunk and routing through Truss gap.  
**Created By :** National TAB                      **Assigned To :** National TAB - Tyler Youells  
**Status :** Open  
**Priority :** High                                      **Asset Tag :**  
**Originated Date :** 03/03/2026 - Tyler Youells - National TAB

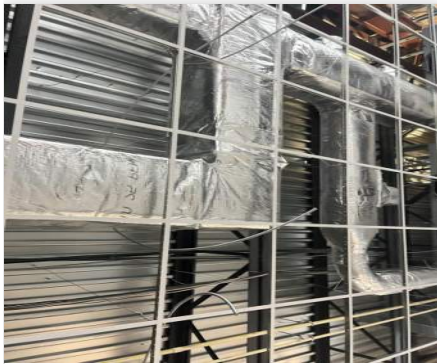
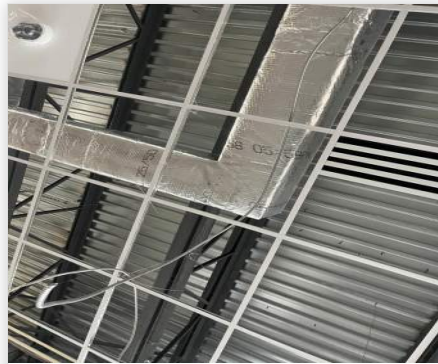
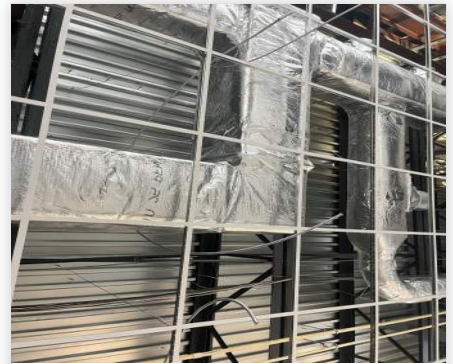
**Issue Name :** 7. Long Radius elbows substituted  
**Description :** Long radius elbows on prints have been substituted for Mitered 90 Degree elbows with turning vanes. confirm substitution is approved by EOR.  
**Created By :** National TAB                      **Assigned To :** National TAB - Tyler Youells  
**Status :** Open  
**Priority :** Low                                      **Asset Tag :**  
**Originated Date :** 03/03/2026 - Tyler Youells - National TAB

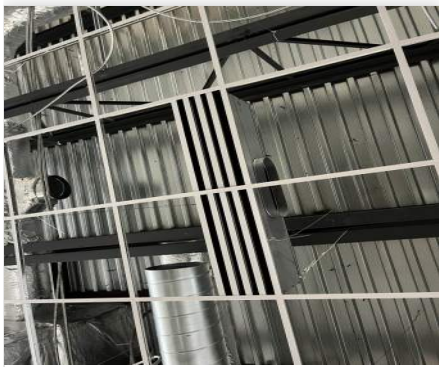
**Issue Name :** 8. Damper and Elbow not yet installed  
**Description :** Damper and elbow is not yet installed for exhaust fan 2 grille. Install prior to TAB and ensure damper is operational  
**Created By :** National TAB                      **Assigned To :** National TAB - Brianna Biggs  
**Status :** Open  
**Priority :** High                                      **Asset Tag :**  
**Originated Date :** 03/03/2026 - Tyler Youells - National TAB

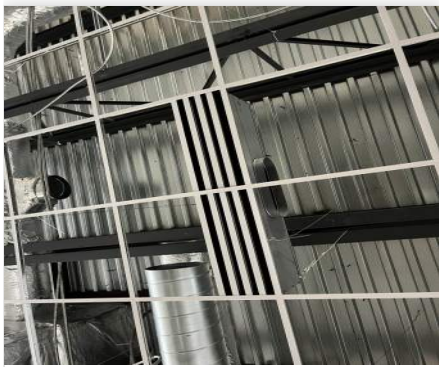
**Issue Name :** 9. Flip Linear diffuser orientation  
**Description :** Recommend flipping Linear diffuser orientation to allow for a more appropriate and laminar flex connection. ensure proper clearances.  
**Created By :** National TAB                      **Assigned To :** National TAB - Tyler Youells  
**Status :** Open  
**Priority :** Medium                                      **Asset Tag :**  
**Originated Date :** 03/03/2026 - Tyler Youells - National TAB

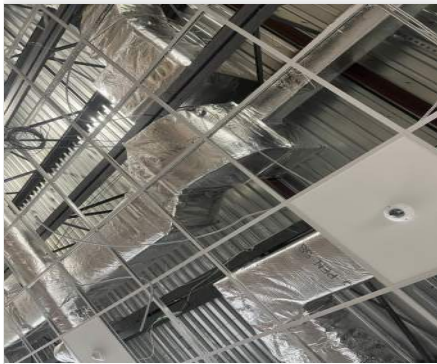
**Issue Name :** 10. AC-3 Supply drop  
**Description :** AC-3 supply drop was installed as a Radiused drop and not as a supply plenum drop per Keynote 18. Recommend EOR review and approve if acceptable  
**Created By :** National TAB                      **Assigned To :** National TAB - Tyler Youells  
**Status :** Open  
**Priority :** High                                      **Asset Tag :**  
**Originated Date :** 03/03/2026 - Tyler Youells - National TAB

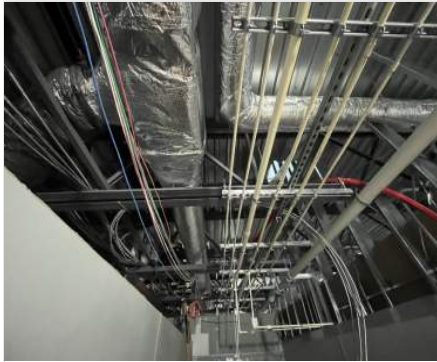
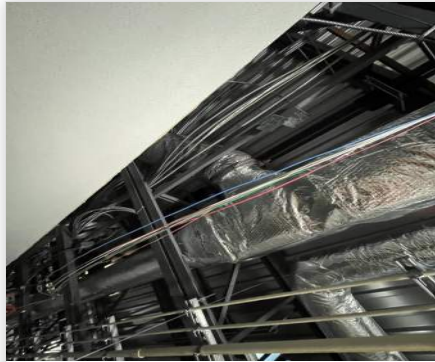
**Issue Name :** 11. Flex connection to linear  
**Description :** Ensure that when the flex duct connection is made to linear there is no kinked flex or pinched ductwork when installed. Space is very tight due to plumbing install not being tighter.  
**Created By :** National TAB                      **Assigned To :** National TAB - Tyler Youells  
**Status :** Open  
**Priority :** Medium                                      **Asset Tag :**  
**Originated Date :** 03/03/2026 - Tyler Youells - National TAB

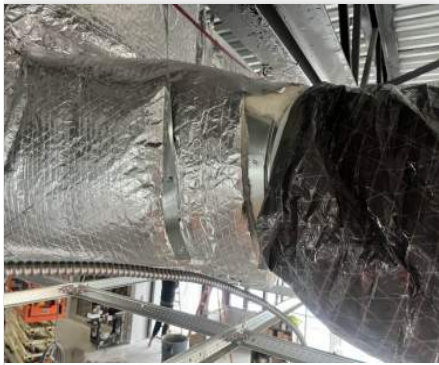
**Issue Name :** 12. Missing Damper- Return Grille  
**Description :** Rtu-1 Return grille does not have a damper installed. Install damper prior to TAB.  
**Created By :** National TAB                      **Assigned To :** National TAB - Tyler Youells  
**Status :** Open  
**Priority :** High                                      **Asset Tag :**  
**Originated Date :** 03/03/2026 - Tyler Youells - National TAB

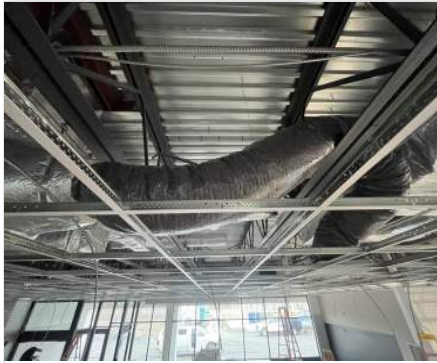
**Issue Name :** 13. Support flex duct  
**Description :** Flexible duct needs to be supported better. RTU-1 return grille.  
**Created By :** National TAB                      **Assigned To :** National TAB - Tyler Youells  
**Status :** Open  
**Priority :** Low                                      **Asset Tag :**  
**Originated Date :** 03/03/2026 - Tyler Youells - National TAB

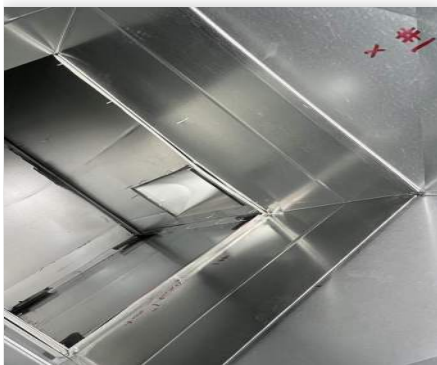
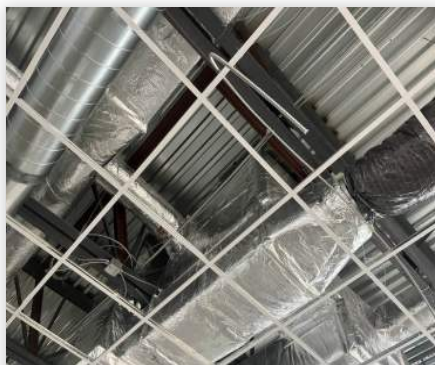
**Issue Name :** 14. Takeoff Orientation RTU-1 drop  
**Description :** Takeoff for Staging room diffuser is facing the opposite direction based on the transition piece. Per MC if the transition was facing the correct way ductwork would interfere with structure, also the damper would then not be accessible. Recommend review by EOR.  
**Created By :** National TAB                      **Assigned To :** National TAB - Tyler Youells  
**Status :** Open  
**Priority :** Low                                      **Asset Tag :**  
**Originated Date :** 03/04/2026 - Tyler Youells - National TAB

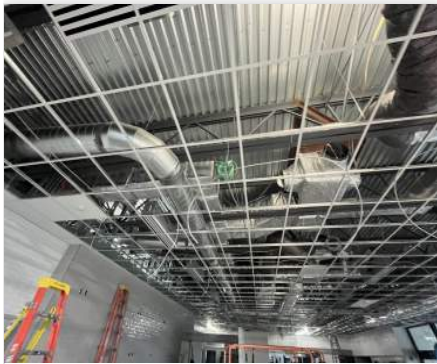
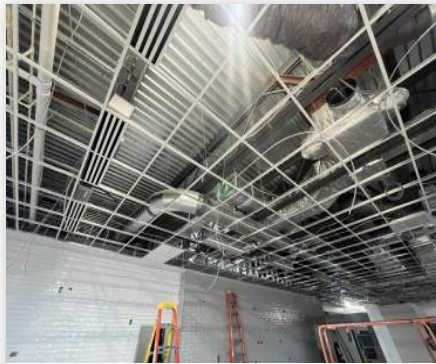
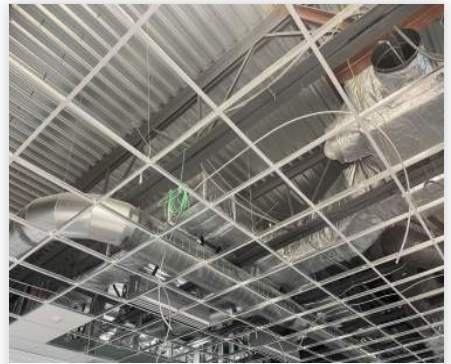
**Issue Name :** 15. Duct for 2x linears  
**Description :** Duct not installed yet for 2x linears. Per MC they were going to takeoff from the bottom of the main trunkline in order to avoid structure. Recommend EOR review and approve if that is an acceptable solution  
**Created By :** National TAB                      **Assigned To :** National TAB - Tyler Youells  
**Status :** Open  
**Priority :** High                                      **Asset Tag :**  
**Originated Date :** 03/04/2026 - Tyler Youells - National TAB

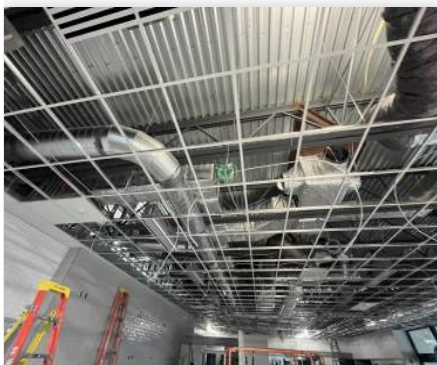
**Issue Name :** 16. Takeoff location  
**Description :** Takeoff location for the Back of the house duct run for RTU-2 was slid up in order to avoid structure. info only. This caused a problem finding a spot for the two linear diffusers serving specialty beverage to to take off without hitting structure.  
**Created By :** National TAB                      **Assigned To :** National TAB - Tyler Youells  
**Status :** Open  
**Priority :** InfoOnly                                      **Asset Tag :**  
**Originated Date :** 03/04/2026 - Tyler Youells - National TAB

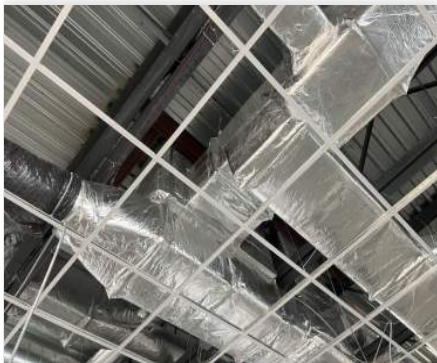
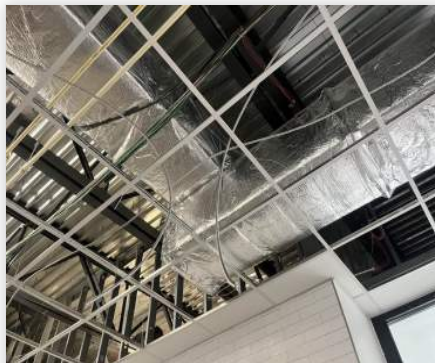
**Issue Name :** 17. Keynote 9 Transition  
**Description :** Info only: Keynote 9 transition has caused problems with TAB for a couple other WAWA locations, believe turbulence is causing restriction that has to be overcome with speeding the unit up and increasing overall system pressure. Recommend EOR review.  
**Created By :** National TAB                      **Assigned To :** National TAB - Tyler Youells  
**Status :** Open  
**Priority :** InfoOnly                                      **Asset Tag :**  
**Originated Date :** 03/04/2026 - Tyler Youells - National TAB

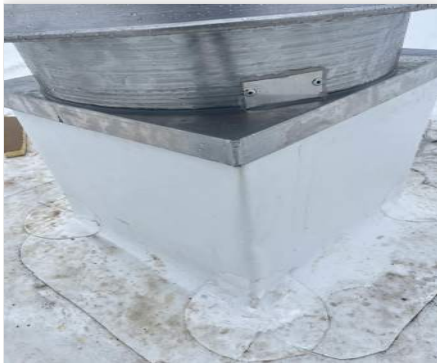
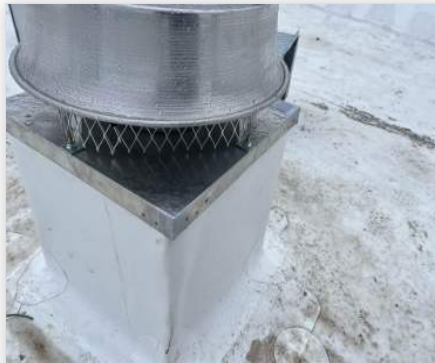
**Issue Name :** 18. Secure EFs to curbs  
**Description :** Secure Efs to curb with appropriate fasteners.  
**Created By :** National TAB                      **Assigned To :** National TAB - Tyler Youells  
**Status :** Open  
**Priority :** Low                                      **Asset Tag :**  
**Originated Date :** 03/04/2026 - Tyler Youells - National TAB

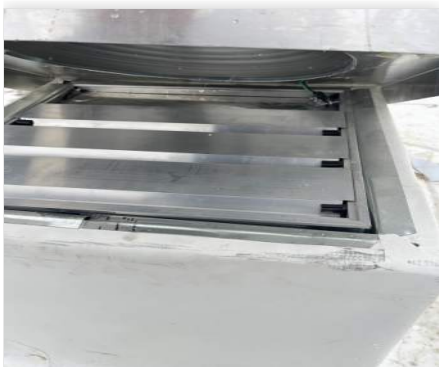
**Issue Name :** 19. Adjust backdraft Damper  
**Description :** Adjust Backdraft damper for EF-2 so that it can fully open when the fan is running.  
**Created By :** National TAB                      **Assigned To :** National TAB - Tyler Youells  
**Status :** Open  
**Priority :** High                                      **Asset Tag :**  
**Originated Date :** 03/04/2026 - Tyler Youells - National TAB
