## 10-03 KROGER 025-387 - COLLIERVILLE, TN (WIW)

**Issue Name :** RTU1 Alarm Code  
**Description :** RTU is displaying alarm 93, see picture attached.  
**Created By :** National TAB **Assigned To :** National TAB - Will Turnbough  
**Status :** Open  
**Originated Date :** 10/05/2022 - Travis Halter - National TAB

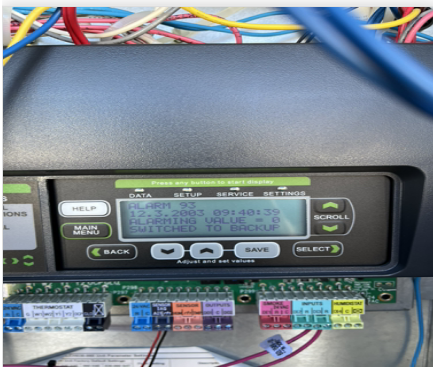
FuselT8199ba812b7b45....

- **10/05/2022 National TAB - Travis Halter**
  - Code information message: "Unit did not receive any primary control/sensor input data monitored at P298-7 or over the network if controller is configured to reference the network for remote demands or zone temperature as the primary control/sensor input source - unit will run using the configured backup mode choice."

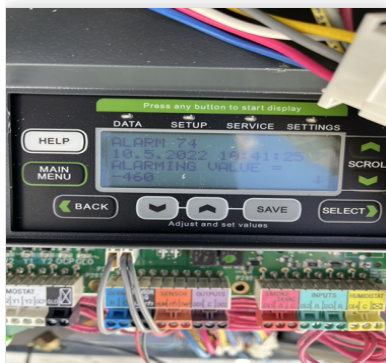
FuselT7d9089c1e61c47.jpeg

**Issue Name :** RTU1&2 Prodigy Alarms

**Description :** Both units have alarm 74

- Code information message: "Equipment local zone temperature sensor failure A2. Failed or miswired zone temperature sensor causing a loss of local temperature sensor data monitored at P298-6 and 7 sensor is 11Kohm @ 77 degree type 2 sensor temperature range is 36 - 100 degrees F.
