10-03 KROGER 025-387 - COLLIERVILLE, TN (WIW)

Project Issue Information

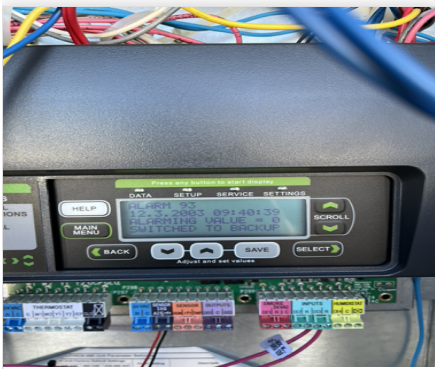
FuseIT8199ba812b7b45....

Issue Name : RTU1 Alarm Code
Description : RTU is displaying alarm 93, see picture attached.
Created By : National TAB **Assigned To :** National TAB - Will Turnbough
Status : Open
Originated Date : 10/05/2022 - Travis Halter - National TAB

- **10/05/2022 National TAB - Travis Halter**
 - Code information message: "Unit did not receive any primary control/sensor input data monitored at P298-7 or over the network if controller is configured to reference the network for remote demands or zone temperature as the primary control/sensor input source - unit will run using the configured backup mode choice."

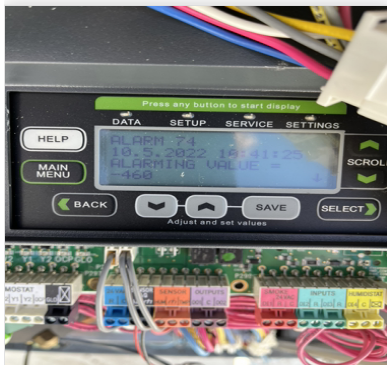
FuseIT7d9089c1e61c47.jpeg

Issue Name : RTU1&2 Prodigy Alarms

Description : Both units have alarm 74

- Code information message: "Equipment local zone temperature sensor failure A2. Failed or miswired zone temperature sensor causing a loss of local temperature sensor data monitored at P298-6 and 7 sensor is 11Kohm @ 77 degree type 2 sensor temperature range is 36 - 100 degrees F.
