Report: ISSUES

Function: Test, Adjust, & Balance

Date: 11/27/2023

11-27-23 CULVERS-DELANO, MN

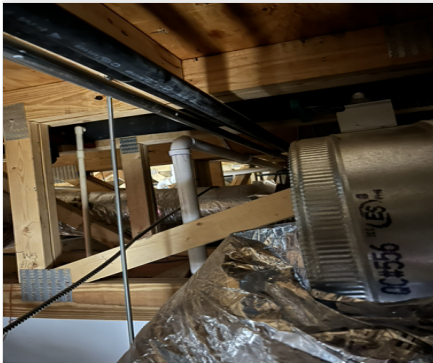
Issue Name : RTU-2 Return Closed/Not Connected
Description : RTU-2, Kitchen, return found disconnected and closed on arrival. Return damper was opened but duct needs to be attached. Unit is pulling from ceiling space. Needs service.
Created By : National TAB **Assigned To :** National TAB - Michael McDonnell
Status : Open
Priority : **Asset Tag :**
Originated Date : 11/27/2023 - Michael McDonnell - National TAB

Notconnected
11/27/2023

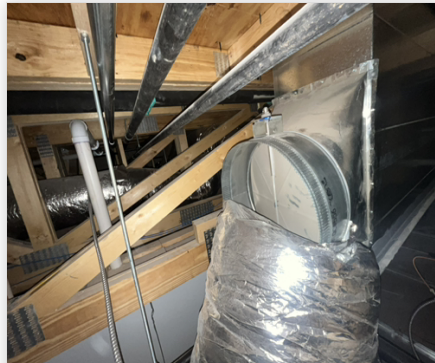
Returnclosed
11/27/2023

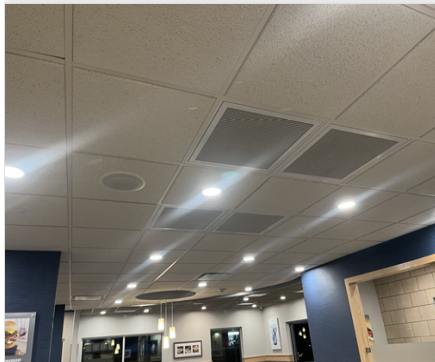
RTU-1Returns
11/27/2023

Issue Name : RTUs: Incorrect Number of Returns
Description : Plans call for RTU-1 to have seven 22" returns installed. Four 16" returns appear to be installed. RTU-2 was to have seven 22" returns. Four 16" returns appear installed. Both RTUs are at/near Full Load Amperage to achieve design airflow. Suspect lack or return is contributing. Recommend returns installed per plans.
Created By : National TAB **Assigned To :** National TAB - Michael McDonnell
Status : Open
Priority : Urgent **Asset Tag :**
Originated Date : 11/27/2023 - Michael McDonnell - National TAB
