**Report: ISSUES**  
**Function: Test, Adjust, & Balance**  
**Date: 11/27/2023**

**PROJECT**  
**11-27-23 CULVERS-DELANO, MN**

800 Babcock Blvd

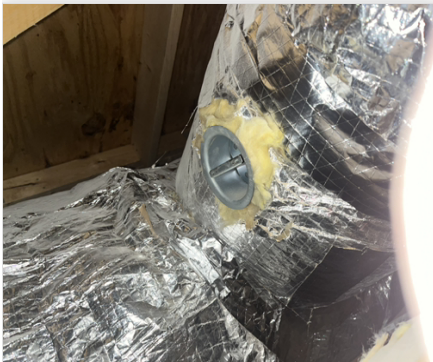
**Issue Name :** Branch Damper Partially Closed  
**Description :** Branch Dampers are installed on the system. Plans DO NOT call for branch dampers in ANY of the locations they are installed. Recommend they are removed. One Branch damper is partially closed on the Dining system and cannot be fully opened. This is restricting airflow. Area of the dining is low on airflow as result. Damper must be opened or removed.  
**Created By :** National TAB                      **Assigned To :** National TAB - Michael McDonnell  
**Status :** Open  
**Priority :**    **Asset Tag :**  
**Originated Date :** 11/27/2023 - Michael McDonnell - National TAB

**Partiallyclosed**  
11/27/2023

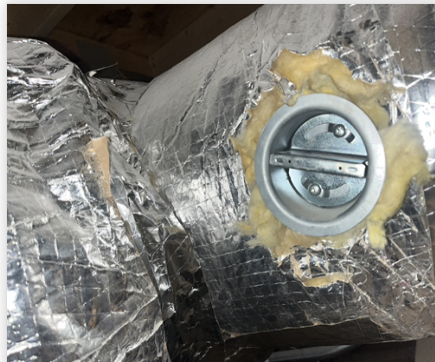
**Stuck**  
11/27/2023

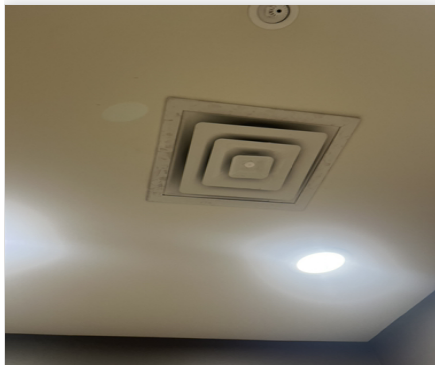
**Issue Name :** PRV-1 (RR Exhaust) Incorrect Grilles Installed  
**Description :** Installed Exhaust grilles in bathroom are supply grilles (SD-4). Plans call for EG-1 return grilles with OBD face damper. Installed grilles do not have have face damper and cannot be balanced. Recommend correct grilles are installed.

**Incorrect**  
**11/27/2023**

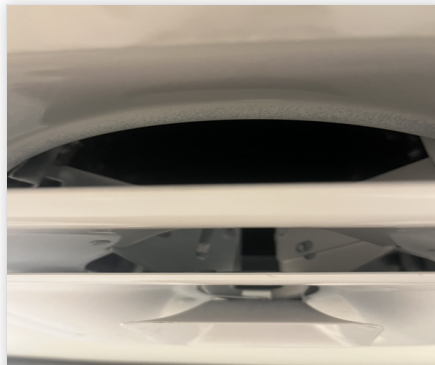
**Nodamper(1)**  
**11/27/2023**

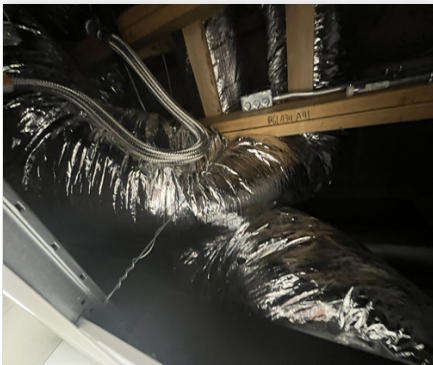
**Issue Name :** RTU-2 Diffuser Flex Duct Pinched  
**Description :** Flex duct running to diffuser 2-11 is pinched and restricting airflow. Recommend duct is rerouted so as not to be pinched.  
**Created By :** National TAB                      **Assigned To :** National TAB - Michael McDonnell  
**Status :** Open  
**Priority :**    **Asset Tag :**  
**Originated Date :** 11/27/2023 - Michael McDonnell - National TAB

Ductpinched  
11/27/2023

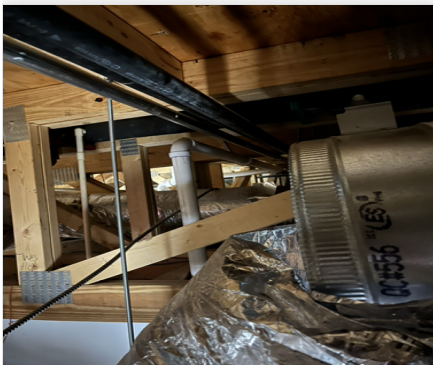
**Issue Name :** RTU-2 Return Closed/Not Connected  
**Description :** RTU-2, Kitchen, return found disconnected and closed on arrival. Return damper was opened but duct needs to be attached. Unit is pulling from ceiling space. Needs service.  
**Created By :** National TAB                      **Assigned To :** National TAB - Michael McDonnell  
**Status :** Open  
**Priority :**    **Asset Tag :**  
**Originated Date :** 11/27/2023 - Michael McDonnell - National TAB

**Notconnected**  
**11/27/2023**

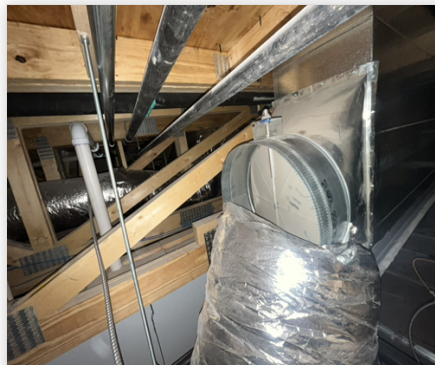
**Returnclosed**  
**11/27/2023**
