Report: TAB Report
Function: Test, Adjust, & Balance
Date: 09/05/2025
Completed By: National TAB

PROJECT
08-25-25 WAWA #6613 CHANTILLY, VA

Project: 08-25-25 WAWA #6613 CHANTILLY, VA

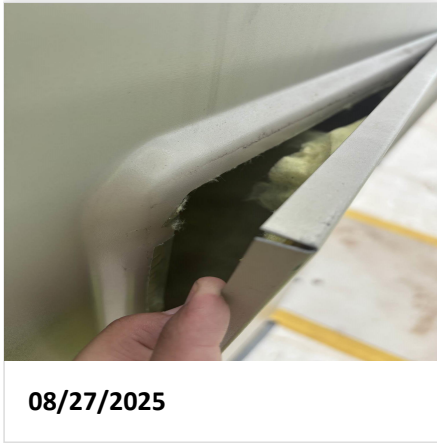
Issue Name : ALL RTU's MIXED AIR COMPARTMENT PLENUM PANEL INSULATION
Description : Insulation is coming loose from inside the mixed air compartment.
Recommend re-securing.
Created By : National TAB **Assigned To :** National TAB - Cody Mauro
Status : Open
Priority : High **Asset Tag :**
Originated Date : 08/27/2025 - Cody Mauro - National TAB

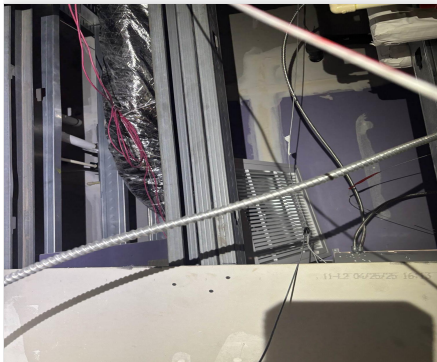
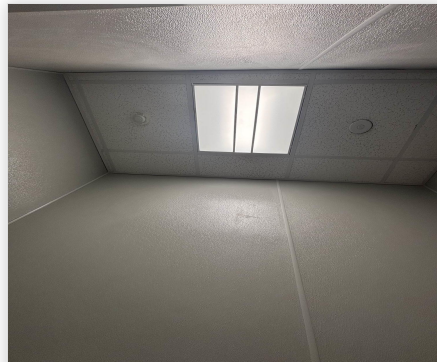
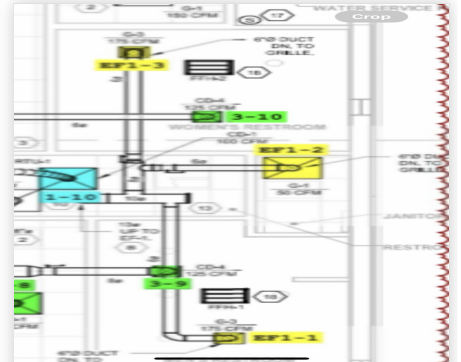
Issue Name : EF1-2 DIFFUSER
Description : Ef1-2 diffuser is sitting above the ceiling, not installed. Unable to measure airflow
Created By : National TAB **Assigned To :** National TAB - Cody Mauro
Status : Open
Priority : High **Asset Tag :**
Originated Date : 08/28/2025 - Cody Mauro - National TAB

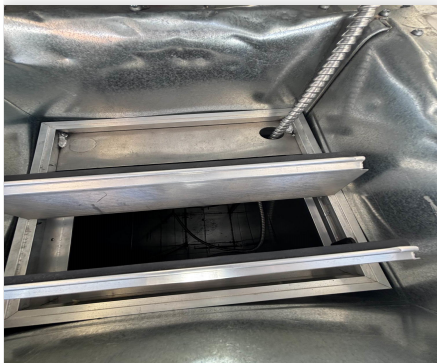
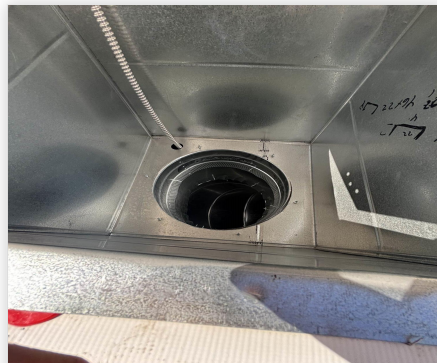
Issue Name : EF2 AIRFLOW LOW
Description : Airflow measured as 869 CFM out of design of 1400 CFM. Design static pressure is 0.25" but the actual static pressure is 0.56" which indicates restriction. Need the mechanical contractor to verify that the balancing dampers are fully open and not closed.
Created By : National TAB **Assigned To :** National TAB - Cody Mauro
Status : Open
Priority : High **Asset Tag :** EF2
Originated Date : 08/28/2025 - Cody Mauro - National TAB

Test Data		
	Design	Actual
CFM	1400	869
Fan Rotation	-	CORRECT
Total ESP	0.250"	0.56'
Fan Inlet SP	-	0.56
Fan Discharge SP	-	ATM

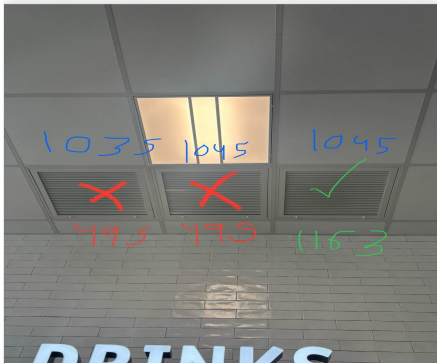
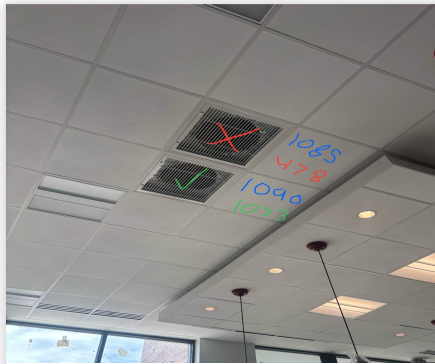
Issue Name : RTU 1 & 3 RETURN DAMPERS
Description : RTU 1 & 3 appear to have closed return dampers. There is elevated static pressure at the units as a result. Need assistance from the mechanical contractor to open the dampers due to the height of the ceiling.
Created By : National TAB **Assigned To :** National TAB - Cody Mauro
Status : Open
Priority : High **Asset Tag :**
Originated Date : 08/28/2025 - Cody Mauro - National TAB

RTU1, RTU3 return diffusers majorly closed. Causing high static pressure in unit

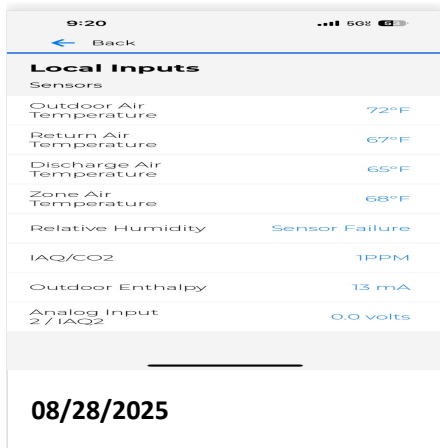
Issue Name : RTU2 SENSOR
Description : There is no heating testing mode on the unit. Unable to test heating. The humidity sensor is also failing to display. Startup needs to be completed on the unit and ensure that the humidity sensor is reading accurately.
Created By : National TAB **Assigned To :** National TAB - Cody Mauro
Status : Open
Priority : High **Asset Tag :**
Originated Date : 08/28/2025 - Cody Mauro - National TAB

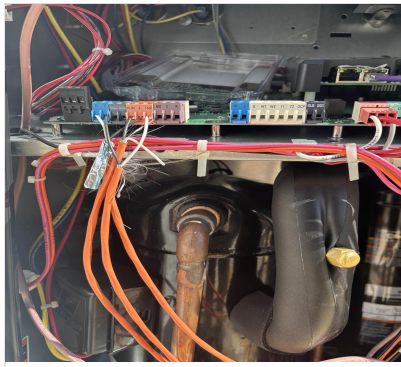
RTU1: 62% RTU2: Sensor Failure RTU3: 55%

Outdoor Air Temperature	72°F
Return Air Temperature	67°F
Discharge Air Temperature	65°F
Zone Air Temperature	68°F
Relative Humidity	Sensor Failure
IAQ/CO2	1PPM
Outdoor Enthalpy	13 mA
Analog Input 2 / IAQ2	0.0 volts

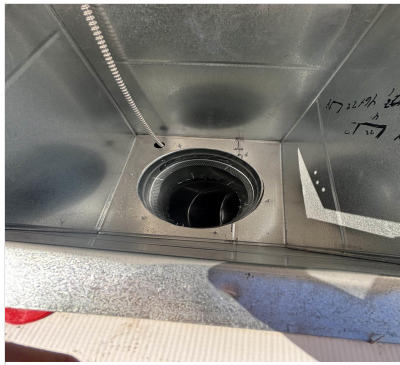
No backdraft damper installed for EF2

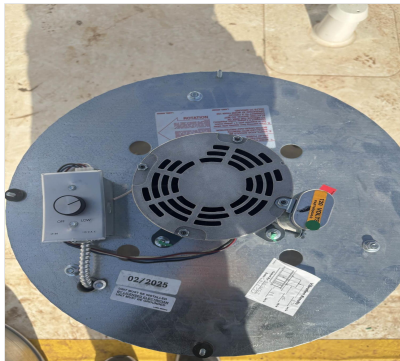
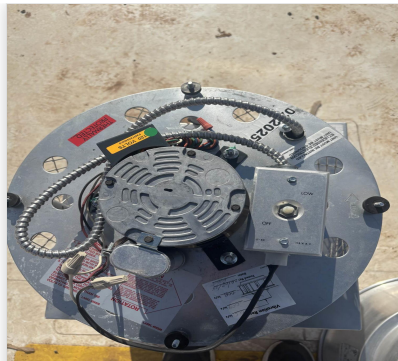
Speed controllers for both EF's are maxed, total not within +/-5%. Grilles unable to be balanced due to lack of air.
