Report: TAB Report
Function: Test, Adjust, & Balance
Date: 09/05/2025
Completed By: National TAB

PROJECT
08-25-25 WAWA #6613 CHANTILLY, VA

Project: 08-25-25 WAWA #6613 CHANTILLY, VA

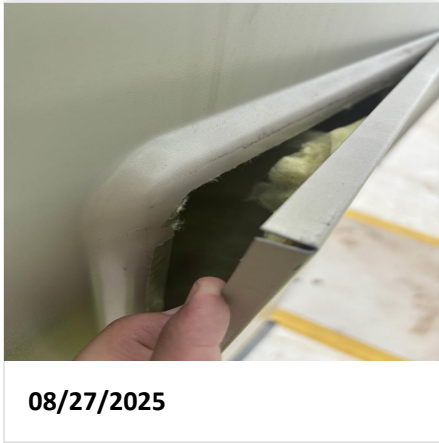
Issue Name : ALL RTU's MA PLENUM PANEL INSULATION
Description : Insulation not sealed to MA Plenum panel Can cause insulation to be sucked into fan! Noticed when taking pressures
Created By : National TAB **Assigned To :** National TAB - Cody Mauro
Status : Open
Priority : High **Asset Tag :**
Originated Date : 08/27/2025 - Cody Mauro - National TAB

Cannot open panel without insulation getting sucked off. Needs to be resealed

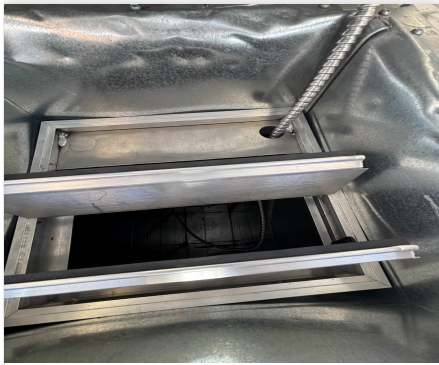
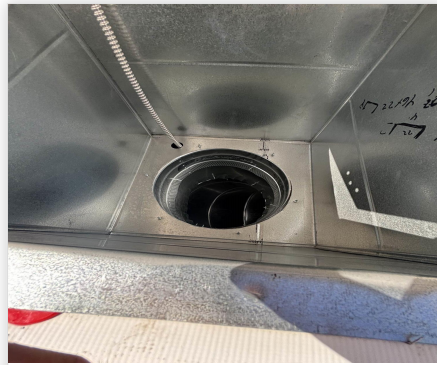
Issue Name : EF1 & 2 LOW

Description : Both speed controller dials are max speed, not enough total exhaust from either EF

Speed controllers for both EF's are maxed, total not within +/-5%. Grilles unable to be balanced due to lack of air.

EF1-2 Janitorial closet diffuser not installed, lying above ceiling. Not suspecting this to be major cause for cfm loss.
 EF1 speed controller max speed.

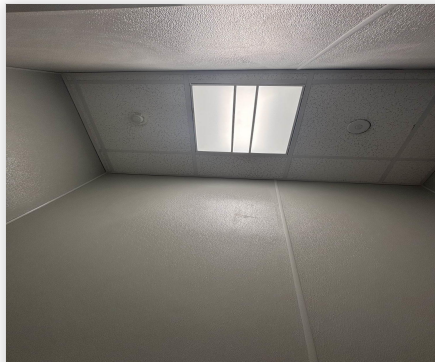
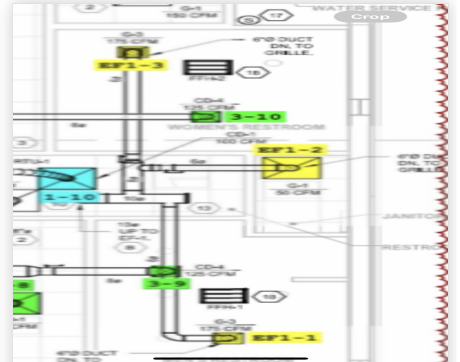
Issue Name : EF1-2 DIFFUSER

Description : Ef1-2 diffuser is sitting above the ceiling, not installed. Cannot reach to read cfm with Pitot tube Could very well be causing leakage of air

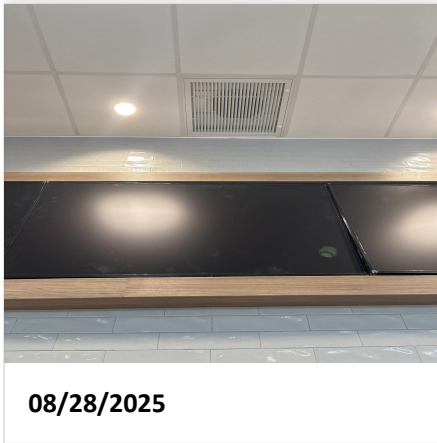
Issue Name : EF2-4 DIFFUSER
Description : Cannot get seal on diffuser due to location above TV's
Created By : National TAB **Assigned To :** National TAB - Cody Mauro
Status : Open
Priority : Medium **Asset Tag :**
Originated Date : 08/28/2025 - Cody Mauro - National TAB

Notes:
 Speed controller max speed
 Cannot hit dampers of exhaust grilles
 EF2-4 cannot get proper flow hood seal due to grille placement above TV Frame
 No backdraft damper installed

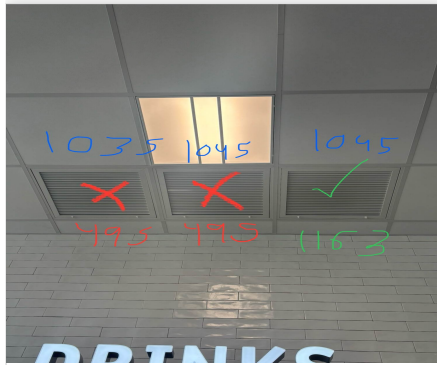
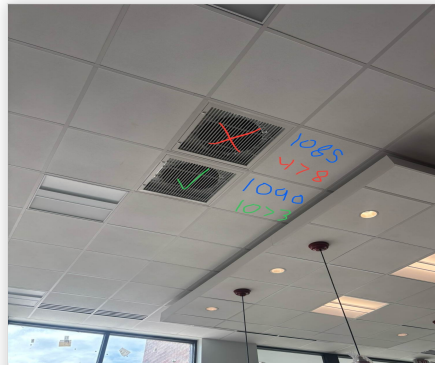
Issue Name : RTU 1 & 3 PRESSURE
Description : RTU 1 & 3 have high static pressures due to closed return grilles.
Created By : National TAB **Assigned To :** National TAB - Cody Mauro
Status : Open
Priority : Urgent **Asset Tag :**
Originated Date : 08/28/2025 - Cody Mauro - National TAB

RTU1, RTU3 return diffusers majorly closed. Causing high static pressure in unit

Static return pressure high due to 2 return diffusers shut
 Totals were taken, balancing unable to be taken place

Static return pressure high due to 1 return diffuser shut
 Totals were taken, balancing unable to be taken place

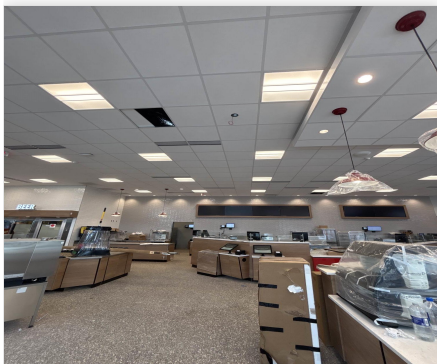
Issue Name : RTU DIFFUSERS
Description : Unable to reach ceiling diffusers, need some type of lift or taller ladder
Cannot hit diffuser dampers
Created By : National TAB **Assigned To :** National TAB - Cody Mauro
Status : Open
Priority : High **Asset Tag :**
Originated Date : 08/25/2025 - Cody Mauro - National TAB

Supply & OA balanced within +/-5%, diffusers are unable to be tampered due to high ceilings. Cannot reach.

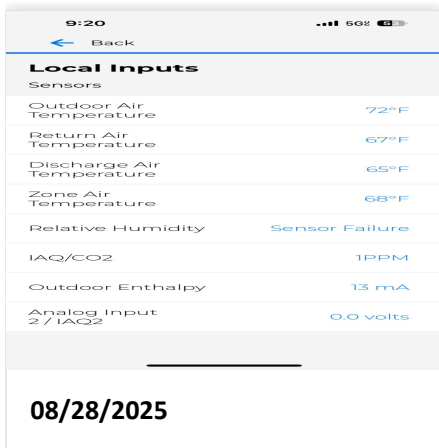
Issue Name : RTU2 SENSOR
Description : There is no heating testing mode on the unit. The humidity sensor is also failing to display.
Created By : National TAB **Assigned To :** National TAB - Cody Mauro
Status : Open
Priority : Urgent **Asset Tag :**
Originated Date : 08/28/2025 - Cody Mauro - National TAB

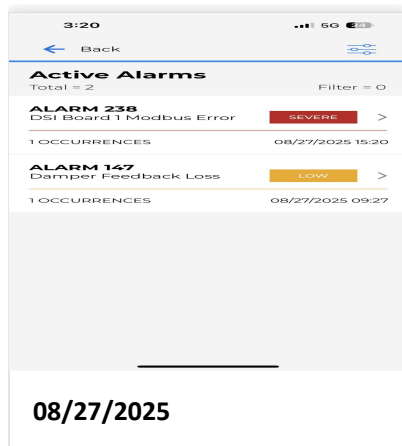
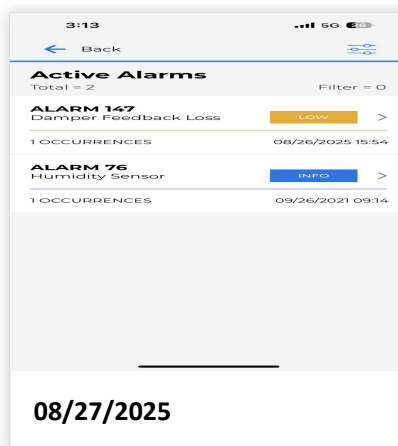
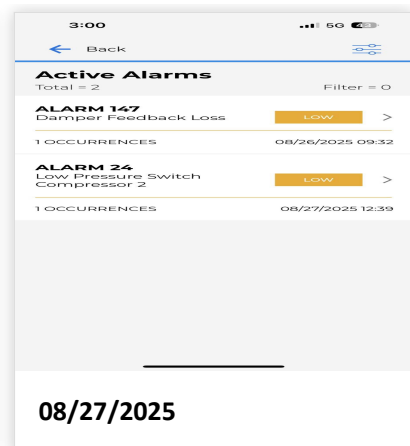
No alarms present?

Fail

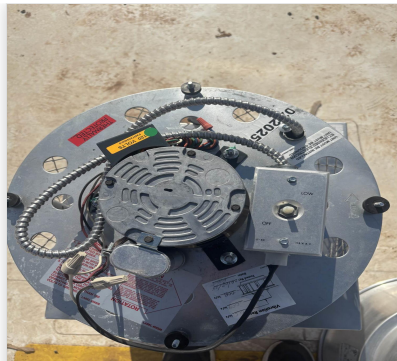
Total exhaust flow balanced within +/-5% and grilles are within +/-10%?
