Report: TAB Report
Function: Test, Adjust, & Balance
Date: 09/05/2025
Completed By: National TAB

PROJECT
08-25-25 WAWA #6613 CHANTILLY, VA

Project: 08-25-25 WAWA #6613 CHANTILLY, VA

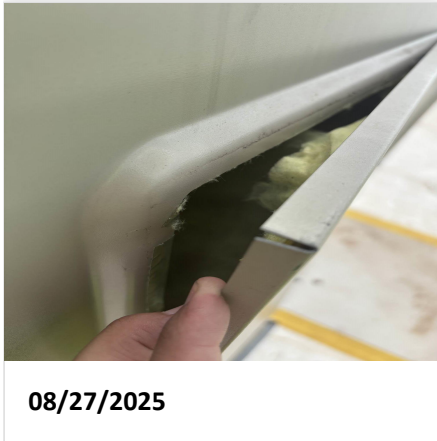
Issue Name : ALL RTU's MIXED AIR COMPARTMENT PLENUM PANEL INSULATION
Description : Insulation is coming loose from inside the mixed air compartment. Recommend re-securing.
Created By : National TAB **Assigned To :** National TAB - Cody Mauro
Status : Open
Priority : High **Asset Tag :**
Originated Date : 08/27/2025 - Cody Mauro - National TAB

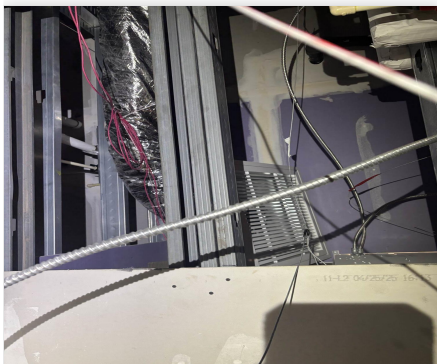
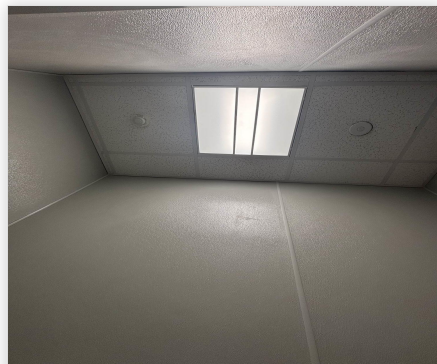
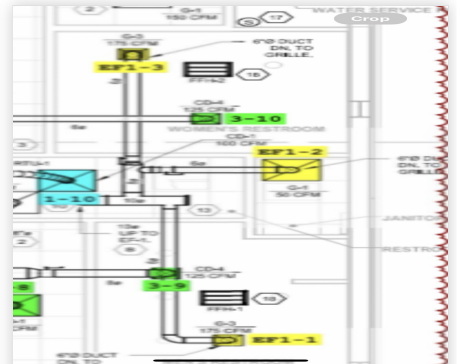
Issue Name : EF1-2 DIFFUSER
Description : Ef1-2 diffuser is sitting above the ceiling, not installed. Unable to measure airflow
Created By : National TAB **Assigned To :** National TAB - Cody Mauro
Status : Open
Priority : High **Asset Tag :**
Originated Date : 08/28/2025 - Cody Mauro - National TAB

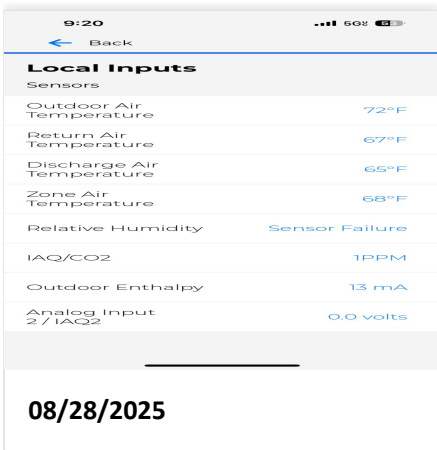
Issue Name : RTU2 SENSOR
Description : There is no heating testing mode on the unit. Unable to test heating. The humidity sensor is also failing to display. Startup needs to be completed on the unit and ensure that the humidity sensor is reading accurately.
Created By : National TAB **Assigned To :** National TAB - Cody Mauro
Status : Open
Priority : High **Asset Tag :**
Originated Date : 08/28/2025 - Cody Mauro - National TAB

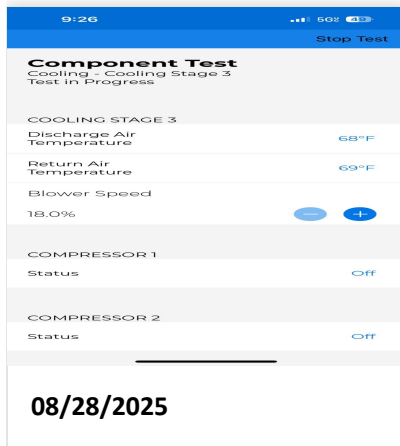
RTU1: EAT - 57F, LAT - 67F RTU2: EAT - 55F, LAT - 67F RTU3: EAT - 55F, LAT - 72F
