**Report: TAB REPORT
Function: Test, Adjust, & Balance
Date: 9/15/2022**

09-12 GERBES #615-124 - COLUMBIA, MO

**KROGER (DILLONS) 615
KPS LLC
2620 ELM HILL PIKE
NASHVILLE, TN 37214**

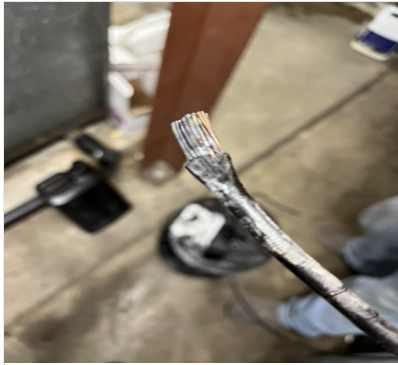
Burntwire.jpeg

Per facility tech, when the vfd was slowed down to 50hz, the motor overheated and the breaker tripped. The vfd wiring was checked and loose, burnt wire was found (repaired)
