**Report: REPORT
Function: Test, Adjust, & Balance
Date: 9/15/2022**

PROJECT
09-12 GERBES #615-124 - COLUMBIA, MO
1729 W Broadway
Columbia, MO 65203

09-12 GERBES #615-124 - COLUMBIA, MO

Name : EVALUATION **Status :** NotSubmitted
Assigned Organization : National TAB **Asset :**
Requesting Organization : National TAB

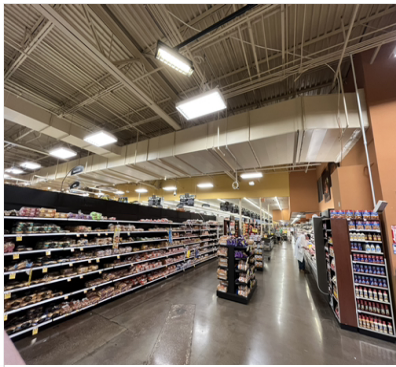
Maintrunk.jpeg

Ductwork

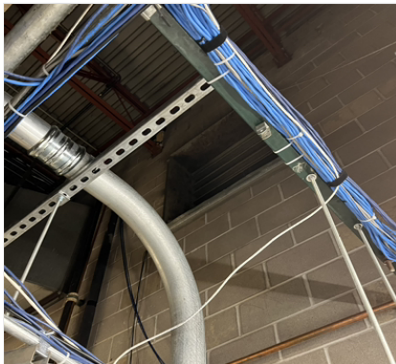
Return.jpeg

Oa intake and return air damper were closed and opened up by Adil recently prior to TAB. There is also a tunnel return.

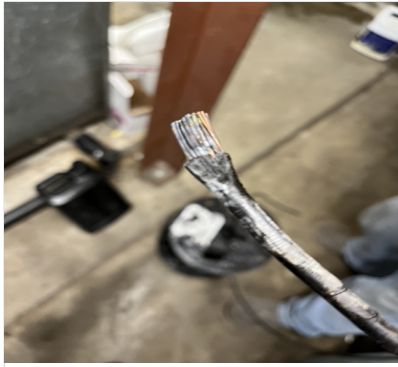
Burntwire.jpeg

Per facility tech, when the vfd was slowed down to 50hz, the motor overheated and the breaker tripped. The vfd wiring was checked and loose, burnt wire was found (repaired)

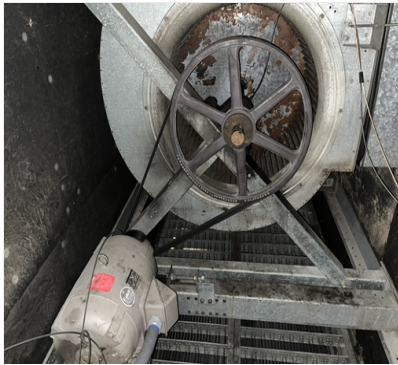
FuseIT1a711db6ceab470...

Blower compartment (blower cleaned recently)
