**Report: TAB REPORT  
Function: Test, Adjust, & Balance  
Date1: 09/13/2022**

**09-12 GERBES #615-124 - COLUMBIA, MO**

**KROGER (DILLONS) 615  
KPS LLC  
2620 ELM HILL PIKE  
NASHVILLE, TN 37214**

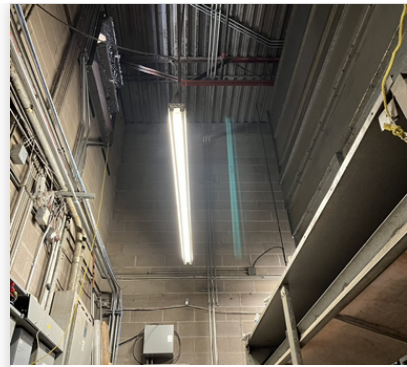
**Outsideair.jpeg**

Based on these measurements it would be around a 37% ratio of outside air at the AHU. The louver is directly above the AHU around 16' AFF and is air is dropping straight down towards the unit. The damper is approximately 40% open and needs to be closed to around 20%. But the damper is stuck and will not move. There is a pole used to try to knock it shut, but it won't budge.

Oa intake and return air damper were closed and opened up by Adil recently prior to TAB. There is also a tunnel return.

3. The outside air damper should be closed from it's current position of around 40% to 20%.
4. The vibration is much improved, but if it continues to be a nuisance, recommend installing another flexible connector on the supply duct in the mechanical room before the duct goes through the wall.
