Report: TAB REPORT
Function: Test, Adjust, & Balance
Date1: 09/13/2022

09-12 GERBES #615-124 - COLUMBIA, MO

Project: 09-12 GERBES #615-124 - COLUMBIA, MO

Project Summary

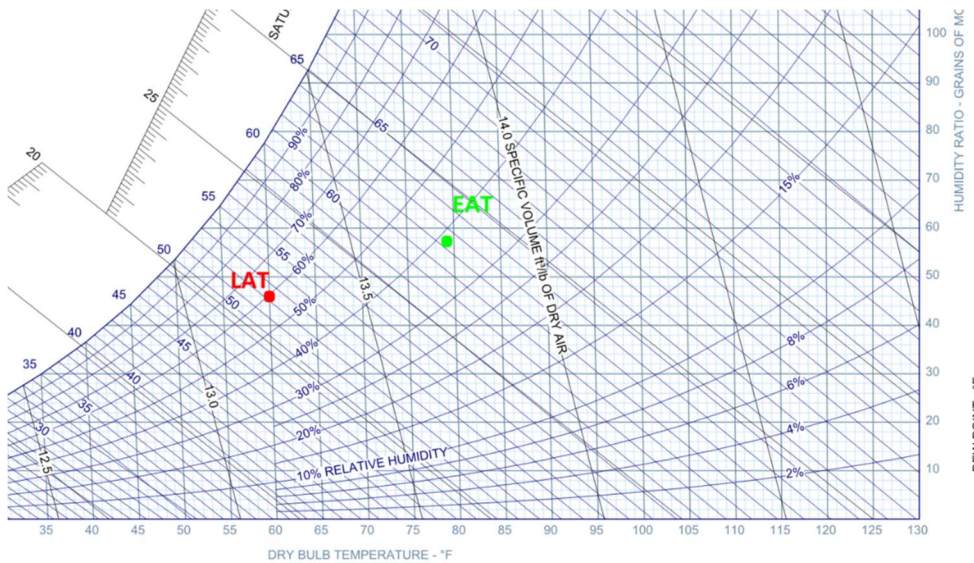
Using a Btuh calculation ($Btuh = 4.5 * CFM * \Delta \text{Enthalpy}$), 740,000 Btu's are being removed by the coil. This is the equivalent of 60 tons which is what Carrier indicated the coil is rated for. Plotting the process on a psychrometric chart, it appears that possibly the air not reaching the saturation temperature due to how dry the entering air is. But it could also indicate the heat reclaim or electric heat strip was on during the test.

6. Appears based on graphing the temperatures and humidity that the heat reclaim or electric heat strip could be on. Possibly this was intentional but unknown to us when performing our tests. Recommend ensuring that this was intentional or if not verifying controls are set up correctly.

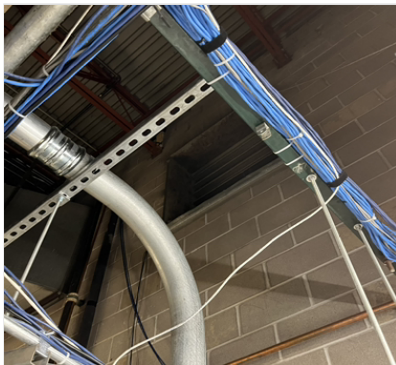
Return.jpeg

Oa intake and return air damper were closed and opened up by Adil recently prior to TAB. There is also a tunnel return.

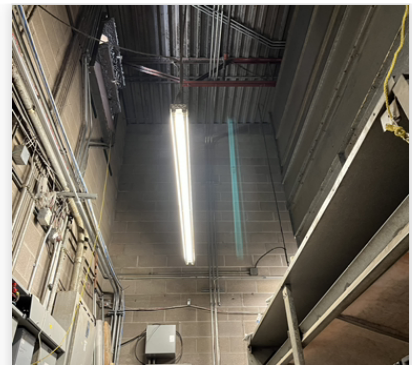
Outsideair.jpeg

Based on these measurements it would be around a 37% ratio of outside air at the AHU. The louver is directly above the AHU around 16' AFF and is air is dropping straight down towards the unit. The damper is approximately 40% open and needs to be closed to around 20%. But the damper is stuck and will not move. There is a pole used to try to knock it shut, but it won't budge.

3. The outside air damper should be closed from it's current position of around 40% to 20%.
4. The vibration is much improved, but if it continues to be a nuisance, recommend installing another flexible connector on the supply duct in the mechanical room before the duct goes through the wall.

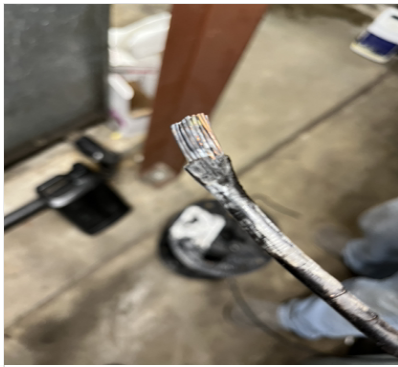
Burntwire.jpeg

Per facility tech, when the vfd was slowed down to 50hz, the motor overheated and the breaker tripped. The vfd wiring was checked and loose, burnt wire was found (repaired)

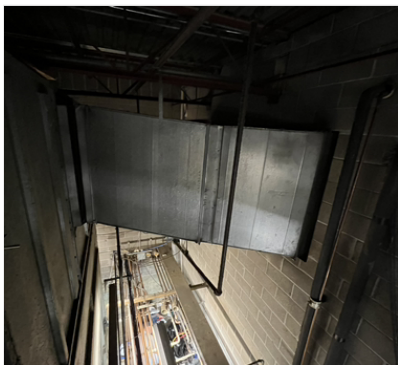
Fandischarge.jpeg

duct. After slowing down the vibration decreased significantly. It appears the cause for this vibration is the small duct size at the discharge of the AHU where air is the most turbulent. The duct at the connection to the AHU is not accessible for direct measurement, but on the duct is written 43"x36.75". That duct size would require 3400 FPM at 37,000 CFM and 2300 FPM at 25,000 CFM both of which are very high. Rule of thumb on systems of this size is 1000-1200 FPM. The duct then expands to 96x50 where it passes through the wall above the cooler, and then transitions to 96x32. These two duct sizes are acceptable. It was confirmed that at the connection of the AHU there is a flexible connector for vibration isolation. The vibration seems to be worst where the duct is secured to and passes through the wall. Vibration was not noted down stream at all. If further reduction is required an additional flexible connector prior to duct entering wall is recommended.

Ductwork vibrating and noisy at 60hz. Setting to 40hz greatly reduced. Appears to be due to high CFM and velocity at 60hz.
