**Report: EVALUATION**  
**Function: Test, Adjust, & Balance**  
**Date: 10/31/2024**  
**Completed By: National TAB**

**PROJECT**  
**Chili's - Lady Lake, FL**

Project: Chili's - Lady Lake, FL

The purpose of this building evaluation at Chili's in Lady Lake, FL was to provide an overall evaluation of the HVAC systems and balance of the space. There have been concerns about humidity issues within the building as well as balance concerns.

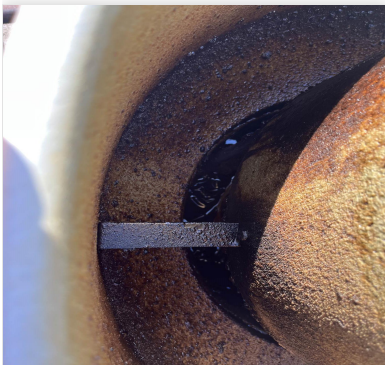
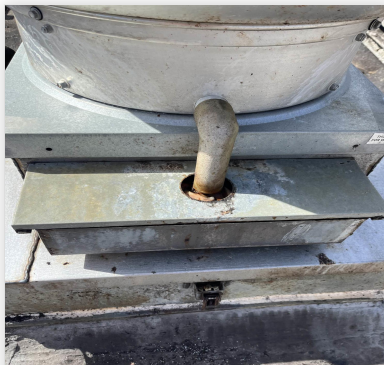
**Issue Name :** EF#2 is dirty  
**Description :** EF#2 servicing the left grill hood is full of grease and does not seem to be draining properly. Fan needs to be cleaned and made sure it properly drains grease.  
**Created By :** National TAB                      **Assigned To :** National TAB - Ian Fuller  
**Status :** Open  
**Priority :** Medium                                      **Asset Tag :**  
**Originated Date :** 11/04/2024 - Ian Fuller - National TAB

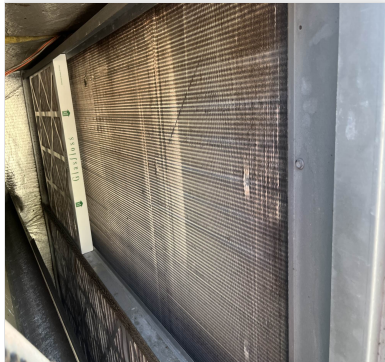
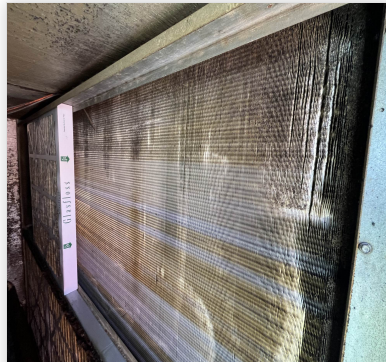
**Issue Name :** Evaporator coils are dirty on RTU#2 and RTU#3  
**Description :** Evaporator coils are dirty on RTU-2 and 3. Recommend cleaning.  
**Created By :** National TAB                      **Assigned To :** National TAB - Ian Fuller  
**Status :** Open  
**Priority :** High                                      **Asset Tag :**  
**Originated Date :** 11/04/2024 - Ian Fuller - National TAB

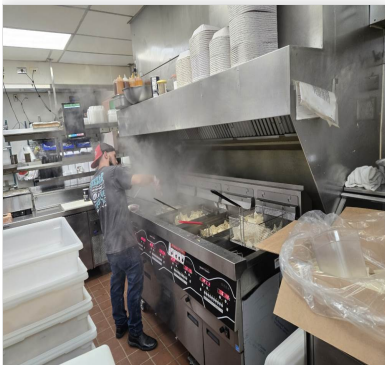
Exhaust airflow for the hoods was measured as is. The fryer and oven hood are both having capture and containment issues. The MUA for the hoods is a non-conditioned unit which is not recommended for Florida. During final TAB, if possible without worsening hood capture, it would be ideal to turn this unit off to avoid introducing more humidity into the space.

**Issue Name :** Fryer hood and Oven hood have smoke capture issues  
**Description :** Both fryer hood and oven hood do not capture all the smoke and is released into the kitchen. There is very little overhang of the hood on both the fryers and the oven.  
**Created By :** National TAB                      **Assigned To :** National TAB - Ian Fuller  
**Status :** Open  
**Priority :** High                                      **Asset Tag :**  
**Originated Date :** 11/04/2024 - Ian Fuller - National TAB

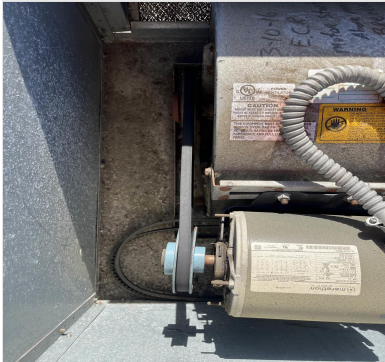
**Issue Name :** Makeup air pulleys are not alligned  
**Description :** Pulleys need to be alligned to lengthen the lifespan of belts and the motor.  
**Created By :** National TAB                      **Assigned To :** National TAB - Ian Fuller  
**Status :** Open  
**Priority :** Medium                                      **Asset Tag :**  
**Originated Date :** 11/04/2024 - Ian Fuller - National TAB

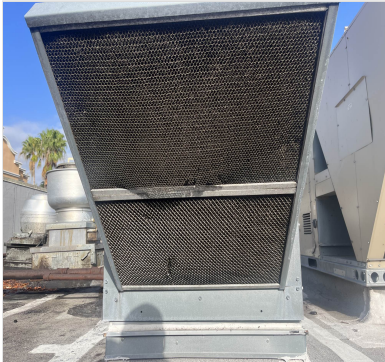
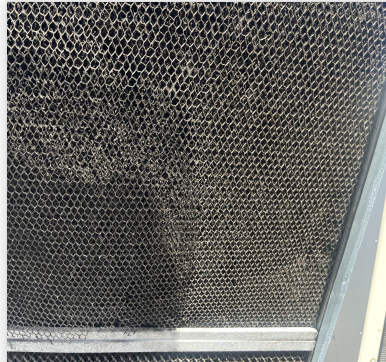
**Issue Name :** MUA outside air filters are dirty and slightly damaged  
**Description :** Recommended to clean or replace filters in order to help airflow of the makeup air unit.  
**Created By :** National TAB                      **Assigned To :** National TAB - Ian Fuller  
**Status :** Open  
**Priority :** Medium                                      **Asset Tag :**  
**Originated Date :** 11/04/2024 - Ian Fuller - National TAB

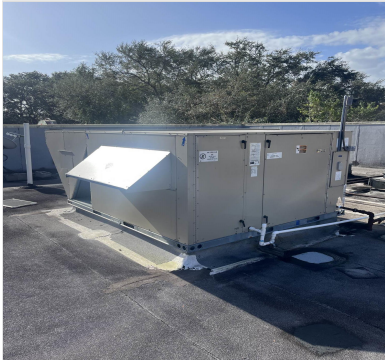
**Issue Name :** Outside air filter not secure on RTU#1  
**Description :** Outside air filter found laying on roof. Filter was put back into place. Recommended to secure OA filter to the unit.  
**Created By :** National TAB                      **Assigned To :** National TAB - Ian Fuller  
**Status :** Open  
**Priority :** Medium                                      **Asset Tag :**  
**Originated Date :** 11/04/2024 - Ian Fuller - National TAB

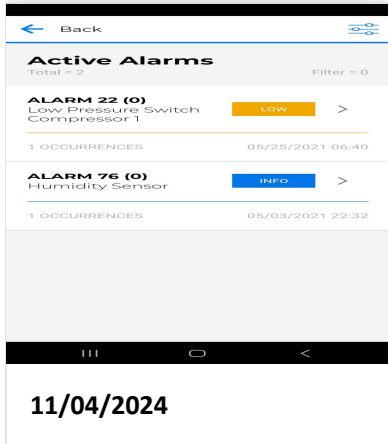
**Issue Name :** RTU#1 alarm 22: Low Pressure Switch Compressor 1  
**Description :** Alarm has shut down use of Compressor 1. Unit is unable to fully cool space.  
**Created By :** National TAB                      **Assigned To :** National TAB - Ian Fuller  
**Status :** Open  
**Priority :** Urgent                                      **Asset Tag :**  
**Originated Date :** 11/04/2024 - Ian Fuller - National TAB

1. Humidity sensor needs to be wired for RTU-1 per the manufacturers recommendations. This requires two separate shielded twisted pairs.
2. Alarms on RTU's 1 and 3 need to be resolved. It appears that they may be preventing 1<sup>st</sup> stage of cooling from operating.

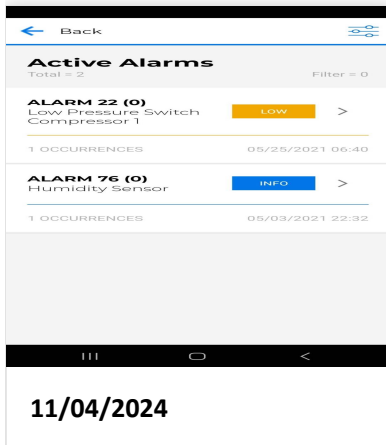
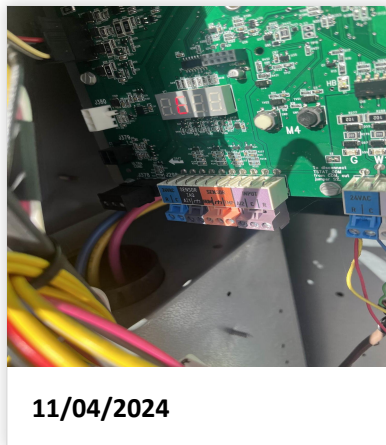
**Issue Name :** RTU#1 humidity sensor is not wired  
**Description :** RTU#1 has humidtrol on its package details, however, there is no humidity sensor wired to unit in order to control humidity of space it services. Recommended to wire humidity sensor to unit in order to dehumidify space.  
**Created By :** National TAB                      **Assigned To :** National TAB - Ian Fuller  
**Status :** Open  
**Priority :** **Urgent**                                      **Asset Tag :**  
**Originated Date :** 11/04/2024 - Ian Fuller - National TAB

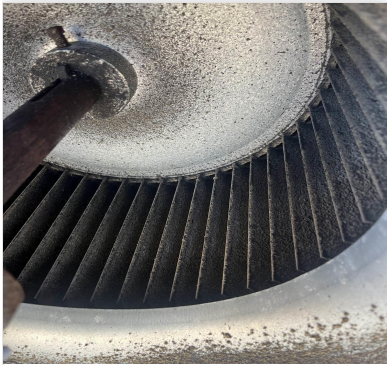
**Issue Name :** RTU#2 blower wheel is dirty  
**Description :** Recommended to clean blower wheel in order to prevent air flow issues.  
**Created By :** National TAB                      **Assigned To :** National TAB - Ian Fuller  
**Status :** Open  
**Priority :** High                                      **Asset Tag :**  
**Originated Date :** 11/04/2024 - Ian Fuller - National TAB

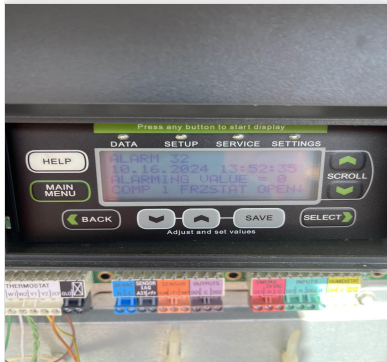
**Issue Name :** RTU#3 alarm 32: Comp 1 FRZSTAT  
**Description :** Alarm has shutdown use of compressor 1. Unit is unable to fully cool space.  
**Created By :** National TAB                      **Assigned To :** National TAB - Ian Fuller  
**Status :** Open  
**Priority :** Urgent                                      **Asset Tag :**  
**Originated Date :** 11/04/2024 - Ian Fuller - National TAB

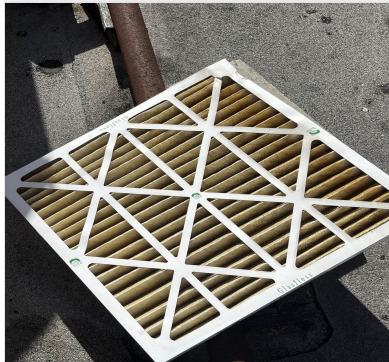
**Issue Name :** RTU#3 has dirty final filters  
**Description :** Final filters are compacted with dirt. Filters need to be replaced.  
**Created By :** National TAB                      **Assigned To :** National TAB - Ian Fuller  
**Status :** Open  
**Priority :** High                                      **Asset Tag :**  
**Originated Date :** 11/04/2024 - Ian Fuller - National TAB

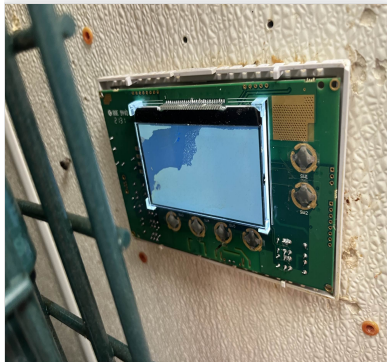
**Issue Name :** RTU#3 thermostat display is not functional  
**Description :** Thermostat display does not work. Staff is unable to control temperature in space. Recommended to replace thermostat.  
**Created By :** National TAB                      **Assigned To :** National TAB - Ian Fuller  
**Status :** Open  
**Priority :** High                                      **Asset Tag :**  
**Originated Date :** 11/04/2024 - Ian Fuller - National TAB

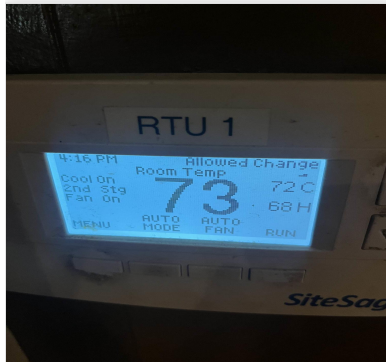
**Issue Name :** RTUs are on auto mode all day  
**Description :** Fans only run to reach temperature inside of space. Fans should run all day to keep pressure of building in order to not bring in humidity.  
**Created By :** National TAB                      **Assigned To :** National TAB - Ian Fuller  
**Status :** Open  
**Priority :** Urgent                                      **Asset Tag :**  
**Originated Date :** 11/04/2024 - Ian Fuller - National TAB

3. Powerhouse Dynamics needs to adjust their controls so that the RTU's are operating in fan ON mode while the restaurant is occupied and not fan auto.

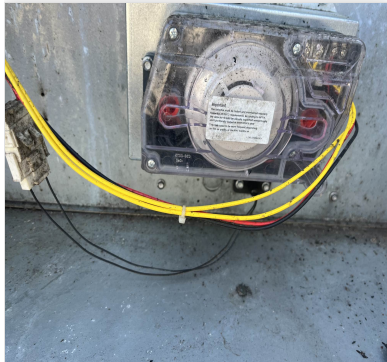
**Issue Name :** Smoke detector dust plug caps need to be removed  
**Description :** Dust plug caps need to be removed from RTU#1 and RTU#2  
**Created By :** National TAB                      **Assigned To :** National TAB - Ian Fuller  
**Status :** Open  
**Priority :** Medium                                      **Asset Tag :**  
**Originated Date :** 11/04/2024 - Ian Fuller - National TAB
