Report: EVALUATION
Function: Test, Adjust, & Balance
Date: 10/31/2024
Completed By: National TAB

PROJECT
Chili's - Lady Lake, FL

Project: Chili's - Lady Lake, FL

Summary

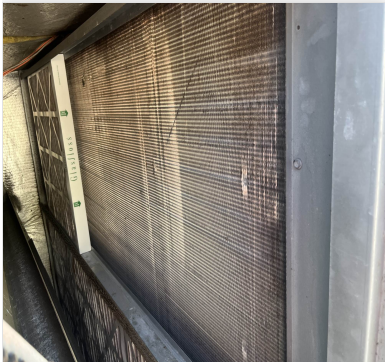
Issue Name : Evaporator coils are dirty on RTU#2 and RTU#3
Description : Evaporator coils are dirty on RTU-2 and 3. Recommend cleaning.
Created By : National TAB **Assigned To :** National TAB - Ian Fuller
Status : Open
Priority : High **Asset Tag :**
Originated Date : 11/04/2024 - Ian Fuller - National TAB

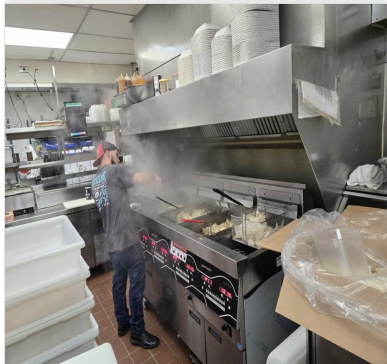
Exhaust airflow for the hoods was measured as is. The fryer and oven hood are both having capture and containment issues. The MUA for the hoods is a non-conditioned unit which is not recommended for Florida. During final TAB, if possible without worsening hood capture, it would be ideal to turn this unit off to avoid introducing more humidity into the space.

Issue Name : Fryer hood and Oven hood have smoke capture issues
Description : The fryer and oven hoods have smoke capture issues. Further evaluation and adjustments may be required during final TAB.
Created By : National TAB **Assigned To :** National TAB - Ian Fuller
Status : Open
Priority : High **Asset Tag :**
Originated Date : 11/04/2024 - Ian Fuller - National TAB

6. After completion of items 1 to 4, National TAB should return to perform the TAB to adjust RTU airflows, further investigate hood performance issues, set OA, and ensure positive building pressure.

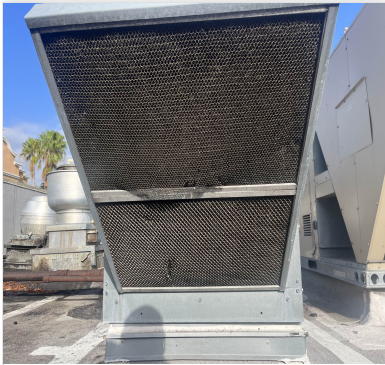
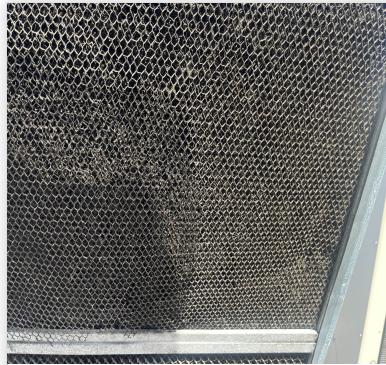
Issue Name : MUA outside air filters are dirty and slightly damaged
Description : Recommended to clean or replace filters to improve airflow
Created By : National TAB **Assigned To :** National TAB - Ian Fuller
Status : Open
Priority : Medium **Asset Tag :**
Originated Date : 11/04/2024 - Ian Fuller - National TAB

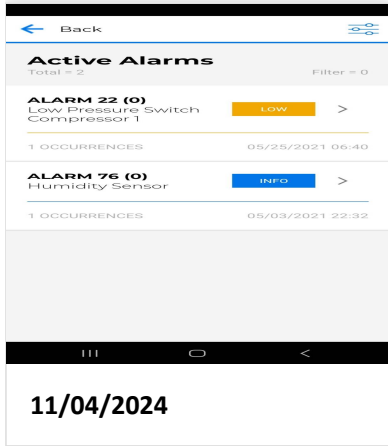
Airflow for the RTU's was measured. Based on a target airflow of 400 CFM/ton, RTU's 1 and 3 are both low on flow. RTU-3 is especially low. The outside air for the RTU's is also low and needs to be increased to ensure positive building pressure. RTU-1 has humidity control listed on it's options sticker but the humidity sensor is not wired. Therefore the unit is not dehumidifying currently. Both RTU's 1 and 3 have active compressor alarms that need to be addressed. s

Issue Name : RTU#1 alarm 22: Low Pressure Switch Compressor 1
Description : Alarm has shut down use of Compressor 1. Unit is unable to fully cool space.
Created By : National TAB **Assigned To :** National TAB - Ian Fuller
Status : Open
Priority : Urgent **Asset Tag :**
Originated Date : 11/04/2024 - Ian Fuller - National TAB

1. Humidity sensor needs to be wired for RTU-1 per the manufacturers recommendations. This requires two separate shielded twisted pairs.
2. Alarms on RTU's 1 and 3 need to be resolved. It appears that they may be preventing 1st stage of cooling from operating.

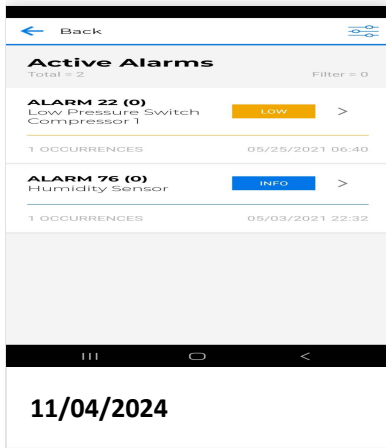
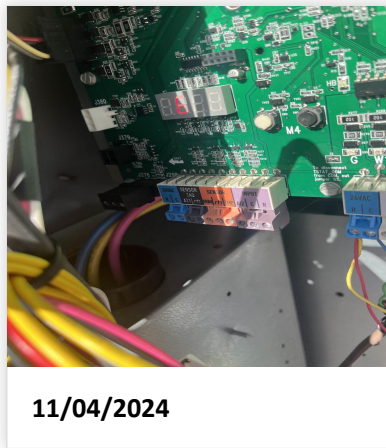
Issue Name : RTU#1 humidity sensor is not wired
Description : RTU#1 has humidtrol on its package details, however, there is no humidity sensor wired to the unit so it cannot dehumidify. Recommended to wire humidity sensor per manufacturers specifications (i.e., two separate shielded twisted pairs required).
Created By : National TAB **Assigned To :** National TAB - Ian Fuller
Status : Open
Priority : **Urgent** **Asset Tag :**
Originated Date : 11/04/2024 - Ian Fuller - National TAB

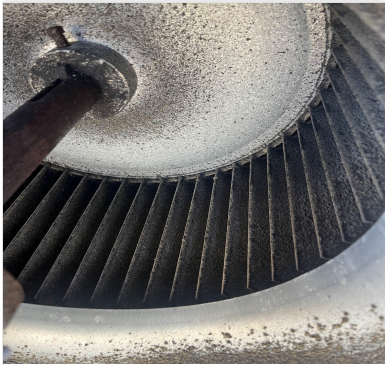
Issue Name : RTU#2 blower wheel is dirty
Description : Recommended to clean blower wheel.
Created By : National TAB **Assigned To :** National TAB - Ian Fuller
Status : Open
Priority : High **Asset Tag :**
Originated Date : 11/04/2024 - Ian Fuller - National TAB

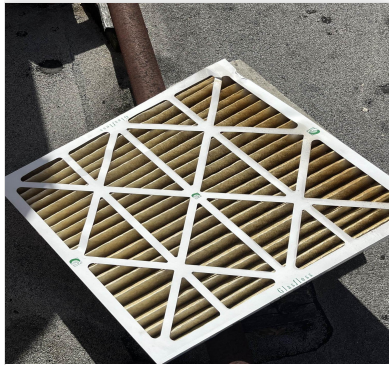
Issue Name : RTU#3 has dirty final filters
Description : Final filters are dirty and need to be replaced
Created By : National TAB **Assigned To :** National TAB - Ian Fuller
Status : Open
Priority : High **Asset Tag :**
Originated Date : 11/04/2024 - Ian Fuller - National TAB

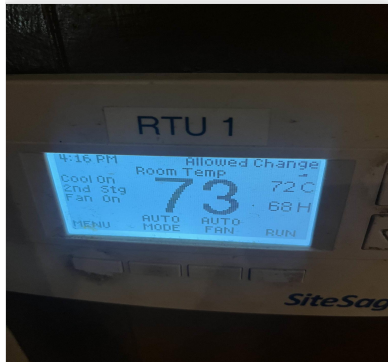
Issue Name : RTUs are on auto mode all day
Description : Fans need to be set to fan on during occupied hours for building pressurization.
Created By : National TAB **Assigned To :** National TAB - Ian Fuller
Status : Open
Priority : Urgent **Asset Tag :**
Originated Date : 11/04/2024 - Ian Fuller - National TAB

3. Powerhouse Dynamics needs to adjust their controls so that the RTU's are operating in fan ON mode while the restaurant is occupied and not fan auto.
