Report: EVALUATION
Function: Test, Adjust, & Balance
Date: 10/31/2024
Completed By: National TAB

PROJECT
Chili's - Orlando, FL

Project: Chili's - Orlando, FL

Summary

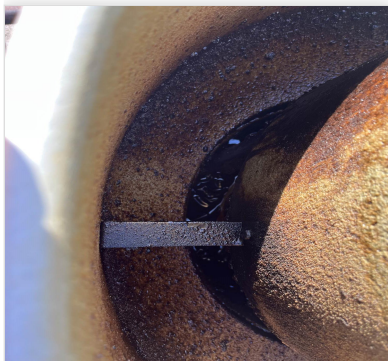
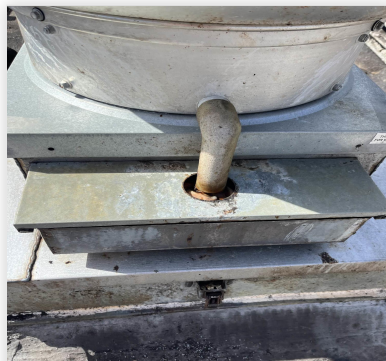
Issue Name : EF#2 is dirty
Description : EF#2 servicing the left grill hood is full of grease and does not seem to be draining properly. Fan needs to be cleaned and made sure it properly drains grease.
Created By : National TAB **Assigned To :** National TAB - Ian Fuller
Status : Open
Priority : Medium **Asset Tag :**
Originated Date : 11/04/2024 - Ian Fuller - National TAB

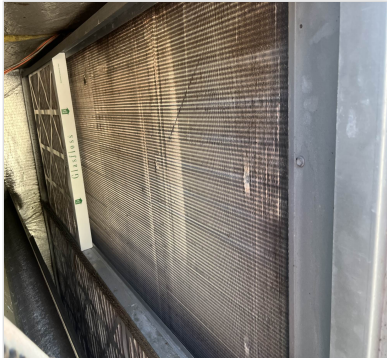
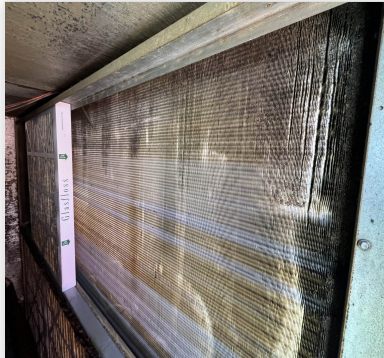
Issue Name : Evaporator coils are dirty on RTU#2 and RTU#3
Description : Evaporator coils are dirty on RTU-2 and 3. Recommend cleaning.
Created By : National TAB **Assigned To :** National TAB - Ian Fuller
Status : Open
Priority : High **Asset Tag :**
Originated Date : 11/04/2024 - Ian Fuller - National TAB

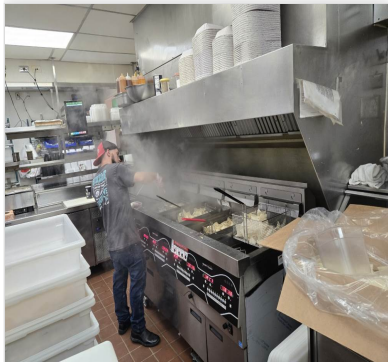
Exhaust airflow for the hoods was measured as is. The fryer and oven hood are both having capture and containment issues. The MUA for the hoods is a non-conditioned unit which is not recommended for Florida. During final TAB, if possible without worsening hood capture, it would be ideal to turn this unit off to avoid introducing more humidity into the space.

Issue Name : Fryer hood and Oven hood have smoke capture issues
Description : The fryer and oven hoods have smoke capture issues. Further evaluation and adjustments may be required during final TAB.
Created By : National TAB **Assigned To :** National TAB - Ian Fuller
Status : Open
Priority : High **Asset Tag :**
Originated Date : 11/04/2024 - Ian Fuller - National TAB

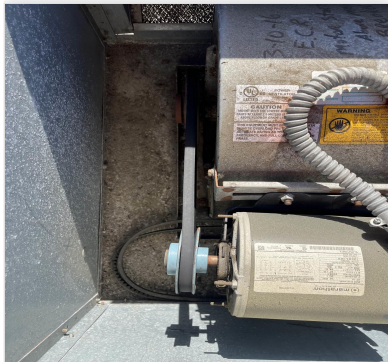
Issue Name : Makeup air pulleys are not alligned
Description : Pulleys need to be alligned to lengthen the lifespan of belts and the motor.
Created By : National TAB **Assigned To :** National TAB - Ian Fuller
Status : Open
Priority : Medium **Asset Tag :**
Originated Date : 11/04/2024 - Ian Fuller - National TAB

Drive Data	
	Actual
Motor Sheave Size	4.25"
Motor Bore Size	0.625"
Fan Sheave Size	8.5"
Fan Sheave Bore	0.75"
Belt CL Distance	12.0"
Num of Belts	1
Belt Size	AX41
Belt Alignment Verified	NOT ALIGNED

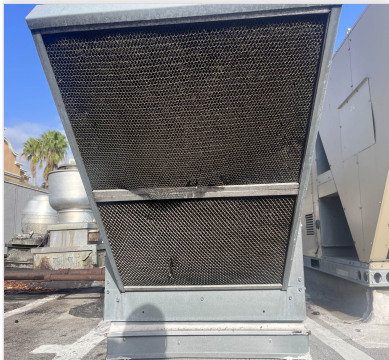
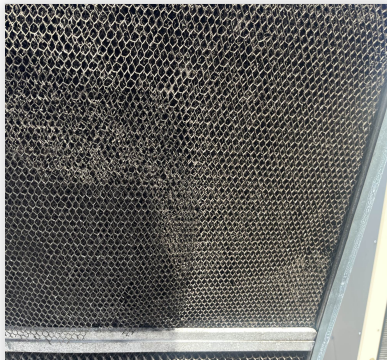
Issue Name : MUA outside air filters are dirty and slightly damaged
Description : Recommended to clean or replace filters to improve airflow
Created By : National TAB **Assigned To :** National TAB - Ian Fuller
Status : Open
Priority : Medium **Asset Tag :**
Originated Date : 11/04/2024 - Ian Fuller - National TAB

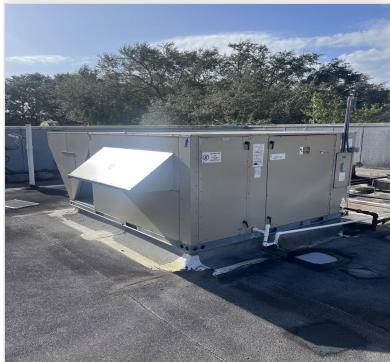
Issue Name : Outside air filter not secure on RTU#1
Description : Outside air filter found laying on roof. Filter was put back into place. Recommended to secure OA filter to the unit.
Created By : National TAB **Assigned To :** National TAB - Ian Fuller
Status : Open
Priority : Medium **Asset Tag :**
Originated Date : 11/04/2024 - Ian Fuller - National TAB

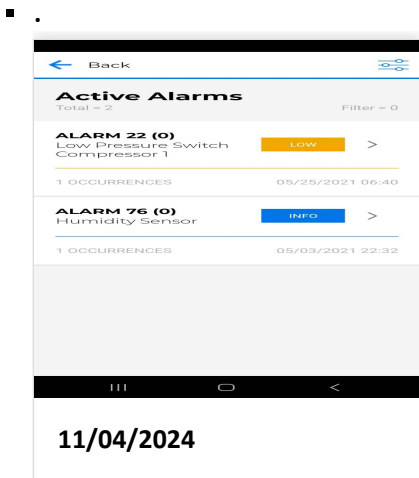
Issue Name : RTU#1 alarm 22: Low Pressure Switch Compressor 1
Description : Alarm has shut down use of Compressor 1. Unit is unable to fully cool space.
Created By : National TAB **Assigned To :** National TAB - Ian Fuller
Status : Open
Priority : Urgent **Asset Tag :**
Originated Date : 11/04/2024 - Ian Fuller - National TAB

1. Humidity sensor needs to be wired for RTU-1 per the manufacturers recommendations. This requires two separate shielded twisted pairs.
2. Alarms on RTU's 1 and 3 need to be resolved. It appears that they may be preventing 1st stage of cooling from operating.

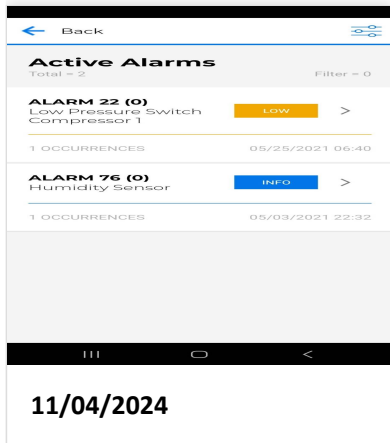
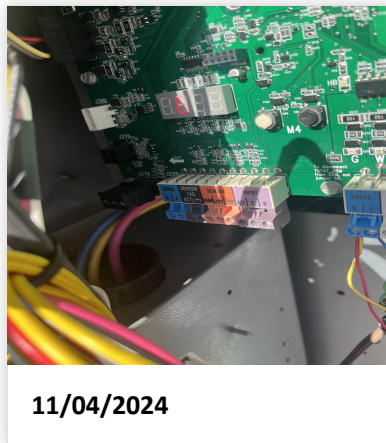
Issue Name : RTU#1 humidity sensor is not wired
Description : RTU#1 has humidtrol on its package details, however, there is no humidity sensor wired to the unit so it cannot dehumidify. Recommended to wire humidity sensor per manufacturers specifications (i.e., two separate shielded twisted pairs required).
Created By : National TAB **Assigned To :** National TAB - Ian Fuller
Status : Open
Priority : Urgent **Asset Tag :**
Originated Date : 11/04/2024 - Ian Fuller - National TAB

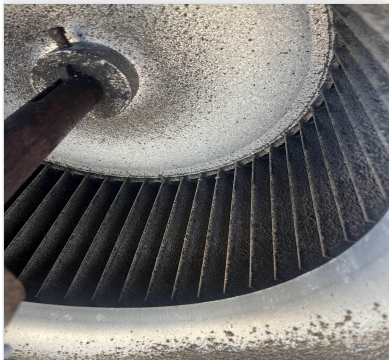
Issue Name : RTU#2 blower wheel is dirty
Description : Recommended to clean blower wheel.
Created By : National TAB **Assigned To :** National TAB - Ian Fuller
Status : Open
Priority : High **Asset Tag :**
Originated Date : 11/04/2024 - Ian Fuller - National TAB

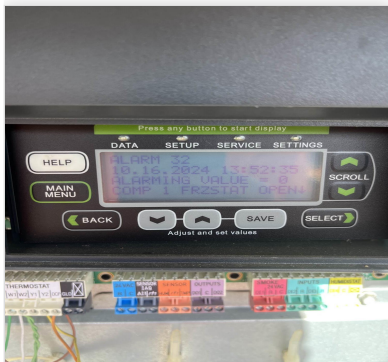
Issue Name : RTU#3 alarm 32: Comp 1 FRZSTAT
Description : Alarm has shutdown use of compressor 1. Unit is unable to fully cool space.
Created By : National TAB **Assigned To :** National TAB - Ian Fuller
Status : Open
Priority : Urgent **Asset Tag :**
Originated Date : 11/04/2024 - Ian Fuller - National TAB

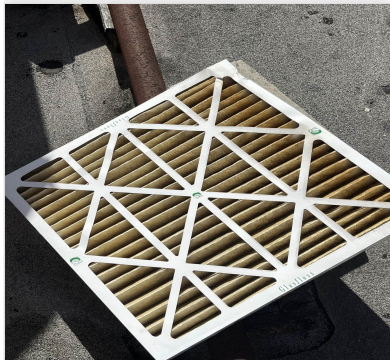
Issue Name : RTU#3 has dirty final filters
Description : Final filters are dirty and need to be replaced
Created By : National TAB **Assigned To :** National TAB - Ian Fuller
Status : Open
Priority : High **Asset Tag :**
Originated Date : 11/04/2024 - Ian Fuller - National TAB

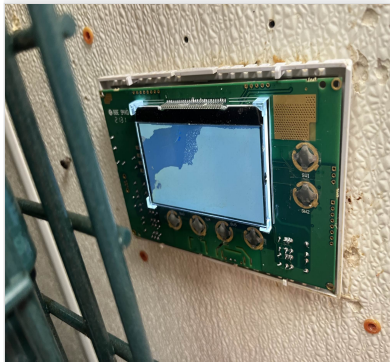
Issue Name : RTU#3 thermostat display is not functional
Description : Thermostat display does not work. Staff is unable to control temperature in space. Recommended to replace thermostat.
Created By : National TAB **Assigned To :** National TAB - Ian Fuller
Status : Open
Priority : High **Asset Tag :**
Originated Date : 11/04/2024 - Ian Fuller - National TAB

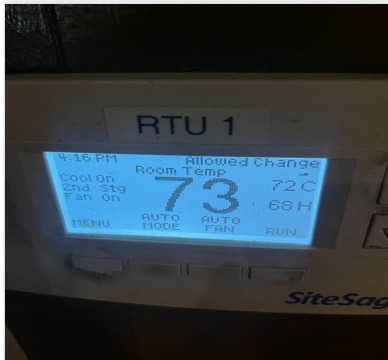
Issue Name : RTUs are on auto mode all day
Description : Fans need to be set to fan on during occupied hours for building pressurization.
Created By : National TAB **Assigned To :** National TAB - Ian Fuller
Status : Open
Priority : Urgent **Asset Tag :**
Originated Date : 11/04/2024 - Ian Fuller - National TAB

3. Powerhouse Dynamics needs to adjust their controls so that the RTU's are operating in fan ON mode while the restaurant is occupied and not fan auto.

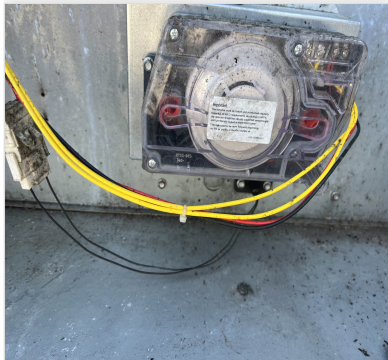
Issue Name : Smoke detector dust plug caps need to be removed
Description : Dust plug caps need to be removed from RTU#1 and RTU#2
Created By : National TAB **Assigned To :** National TAB - Ian Fuller
Status : Open
Priority : Medium **Asset Tag :**
Originated Date : 11/04/2024 - Ian Fuller - National TAB
