Report: CONDITION SURVEY
Function: Test, Adjust, & Balance
Date: 10/31/2024
Completed By: National TAB

PROJECT
Chili's - Lady Lake, FL

Project: Chili's - Lady Lake, FL

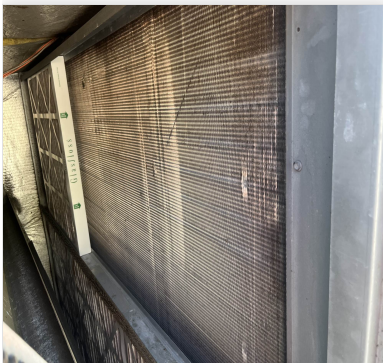
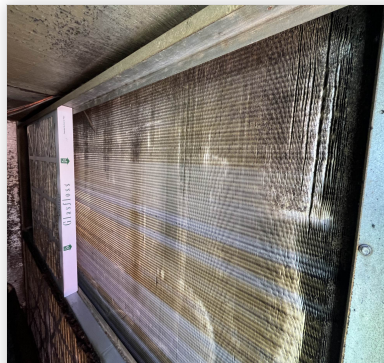
Issue Name : Evaporator coils are dirty on RTU#2 and RTU#3
Description : Evaporator coils are not yet compacted with dirt, however, are very dirty. Recommended to clean coils with cold water to prevent coils from being plugged with dirt on RTU#2 and RTU#3.
Created By : National TAB **Assigned To :** National TAB - Ian Fuller
Status : Open
Priority : High **Asset Tag :**
Originated Date : 11/04/2024 - Ian Fuller - National TAB

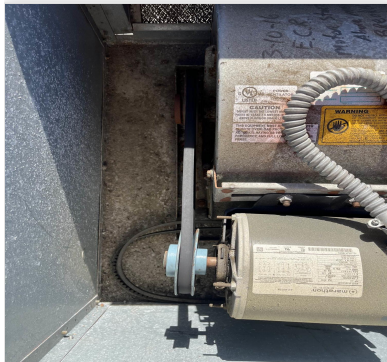
Issue Name : Makeup air pulleys are not alligned
Description : Pulleys need to be alligned to lengthen the lifespan of belts and the motor.
Created By : National TAB **Assigned To :** National TAB - Ian Fuller
Status : Open
Priority : Medium **Asset Tag :**
Originated Date : 11/04/2024 - Ian Fuller - National TAB

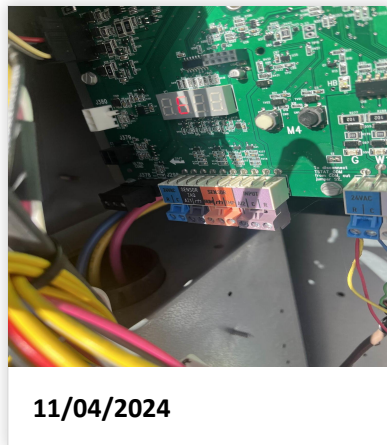
Issue Name : RTU#1 humidity sensor is not wired
Description : RTU#1 has humidtrol on its package details, however, there is no humidity sensor wired to unit in order to control humidity of space it services. Recommended to wire humidity sensor to unit in order to dehumidify space.
Created By : National TAB **Assigned To :** National TAB - Ian Fuller
Status : Open
Priority : **Urgent** **Asset Tag :**
Originated Date : 11/04/2024 - Ian Fuller - National TAB

1. Humidity sensor needs to be wired for RTU-1 per the manufacturers recommendations. This requires two separate shielded twisted pairs.
2. Alarms on RTU's 1 and 3 need to be resolved. It appears that they may be preventing 1st stage of cooling from operating.

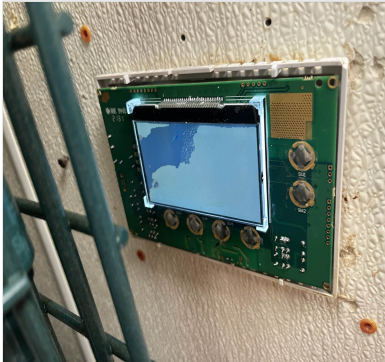
Issue Name : RTU#3 thermostat display is not functional
Description : Thermostat display does not work. Staff is unable to control temperature in space. Recommended to replace thermostat.
Created By : National TAB **Assigned To :** National TAB - Ian Fuller
Status : Open
Priority : High **Asset Tag :**
Originated Date : 11/04/2024 - Ian Fuller - National TAB

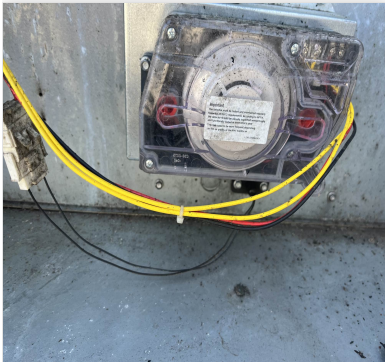
Issue Name : Smoke detector dust plug caps need to be removed
Description : Dust plug caps need to be removed from RTU#1 and RTU#2
Created By : National TAB **Assigned To :** National TAB - Ian Fuller
Status : Open
Priority : Medium **Asset Tag :**
Originated Date : 11/04/2024 - Ian Fuller - National TAB
