**Report: TAB REPORT
Function: Test, Adjust, & Balance
Date: 07/03/2024**

**PROJECT
07-01-24 PIZZA HUT CEDAR FALLS, IA**

Summary and Recommendations

The purpose of the visit to the Pizza Hut in Cedar Falls, IA was to address complaints of condensation on the ceiling.

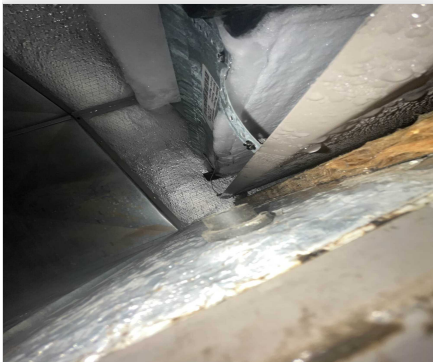
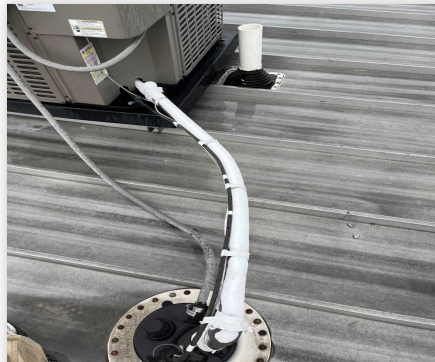
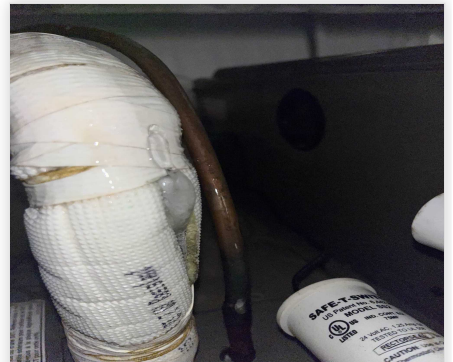
1. FCU-1 coil is frozen appears that FCU-2 may be partially frozen as well. There is water leaking from the frozen copper lines as well as the coil are dripping onto the ceiling. Appears the coils are freezing primarily due to low airflow. The FCU's are set to the highest fan speed and speed cannot be increased. The airflow is low on FCU-2 due to dirty filters. When the filters were removed, the airflow substantially increased. FCU-1 filters were clean but just had been changed the day before.
2. With reduced airflow, the discharge air on the FCU's is lowered which can cause condensation to form on the diffusers and surrounding surfaces.
3. The building pressure is highly negative due to several issues which allows hot, humid unconditioned outside air to enter the building. This hot, humid unconditioned air can cause condensation on surfaces due to the increased dew point.

Issue Name : FCU-1/FCU-2 leakage
Description : FCU-1/FCU-2 show signs of leakage from coils. FCU-1 coils are completely blocked with ice, Lines going into coils are frozen/dripping water from line and coil compartment. Recommend thawing and cleaning coils to prevent buildup. FCU-2 shows signs of leakage from line going into coils. No signs of leakage from coil compartment panel.
Created By : National TAB **Assigned To :** National TAB - Dylan Crisman
Status : Open
Priority : Urgent **Asset Tag :** FCU1
Originated Date : 07/02/2024 - Dylan Crisman - National TAB

1. FCU's 1 and 2 evaporator coils should be thawed and then cleaned.
2. FCU's 2 filters need to be changed ASAP. Filters for both units need to be changed on a quarterly basis.
3. MUA airflow is low due to a couple issues:
 - a. MUA intake air filter is very dirty and needs to be cleaned.
 - b. The MUA PSP at the hood appears to be clogged due to the high discharge static pressure on the MUA. The PSP needs to be physically dropped down and then the top of the PSP cleaned off.

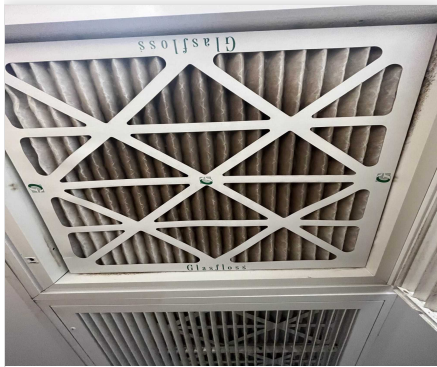
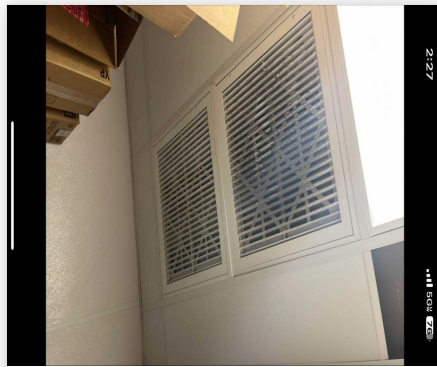
Issue Name : FCU-2 filters are dirty
Description : FCU-2 filters behind wall to left of checkout counter inside return vents are dirty. Recommend replacing. With filters temporarily removed, airflow increased from 1100 CFM to 1700 CFM. Airflow increased to 1345CFM from 837CFM when tested with filters removed.
Created By : National TAB **Assigned To :** National TAB - Dylan Crisman
Status : Open
Priority : Urgent **Asset Tag :** FCU2
Originated Date : 07/02/2024 - Dylan Crisman - National TAB

Notes:
 FILTERS DIRTY. AIRFLOW INCREASED TO 1700 CFM WITH FILTERS TEMPORARILY REMOVED.

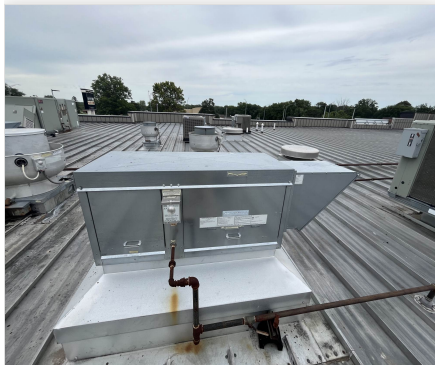
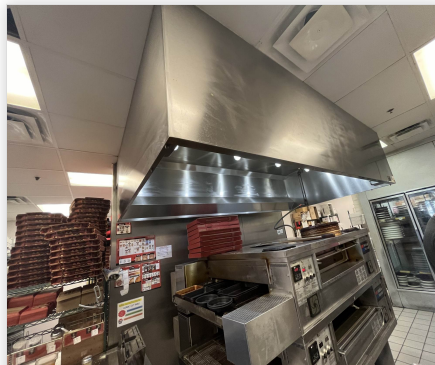
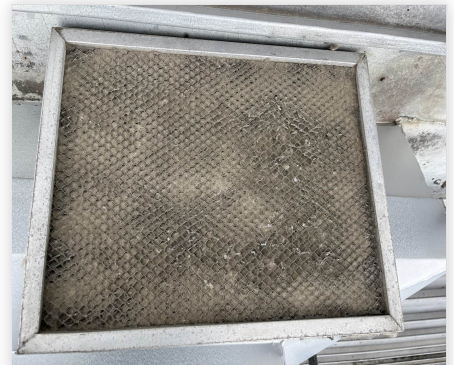
Issue Name : MUA intake filter is dirty
Description : MUA intake filter is clogged. Recommend replacement. MUA belt was loose on arrival, tightened and adjusted motor for tension. Resulting in increase of only 21CFM. 308CFM initial reading, 329 final
Created By : National TAB **Assigned To :** National TAB - Dylan Crisman
Status : Open
Priority : High **Asset Tag :** MUA1
Originated Date : 07/02/2024 - Dylan Crisman - National TAB

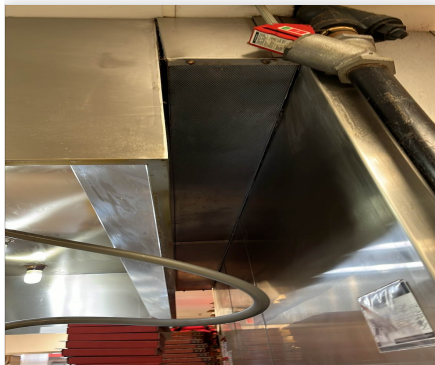
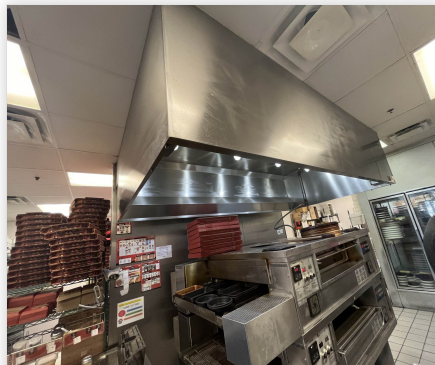
Issue Name : MUA PSP Plenum is clogged
Description : MUA airflow is high and the discharge pressure indicates that the top of the PSP is dirty. The PSP needs to be dropped down and then the top thoroughly cleaned. It should be cleaned approximately every 2 years minimum.
Created By : National TAB **Assigned To :** National TAB - Dylan Crisman
Status : Open
Priority : Urgent **Asset Tag :** MUA1
Originated Date : 07/03/2024 - Dylan Crisman - National TAB

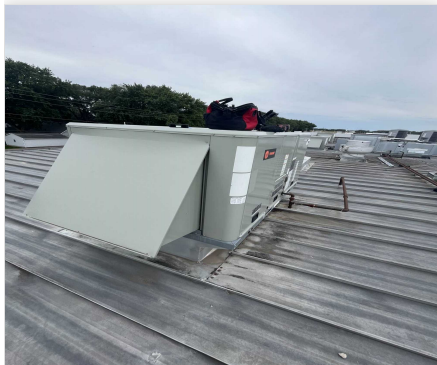
Issue Name : RTU-1 economizer not functional
Description : Economizer for RTU-1 is not functional. Damper was manually set but will remain open even during unoccupied hours. Recommend servicing so that the damper will open to the minimum position during occupied hours and close during unoccupied hours.

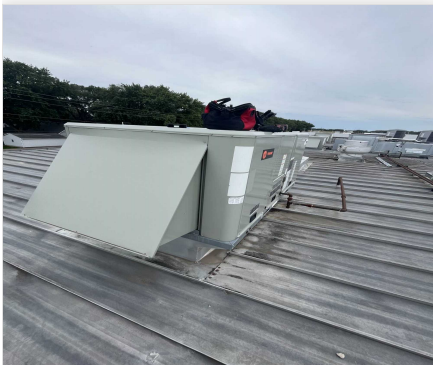
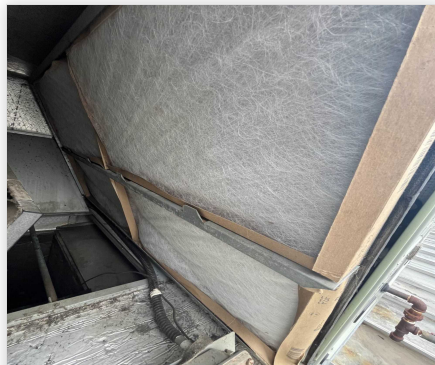
Issue Name : RTU-1 Final Filters
Description : RTU-1 has construction filters currently installed for final filters. Recommend replacing with correct size. Qty 4 16x25x2 merv 8 rated pleated filters.
Created By : National TAB **Assigned To :** National TAB - Dylan Crisman
Status : Open
Priority : Low **Asset Tag :** RTU1
Originated Date : 07/02/2024 - Dylan Crisman - National TAB
