LINWOOD ELEMENTARY SCHOOL (BONNER SPRINGS, KS)

Project Issue Information

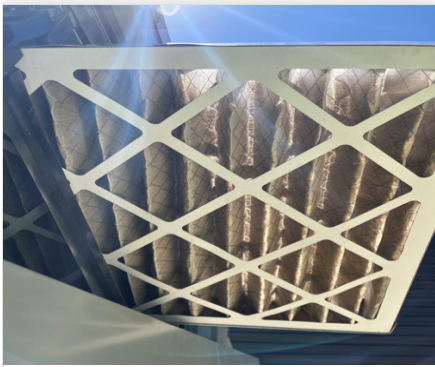
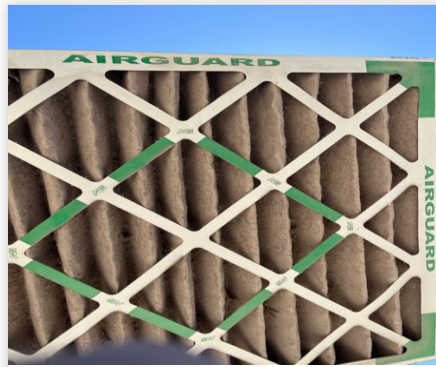
Issue Name : DOAS 3 dirty filters

Description : Filters for both supply and exhaust sides are very dirty and need to be replaced.

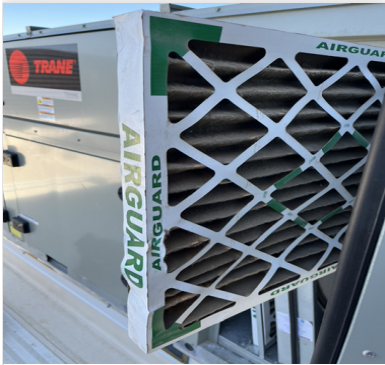
Issue Name : DOAS-1 filters are very dirty and need to be changed.

Description : Responsibility - Temp Con (Jake notified on site and is in process of resolving).

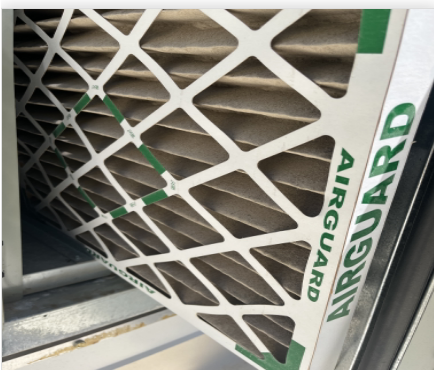
Issue Name : DOAS2 dirty filters

Description : Filters are dirty and need to be replaced. MC Jake is in the process of getting new filters

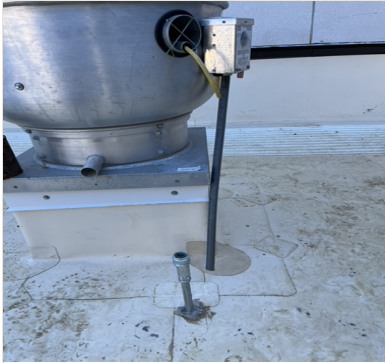
Issue Name : Kitchen exhaust fan wiring not completed (Dish fan pictured)
Description : Responsibility - electrician
Created By : National TAB **Assigned To :** National TAB - Will Turnbough
Status : Open
Originated Date : 07/19/2022 - Will Turnbough - National TAB

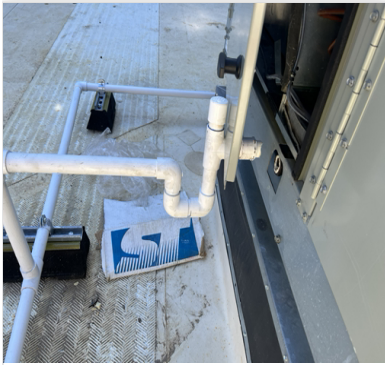
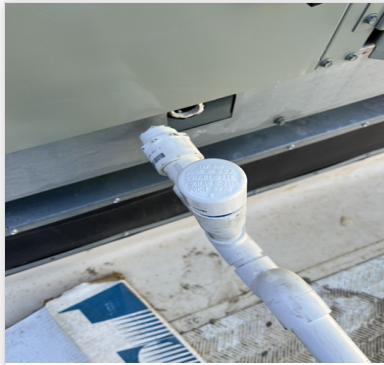
Issue Name : RTU-1 Condensate drain found broken.

Description : Does not affect balancing but noted as it could cause water to back up into the space. Door is hitting the P-trap and appears to be why it broke. Recommend repair. Responsibility - McCown Gordon
