PlanGrid Task Report - Feb 14, 2025

L05590 Ogden & Iroquois (IL) FSU

1159 East Ogden Avenue, Naperville, Illinois

TAB Punch List

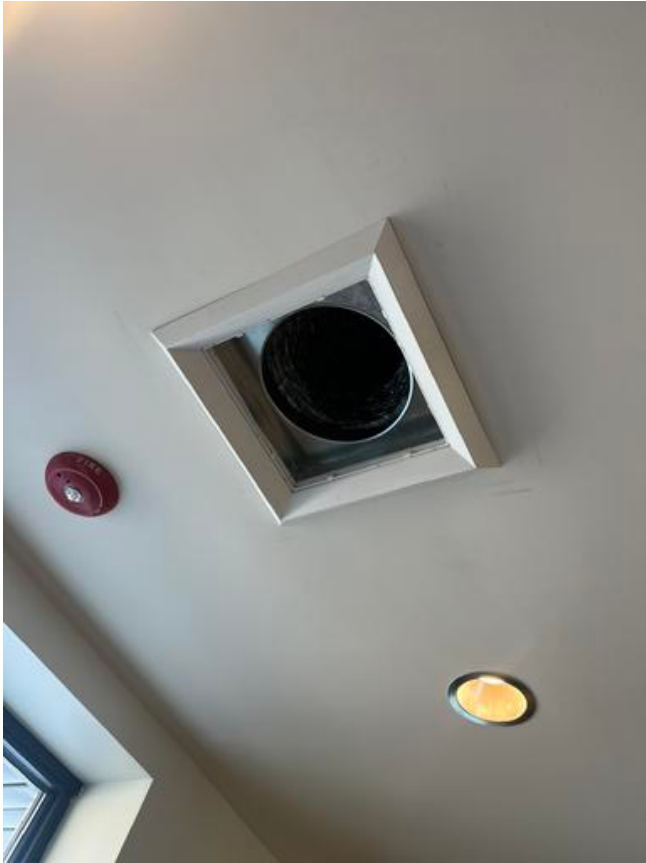
IMG_5011

#583 [DUCT 500] [NEW] AC-3 Vestibule Diffuser.

Deflector blades for vestibule diffuser were damaged and need to be replaced.

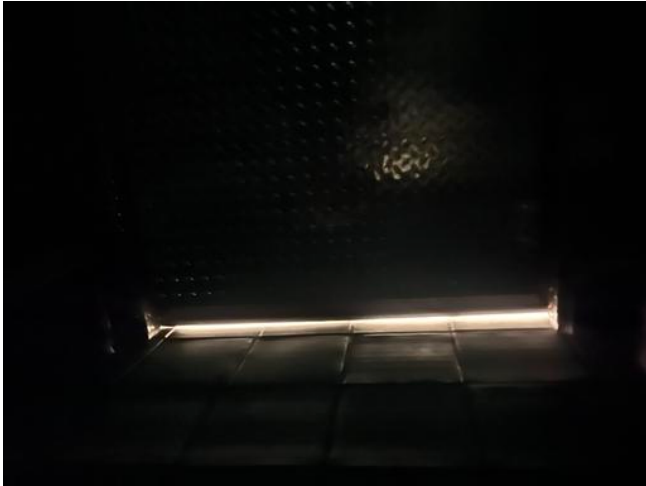
#579 [REFG 505/6] [NEW] WIC / WIF door sweep vs threshold.

WIC door sweep is not sealed tightly with threshold when door is closed. Only translucent light should be present inspecting from the inside out with box lights off. ALSO, WIF door sweep is not sealed tightly with threshold when door is closed. No light should be present inspecting from the inside out with box lights off.

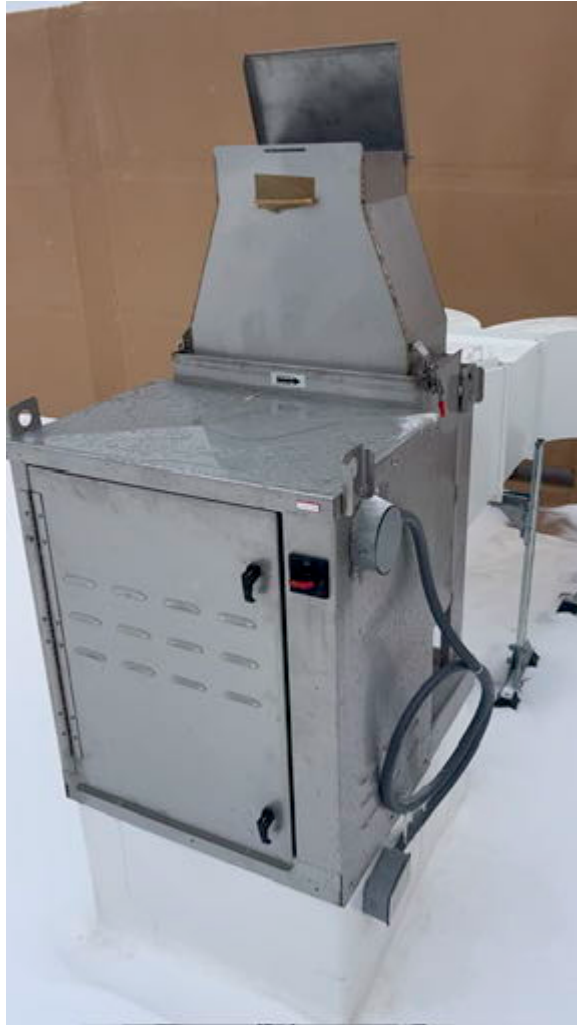
#578 [EXHA 999] [NEW] (MISC) EF-1 and EF-2 Noise

EF-1 is randomly creating significant noise. Unsure what the cause is, as the blower wheel spins freely and does not appear to be rubbing. The noise has only been present twice during TAB and went away after fan was restarted several times. EF-2 drive has an unusual whine that is not typical. Recommend both fans are further inspected for any defects and pulley / blower wheel alignment are verified.

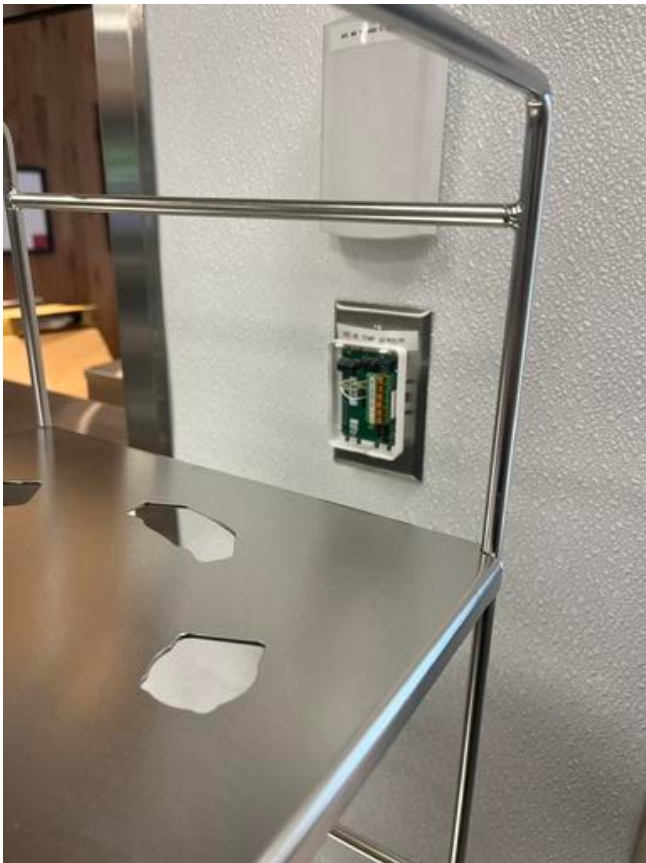
IMG_4978

#574 [CNTL 501] [NEW] Temperature Sensor cover.

Cover is missing for AC-2 temperature sensor.
