# PlanGrid Task Report - Feb 13, 2025

**L05590 Ogden & Iroquois (IL) FSU**

1159 East Ogden Avenue, Naperville, Illinois

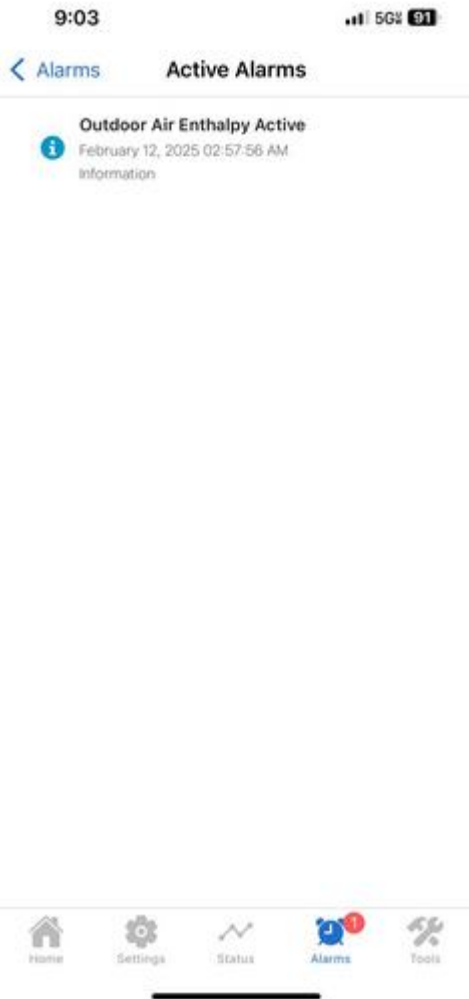
IMG\_5014  
Michael McDonnell  
Feb 13, 2025 2:53 PM

**#582 [UNIT 999] [NEW] (MISC) AC-2 and AC-3 Outdoor Enthalpy Alarm**

During TAB, both AC-2 and AC-3 were alarmed for "OUTDOOR AIR ENTHALPY ACTIVE." Recommend alarm is investigated.

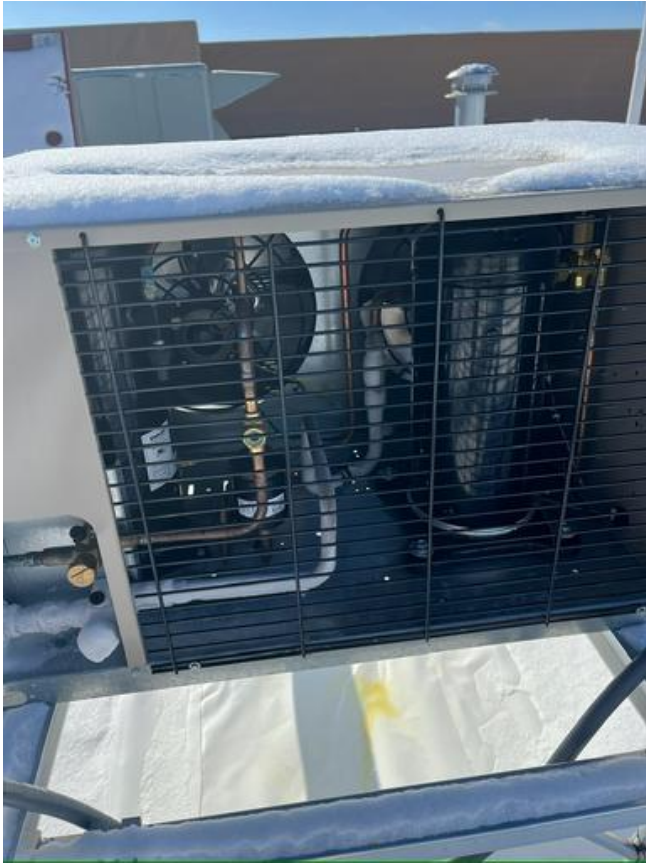
IMG\_2281

**#580 [REFG 999] [NEW] WIF CONDENSER FROZEN LINES**

WIF Condenser refrigerant lines on roof are frozen. Recommend operation is verified.

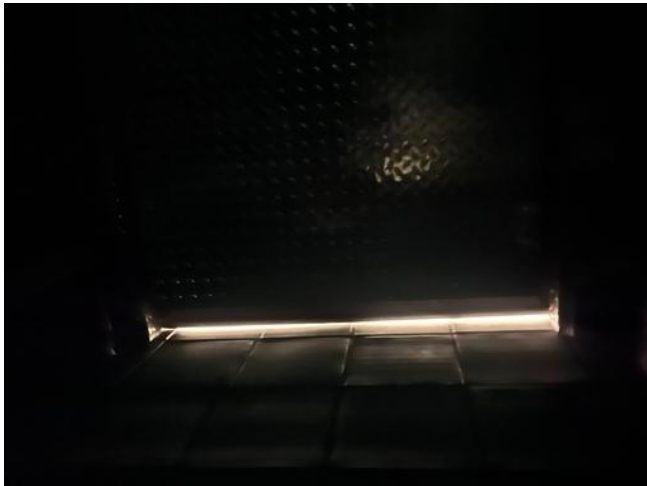
## #579 [REFG 505/6] [NEW] WIC / WIF door sweep vs threshold.

WIC door sweep is not sealed tightly with threshold when door is closed. Only translucent light should be present inspecting from the inside out with box lights off. ALSO, WIF door sweep is not sealed tightly with threshold when door is closed. No light should be present inspecting from the inside out with box lights off.

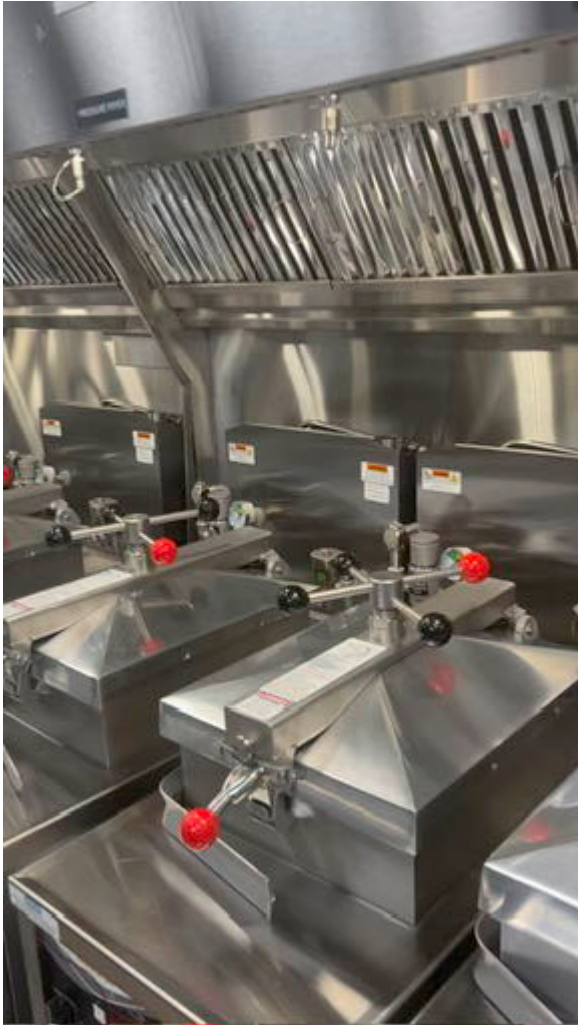
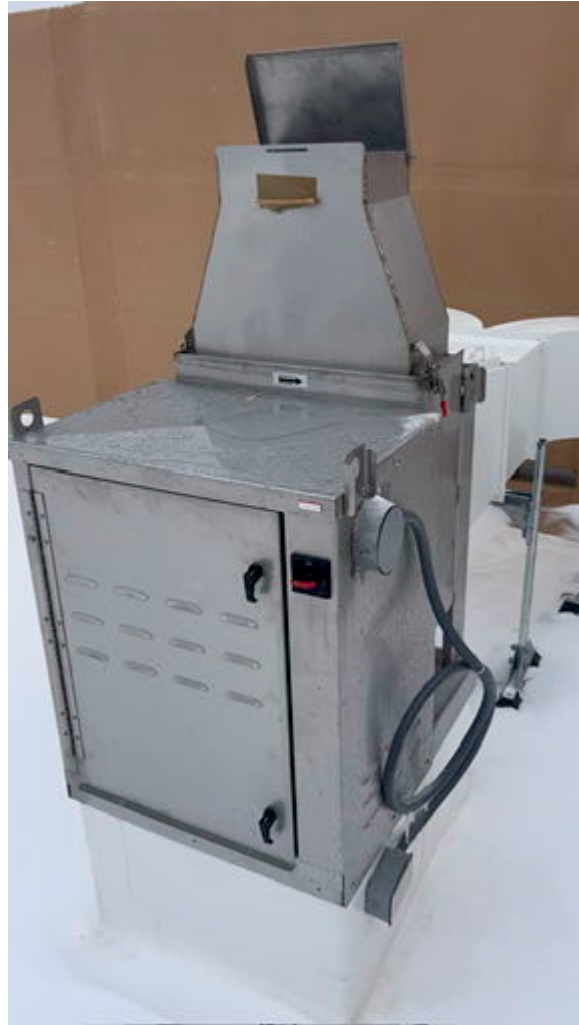
## #578 [EXHA 999] [NEW] (MISC) EF-1 and EF-2 Noise

EF-1 is randomly creating significant noise. Unsure what the cause is, as the blower wheel spins freely and does not appear to be rubbing. The noise has only been present twice during TAB and went away after fan was restarted several times. EF-2 drive has an unusual whine that is not typical. Recommend both fans are further inspected for any defects and pulley / blower wheel alignment are verified.

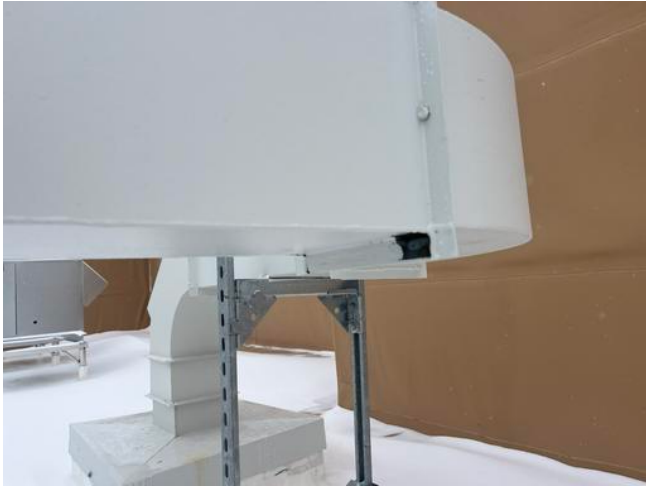
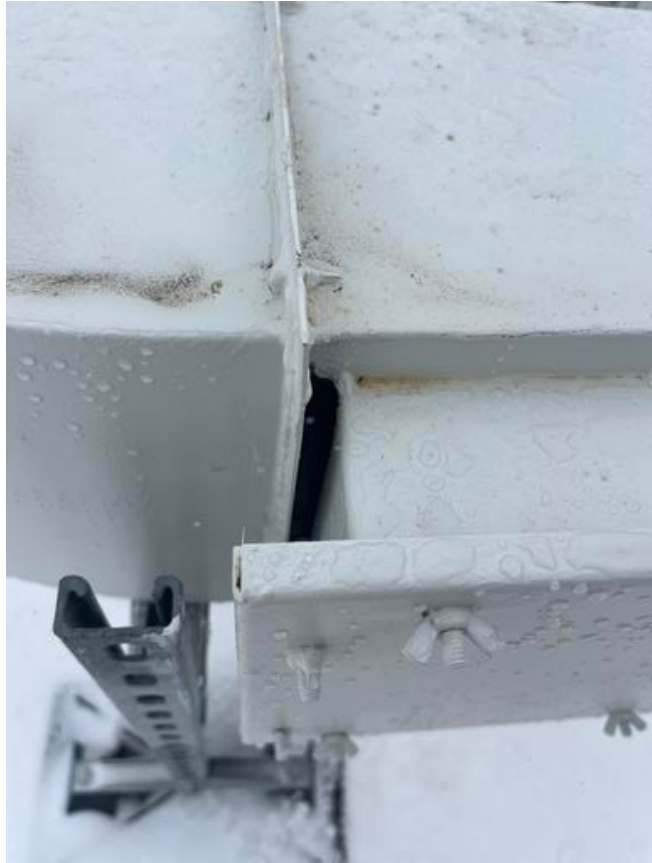
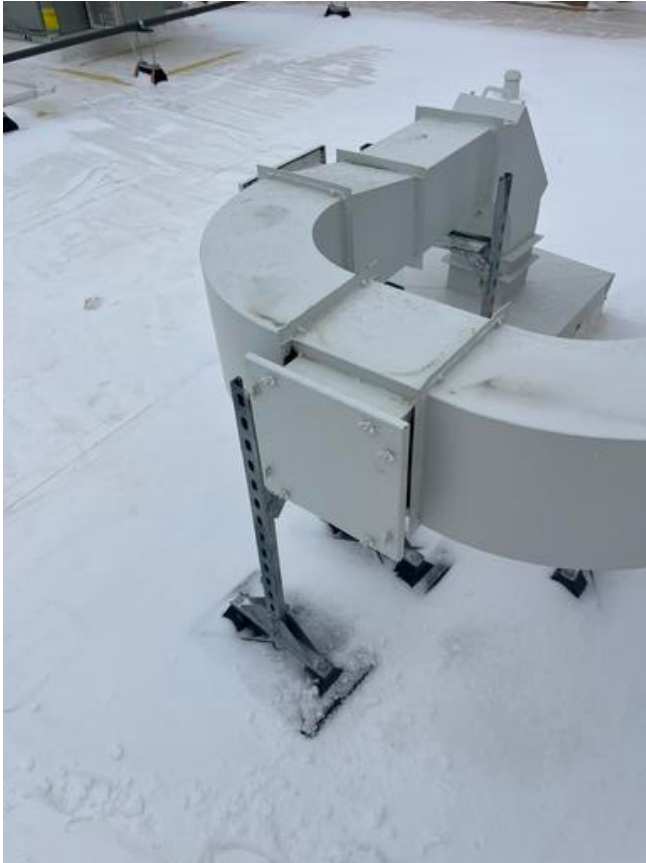
**#577 [EXHA 509] [NEW] Grease exhaust duct is not fully painted.**

Several spots on grease duct where paint was not applied. Recommend duct is fully painted to prevent rust etc.

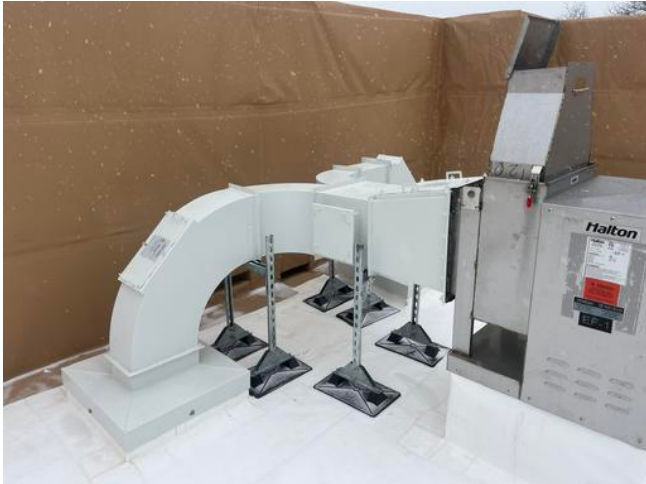
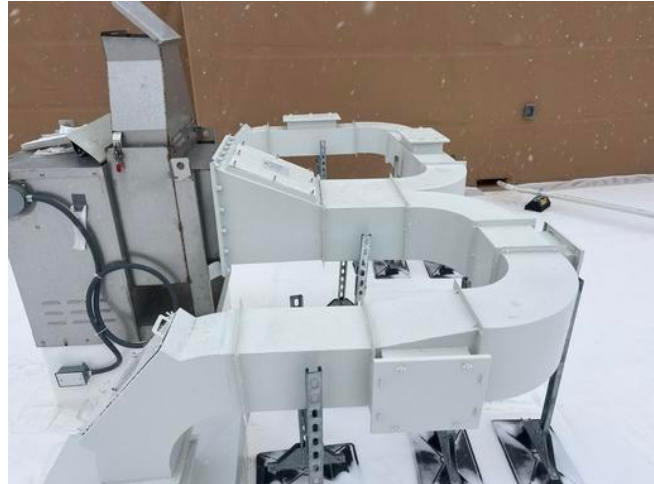
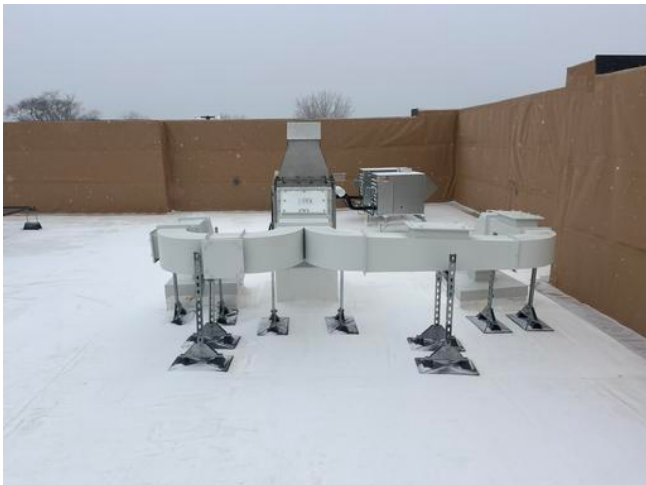
## #575 [EXHA 999] [NEW] (MISC) Grease Duct Cleanout Doors

CORRECT number of access doors installed, and doors installed in approximate locations. In instances on both fans, cleanout doors do not meet sizing specification. Additionally, some doors installed on top of duct. Appears these changes were made to accommodate supports as well as adjustments made to MC constructed duct length due to position of fan and duct penetrations. Fans are both operating at design and within design static pressure. SEEK APPROVAL.

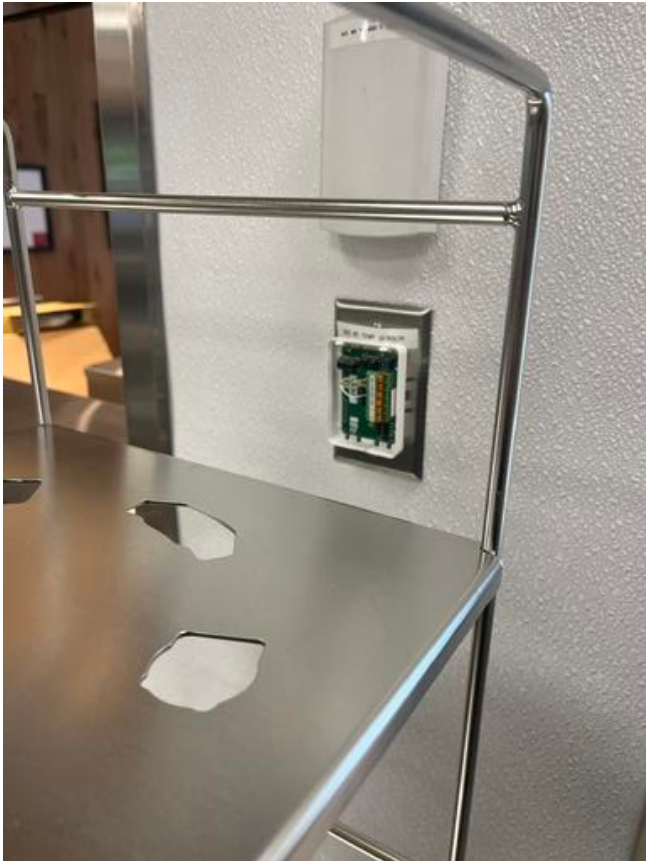
IMG\_4978

## #574 [CNTL 501] [NEW] Temperature Sensor cover.

Cover is missing for AC-2 temperature sensor.

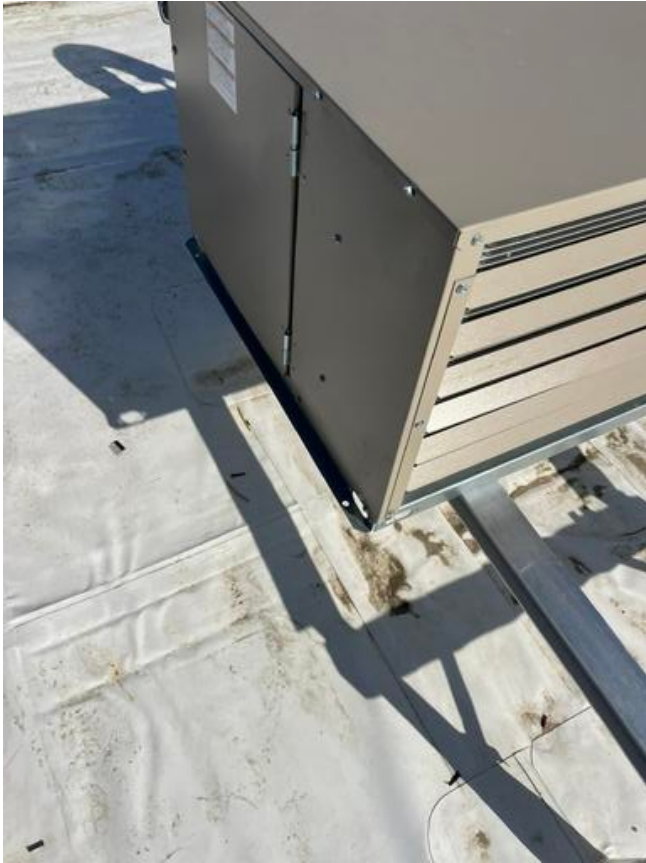
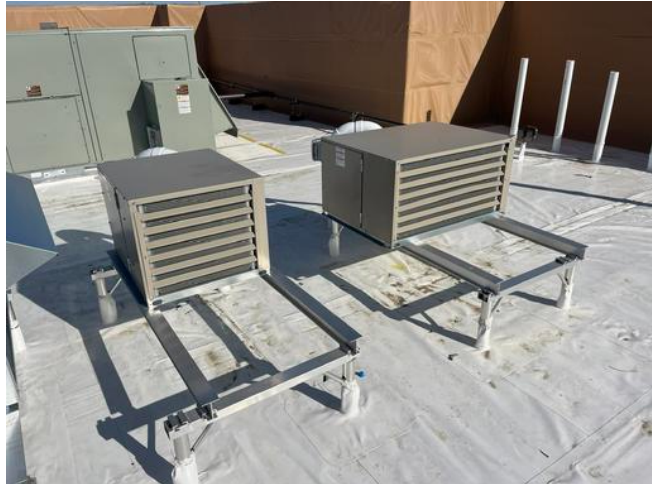
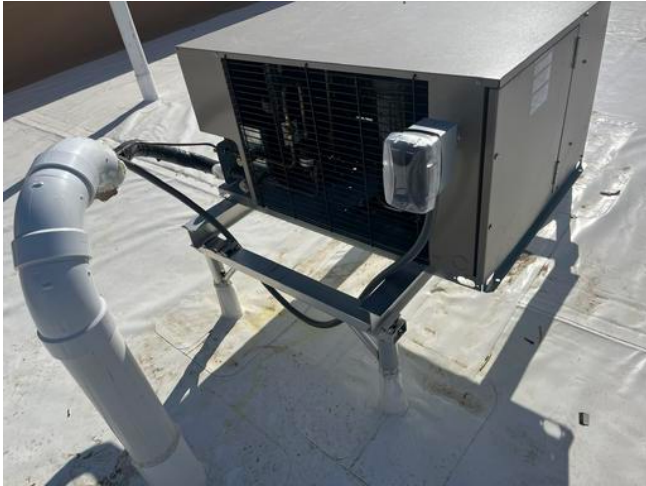
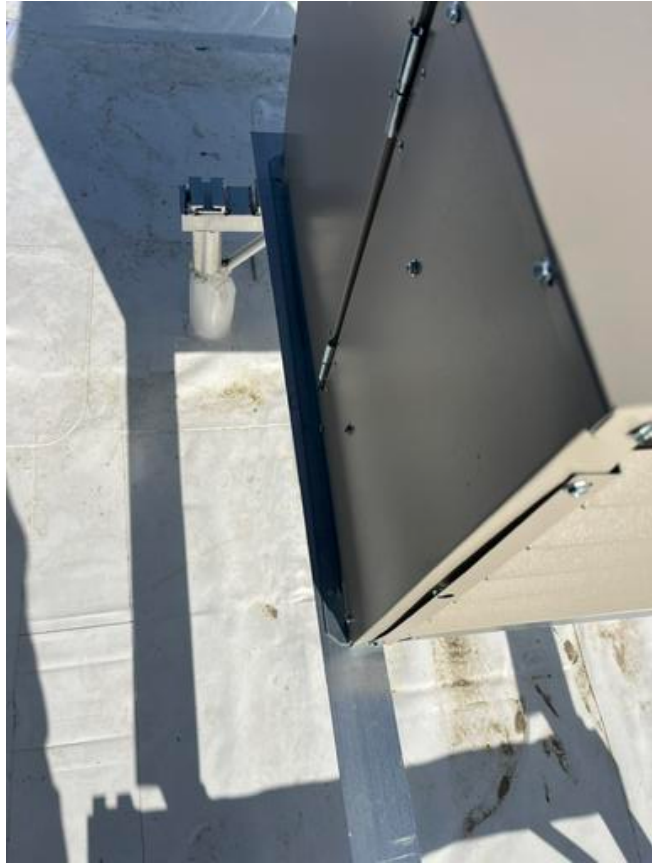
**#572 [REFG 514] [NEW] Condenser anchoring.**

Condensers are not properly anchored to equipment stands.

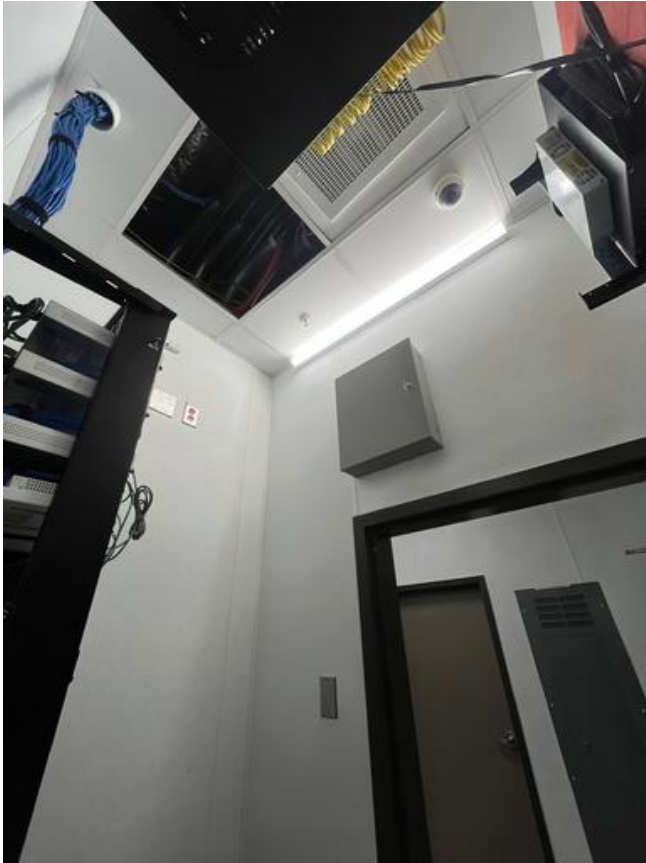
IMG\_4906

**#566 [CNTL 999] [NEW] (MISC) TF-1 Missing Thermostat**

TF-1 Thermostat is not installed; fan running continuously.

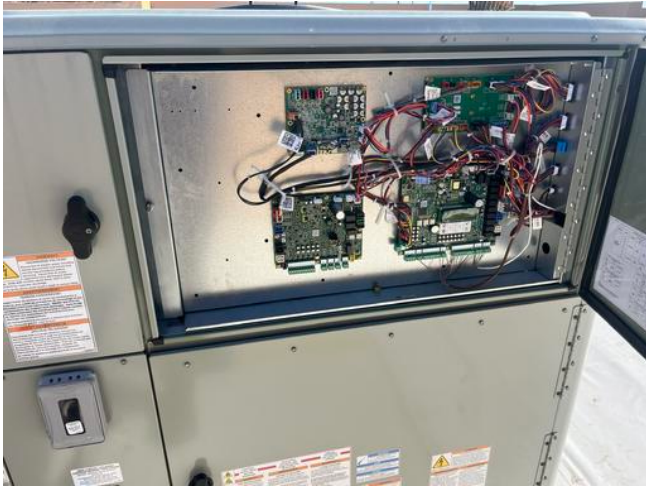
IMG\_4844

## #559 [UNIT 503] [NEW] Trane equipment missing field kits.

Trane equipment does not have manufacturer supplied Fresh Air Tempering Kit. Field installed relays, icm104 delay timer, and Penn controller are not on site or installed and FAT is specified in schedule for all AC units.

Fresh Air Tempering to be installed per RTU schedule on AC-1,2,3,4; not present.

Discharge sensors installed after first elbow per plans and MC. Need additional parts.

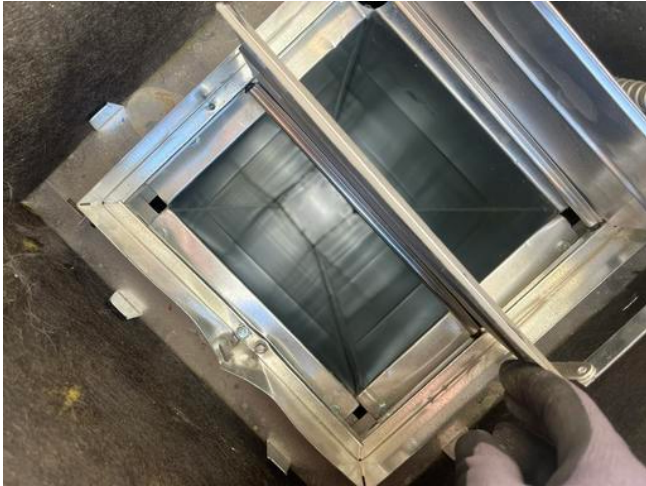
IMG\_4831

## #558 [EXHA 500] [NEW] Restroom Exhaust duct riser.

Plans call for 10" Diameter Round riser duct. Rectangular duct installed. Specifications call for round duct to be externally insulated and rectangular duct internally lined. Rectangular duct incorrectly installed and duct not lined. SEEK APPROVAL

Exhaust duct is externally insulated.

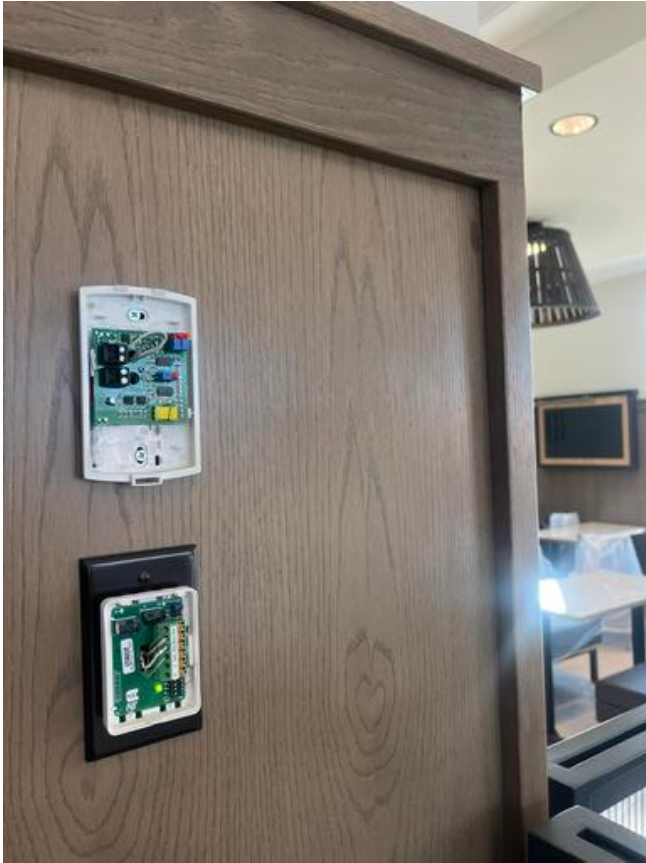
IMG\_4778

## #557 [CNTL 500] [NEW]AC-4 Humidistat needs replacement

Humidistat wiring not terminated correctly per control wiring detail- Check wiring, Wires are swapped on AC-3 and space humidity reading 1000%.

Humidity Sensor installed on AC-4 is defective.

Humidity sensor found to be defective. Replaced with AC-4 humidity sensor, now operational. Need to order humidity sensor for AC-4.

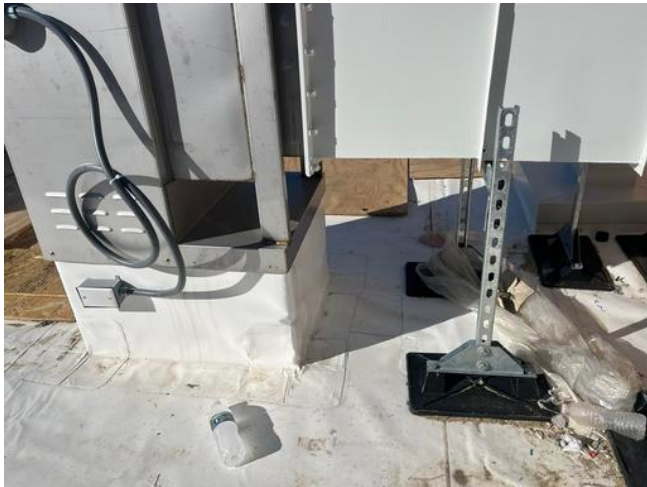
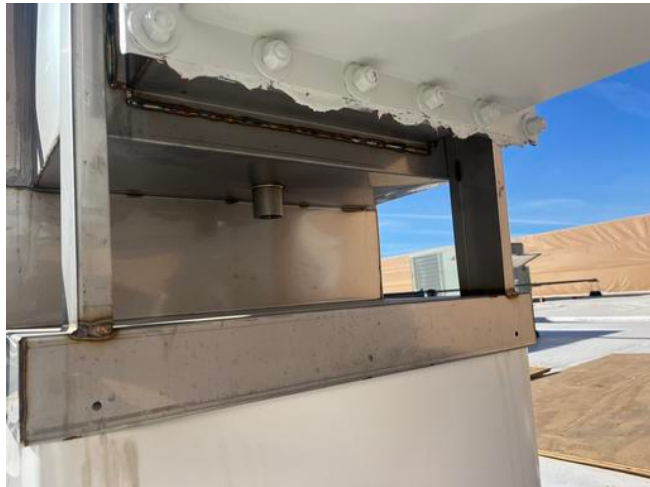
**#555 [EXHA 508] [NEW] Exhaust fan G2 Drip Guard.**

Exhaust fan G2 Drip Guard is not installed correctly or is missing.
