PlanGrid Task Report - Oct 11, 2024

L05462_Cutler Bay FSU (FL)
18240 South Dixie Highway, Miami, Florida
L1020005462

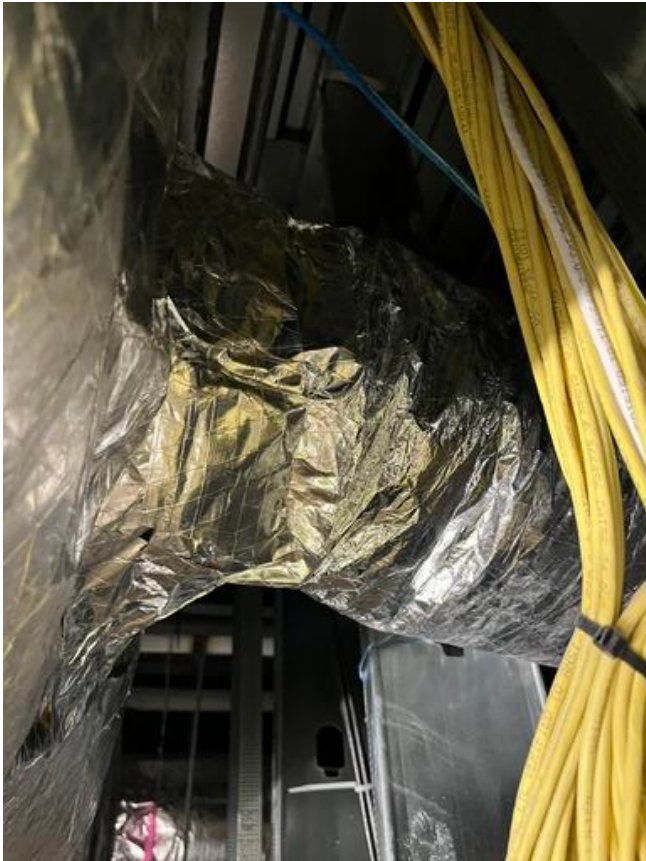
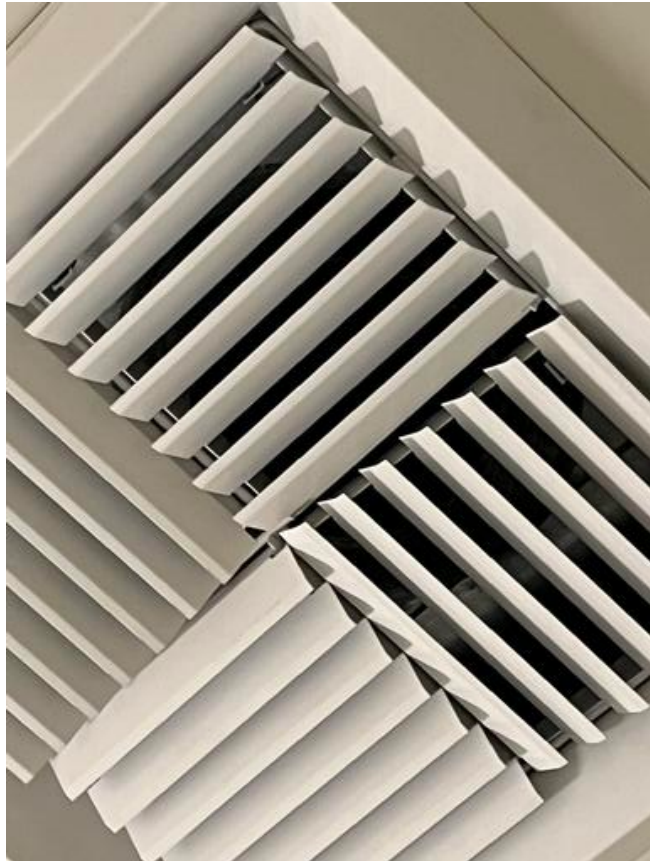
#18 [DUCT 052] CRITICAL – Damper missing

Damper(s) not installed at branch location or on run-out on plans on diffuser 4-10 located in employee restroom. Unable to balance system until corrected.

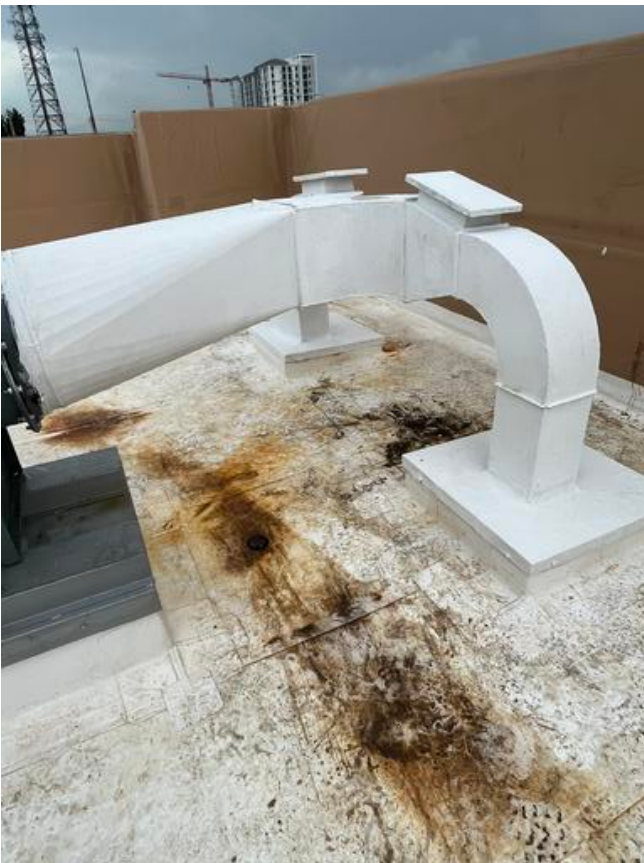
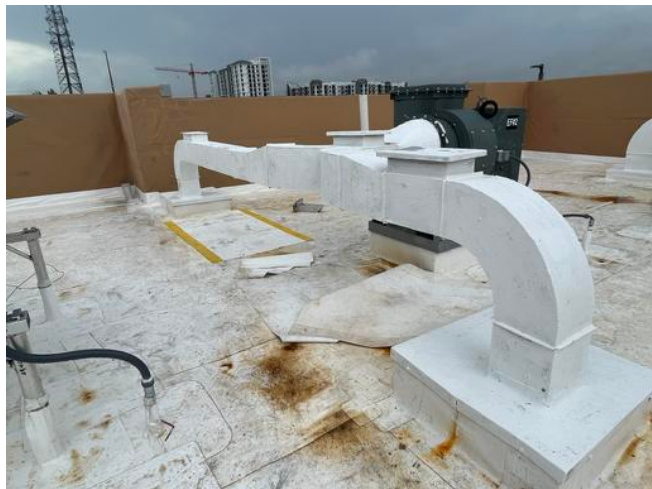
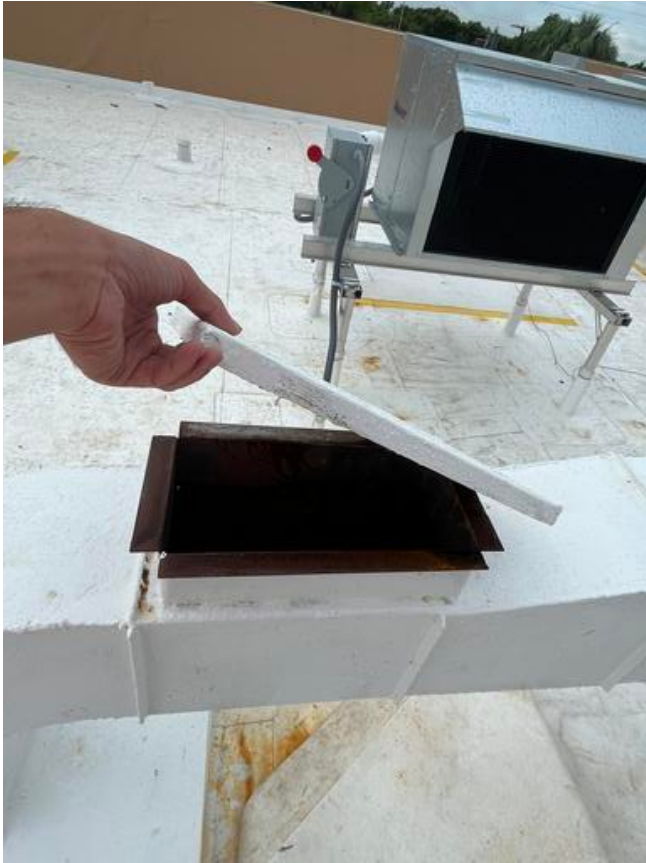
#17 [EXHA 012] CRITICAL – Grease duct access doors.

Access doors are missing or not constructed properly in grease duct work.

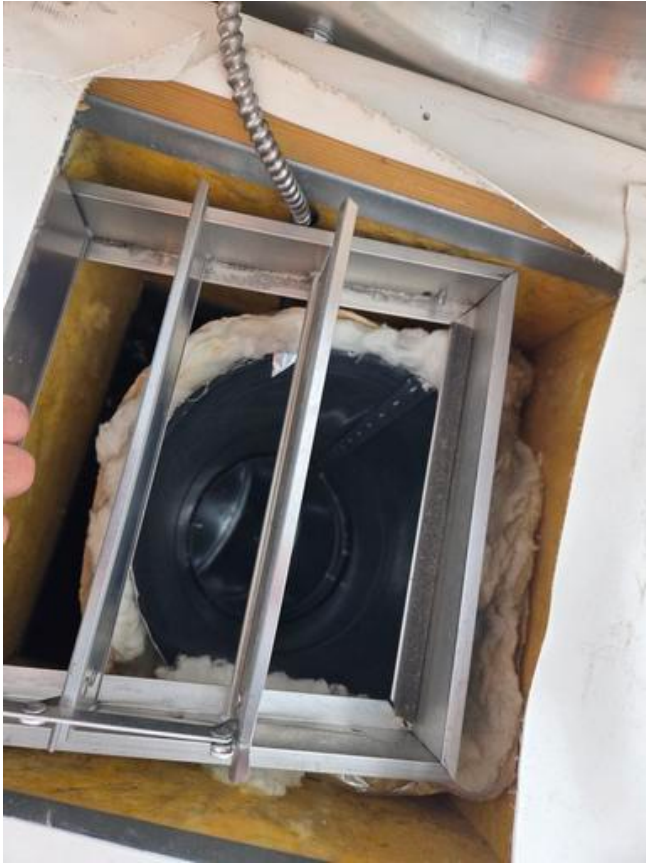
#16 [EXHA 020] CRITICAL (MISC) – Restroom fan duct is not square

Square duct with lining on the inside is supposed to be ran to curb of restroom exhaust fan. Duct is also not sealed to the curb and is exhausting most of the air from above the ceiling.

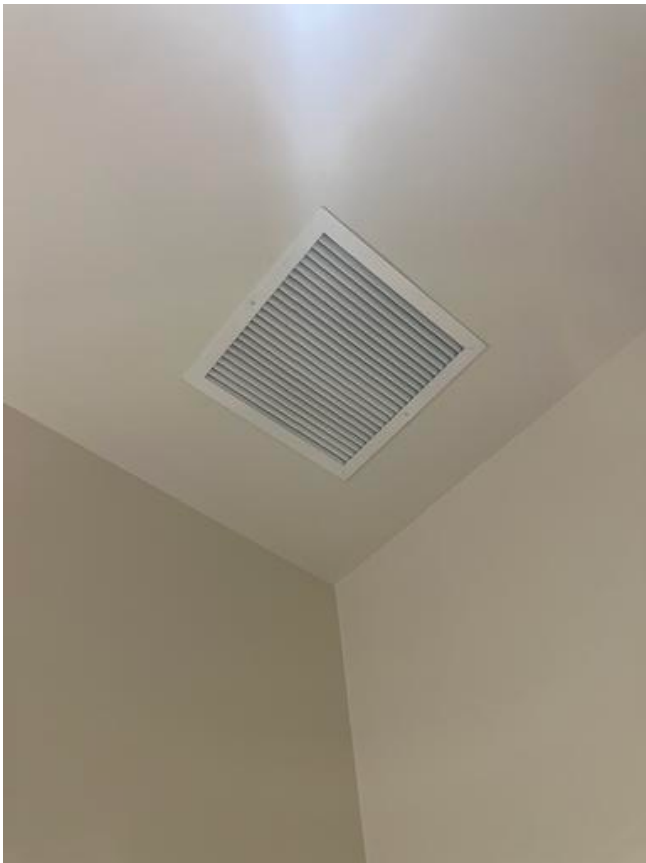
#15 [DUCT 055] CRITICAL – Air device wrong type.

Return diffuser EF3-3 located in employee restroom does not match specified type on air device schedule. Diffuser should be a type K diffuser.

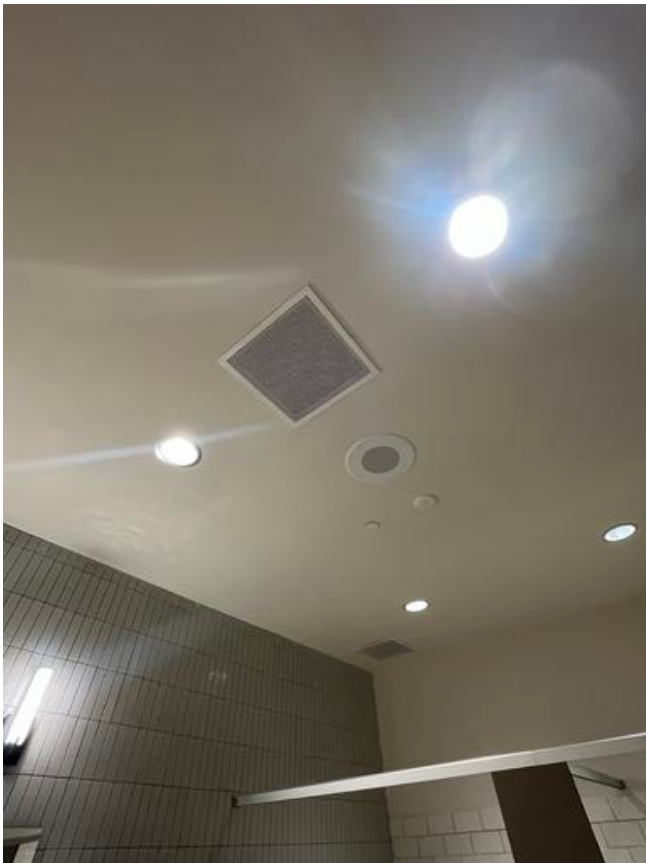
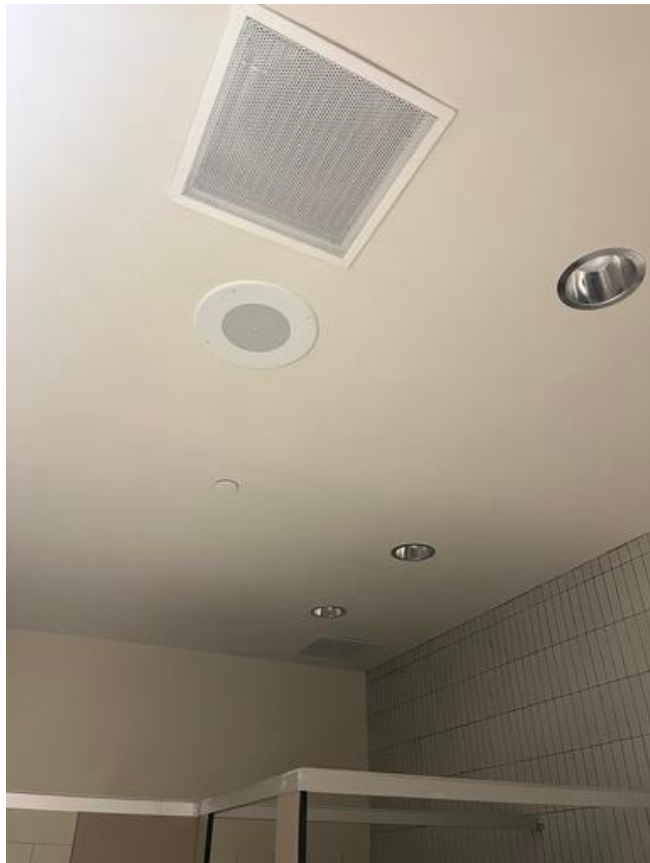
#14 [DUCT 055] CRITICAL – Air device wrong type.

Diffuser 3-15 and diffuser 3-16 located in customer bathroom do not match specified type on air device schedule. Diffusers should be type J diffusers.

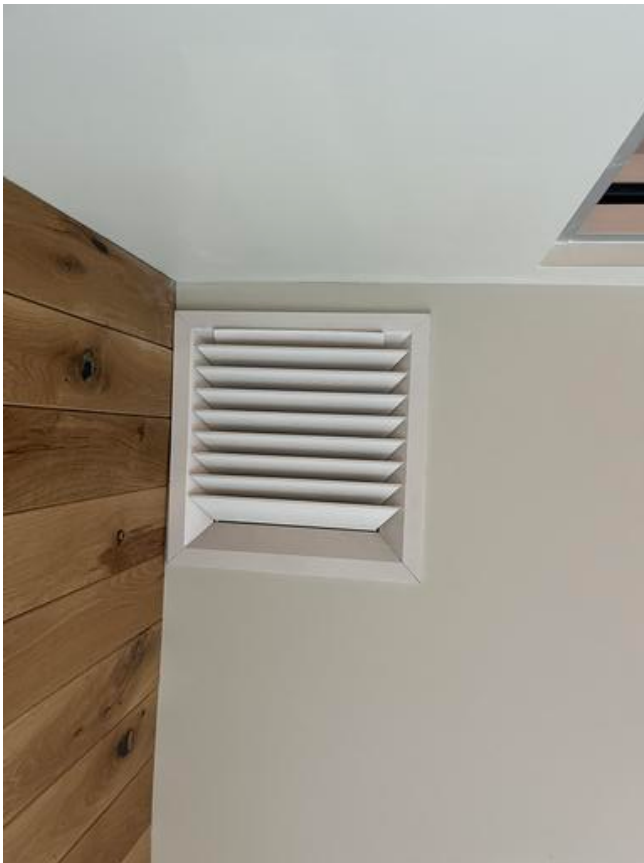
#13 [DUCT 055] CRITICAL – Air device wrong type.

Return diffuser 3-1 located in front vestibule does not match specified type on air device schedule. It is supposed to be a type K perforated diffuser.

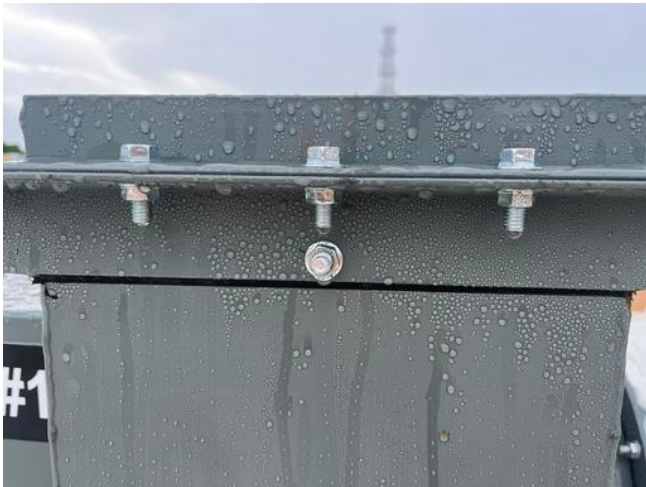
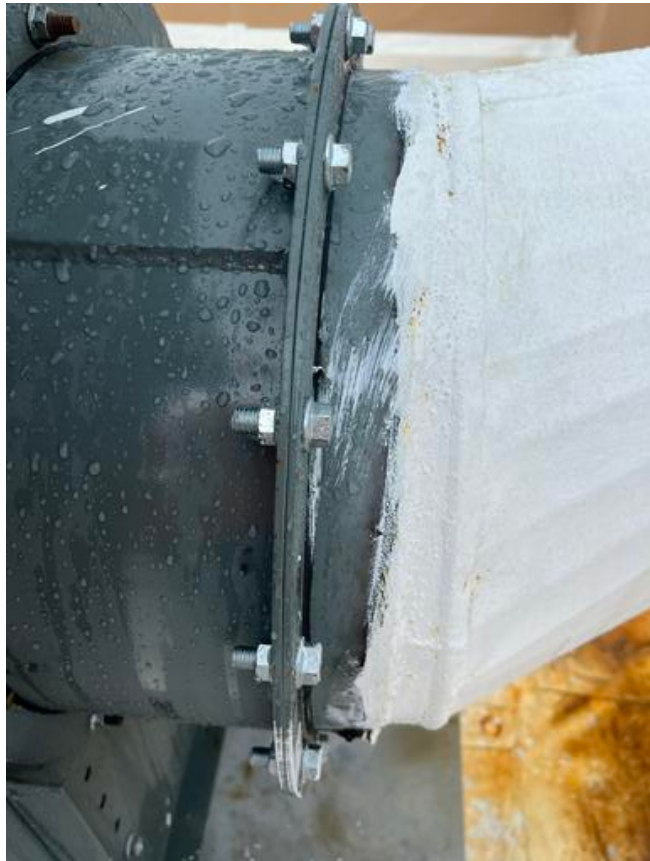
#11 [EXHA 122] Exhaust fan 1500F gasketing.

Exhaust fan is missing
1500°F rated field provided/
installed gasketing at intake
flange or at discharge nozzle
flange.

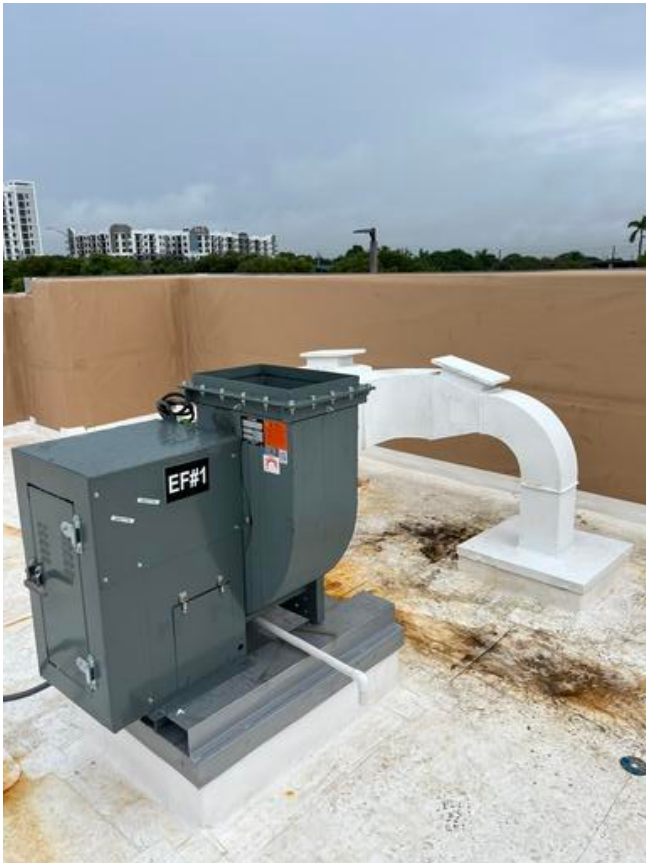
#10 [EXHA 123] Exhaust fan discharge nozzle.

Exhaust fan discharge nozzle is not installed to kitchen hood exhaust fan detail.

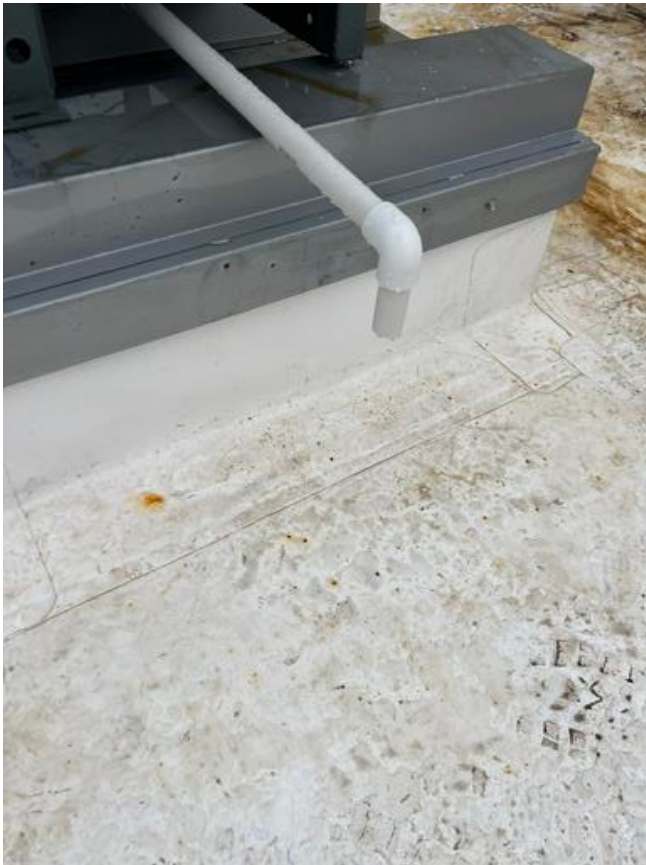
#9 [EXHA 125] Exhaust fan G2 drip guard.

Exhaust fan G2 drip guard is missing.

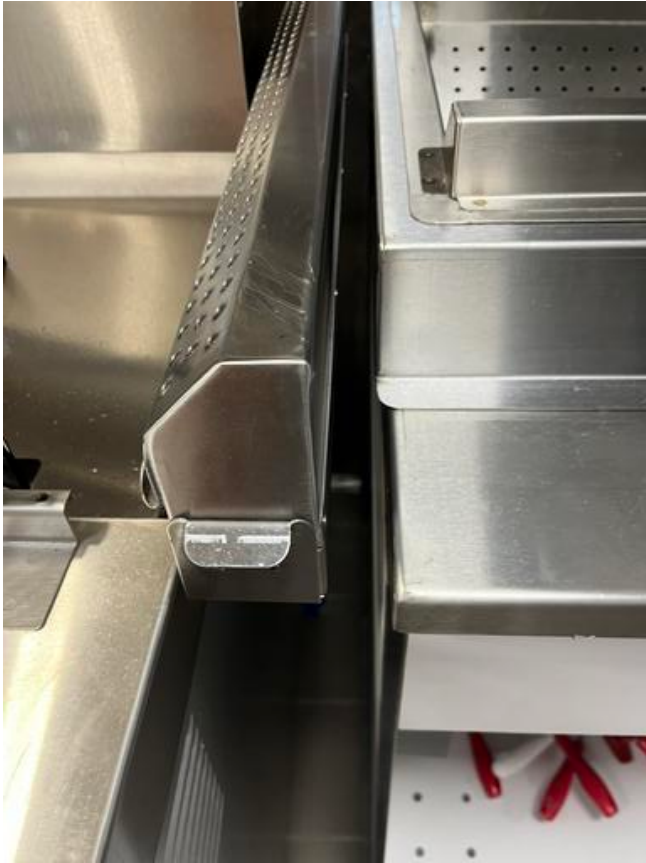
#6 [HOOD 142] Sidejet arm angle bracket.

The Halton supplied angle bracket that connects the integral sidejet arm to the counter is missing or not installed correctly. Secure bracket to arm and bracket to counter underneath removeable fry dump via stainless steel rivets.

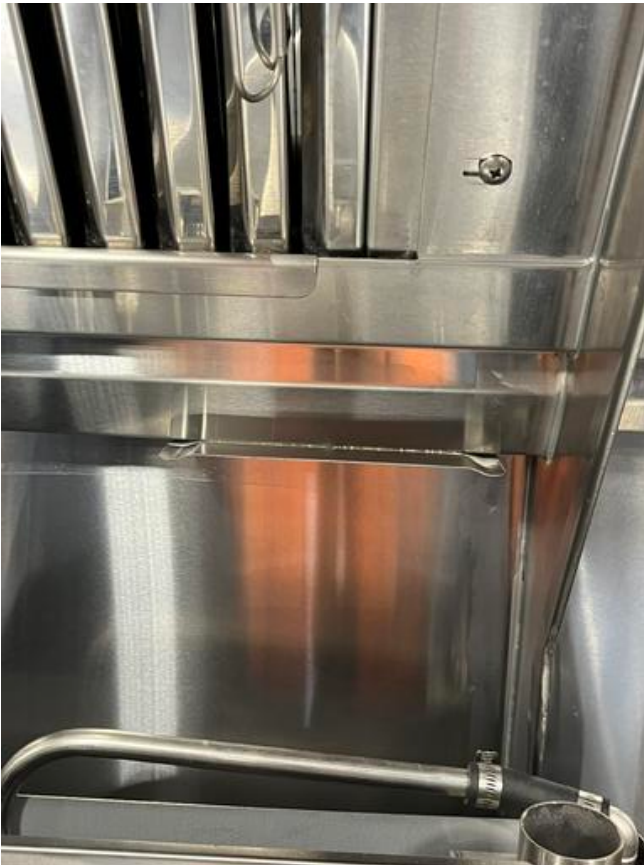
#4 [HOOD 146] Grease cup and fry chute.

Hood#1L is missing its
grease cup

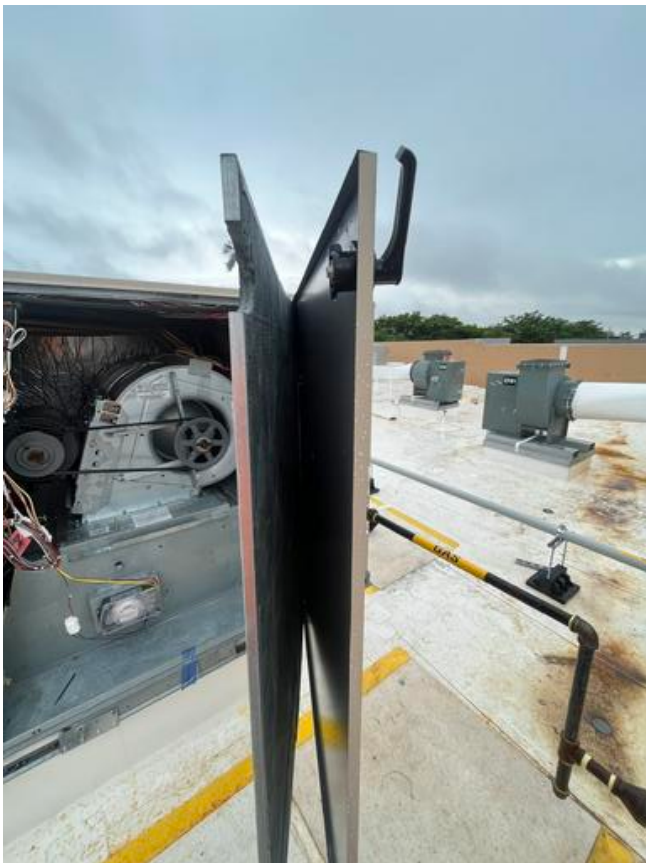
#2 [UNIT 160] Equipment weather stripping or insulation.

Internal weather stripping or insulation is not secured properly in AC#1 and AC#2

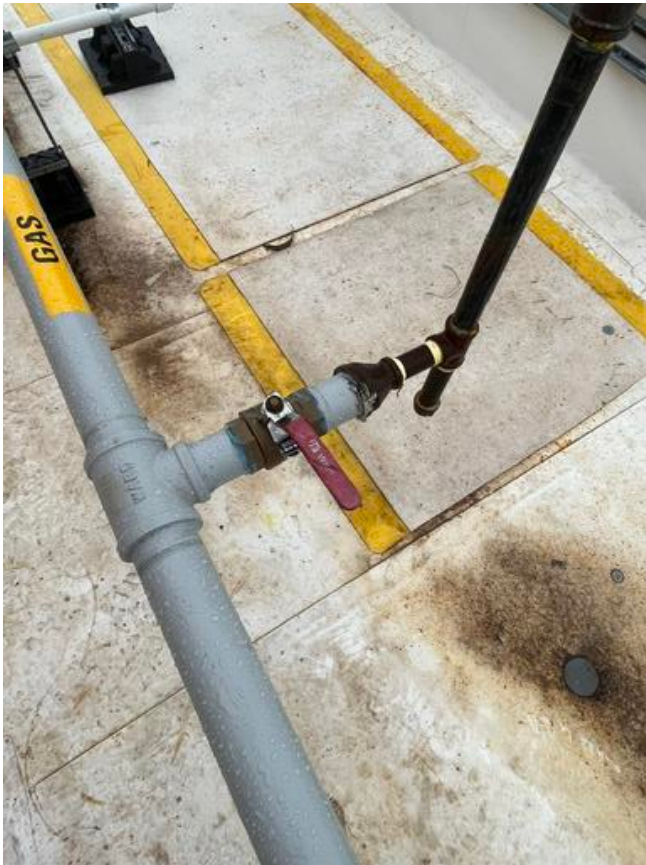
#1 [UNIT 164] Equipment gas piping.

Equipment gas valves are not turned on.
