TAB Punchlist CFA 05887 Bristol FSU

Dec 4, 2025

L05887_Bristol (CT) FSU (CT)

1251 Farmington Avenue, Bristol, Connecticut

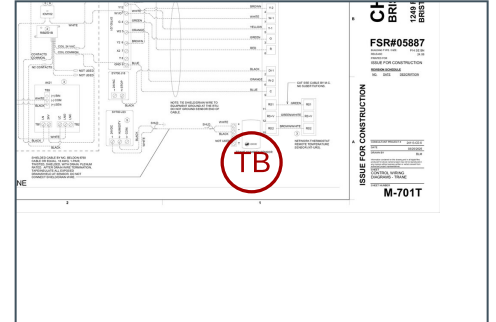
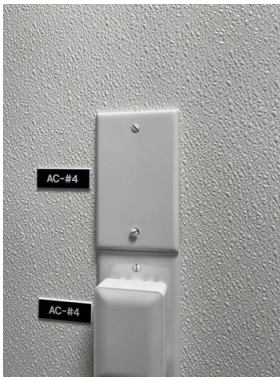
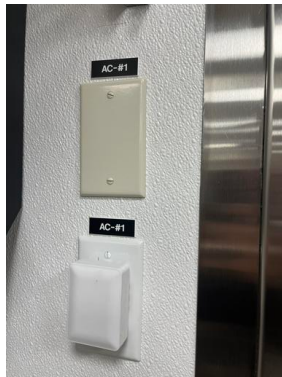
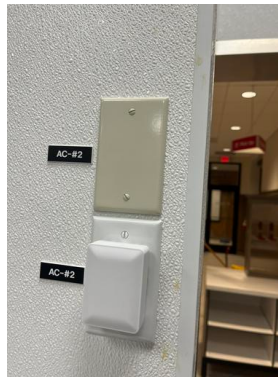
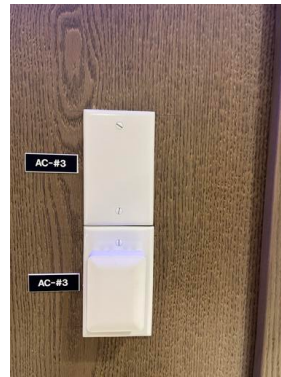
Sheet
M-701T

Humidity Sensors were backordered from Trane. Per RJ they are arriving onsite 12/5 and will be installed by MC. Verify RTUs are ready humidity once completed.

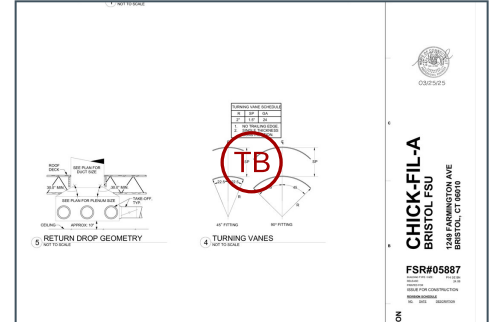
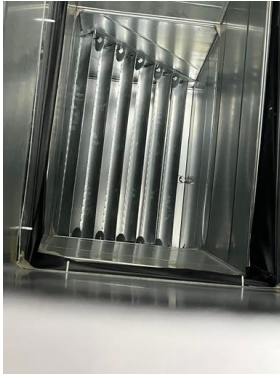
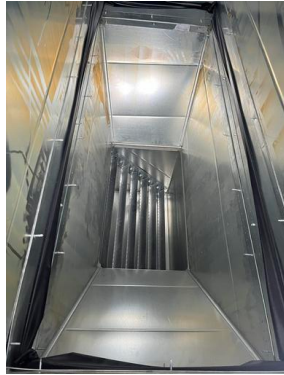
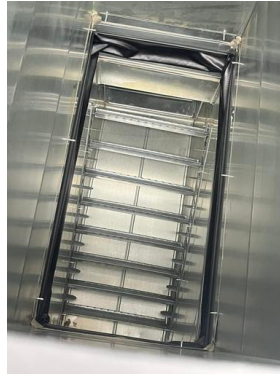
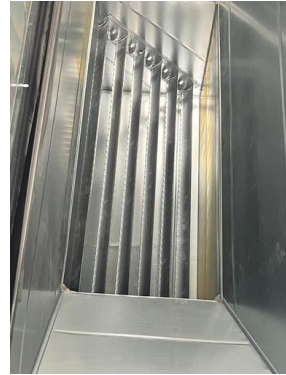
Sheet
M-501

Double thickness turning vanes are present in the system. Per specification only single thickness are to be installed in 90 degree turns where any dimension is greater than 12". Note units have been balanced and all ESPs are under design indicating the double thickness vanes are not causing restriction or reduced energy efficiency. recommend review by the project team.

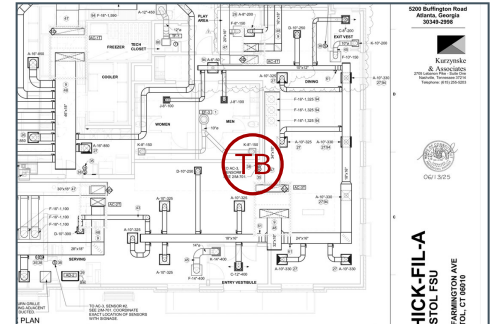
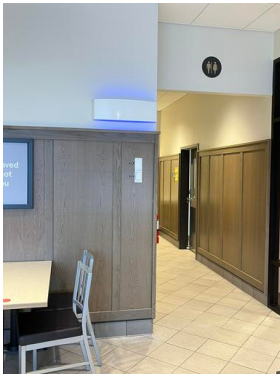
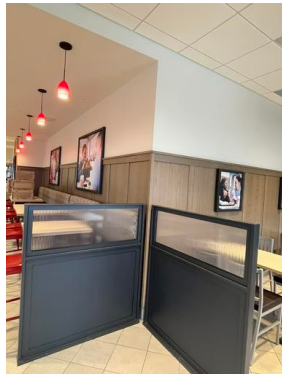
M-101T

Control not installed at drawing location. (sensor, *stat, etc). AC-3 Sensor-1 Temp/Hum is not located per the MSET. Installed location may be deemed suitable, recommend review by project and relocate if deemed necessary.

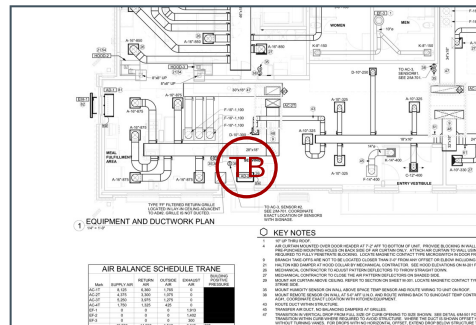
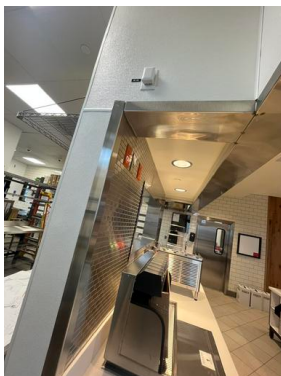
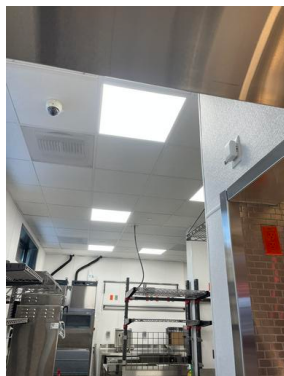
Sheet
M-101T

AC-3 Sensor-2 is installed where shown on the drawing, but location may be deemed not Ideal. Recommend review from project team to approve current location or relocate if deemed necessary. It seems like current location it could be thrown off by drafts from AC-1 diffuser.

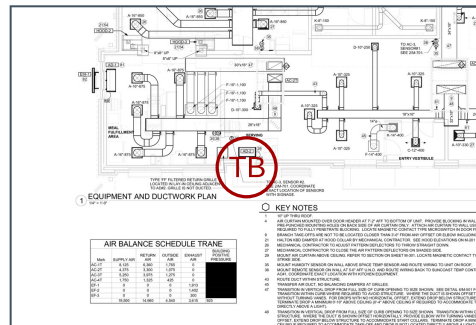
Sheet
M-101T

Air curtain heating element or fan not energizing correctly due to internal mechanical problem (switches work correctly). Serving AD-2 is not operating correctly, sound like the contact pulls in but the AD is not functional. Found cover off during inspection. Ensure AD-2 is made functional, reinstall covers, and set the Timer to 0sec so the AD shuts off immediately after the Door closes for minimal noise disruption.

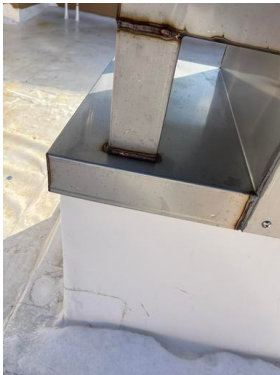
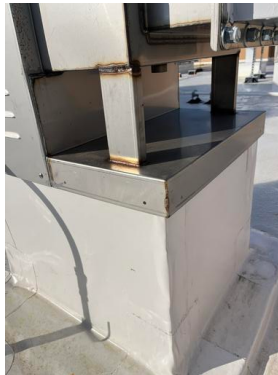
Exhaust fan is to be securely Screwed to the curb at the prepunch locations Per manufacturers recommendation.

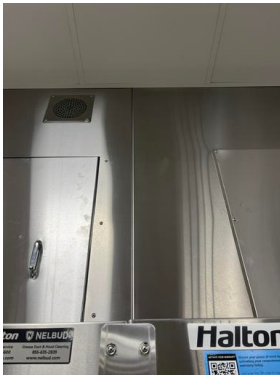
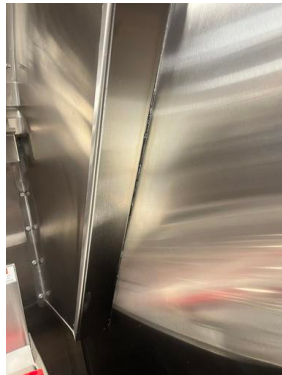
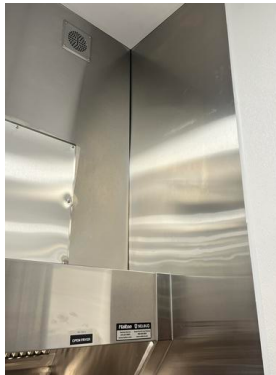
Caulk edge of Hood-2
against wall, and Caulk
between HD-1L/R

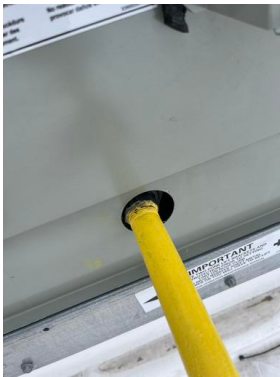
AC gas inlet grommet is missing at the gas line/RTU penetration point. AC-1,3 do not have grommets on the gas piping, seal with grommet or plumbers putty.

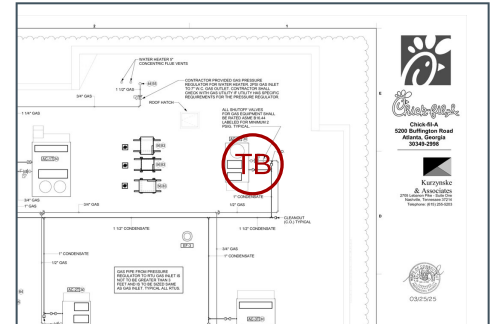
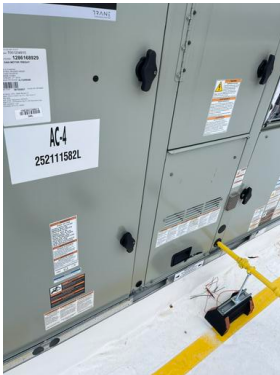
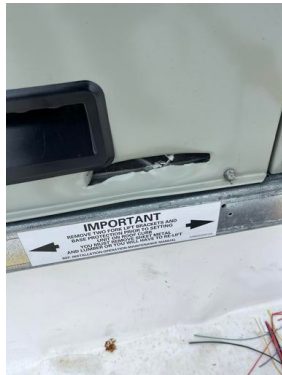
Sheet
M-102T

Equipment exterior or interior appears damaged. AC-4 has damage to the heater section panel and needs to be replaced.

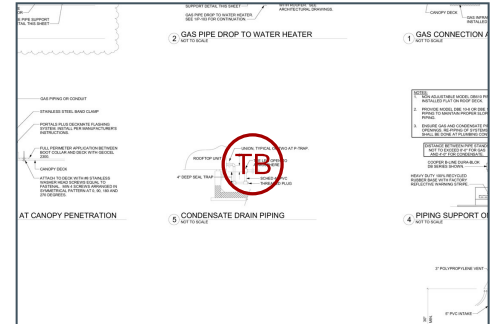
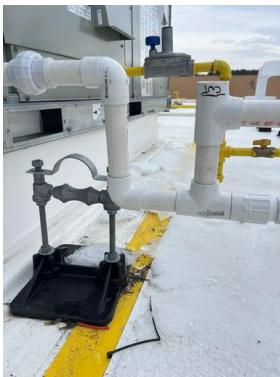
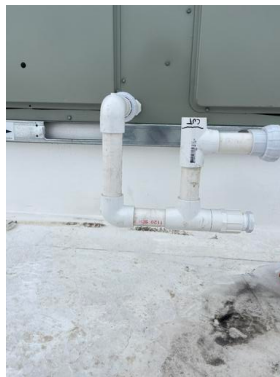
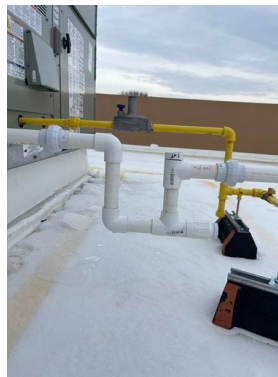
Sheet
M-502

Equipment condensate piping or p-trap is not constructed per normal CFA specifications. Trim the T fitting that is open to the atmosphere so that it is below the outlet pipe of the unit

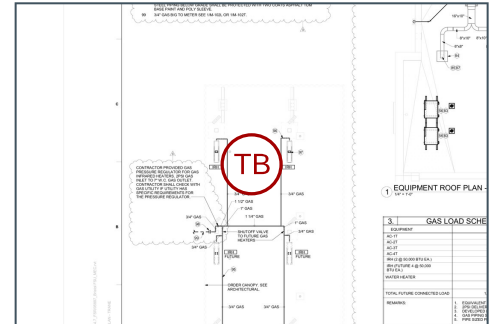
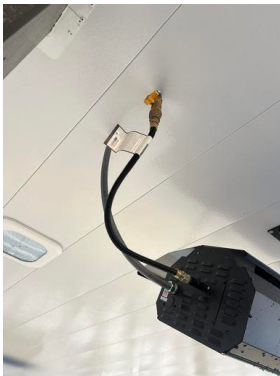
Sheet
M-102T

Drive thru heater gas valves are off, Turn valves on and ensure proper startups have been completed.

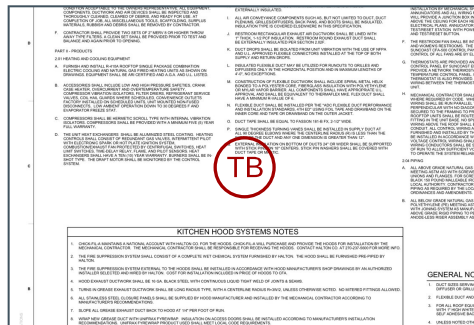
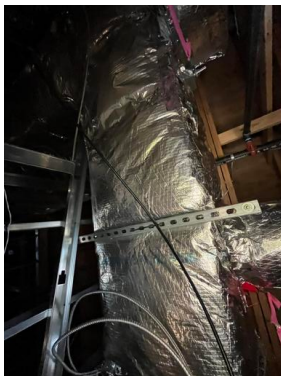
Sheet
M-001

External insulation on bottom of ducts 24" or wider is to be supported by stick pins 18" on center. Cut pins and apply tape or mastic over stick pin washers. AC-2/3 are missing stick pins, AC-2 supply and return trunks, AC-3 on the supply trunks. AC-1 does have stick pins

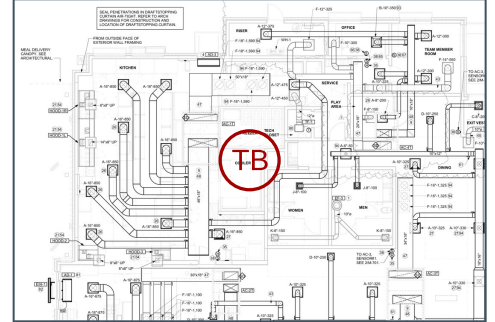
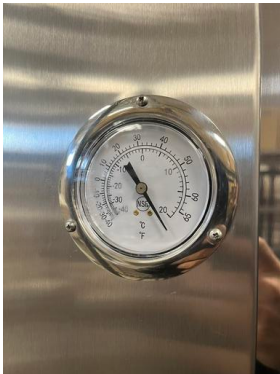
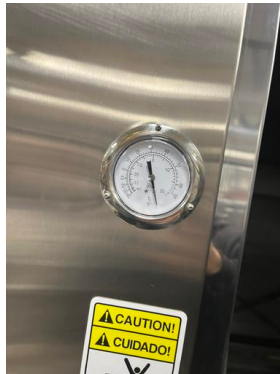
Sheet
M-101T

At time of inspection WIC/WIF boxes are not running so capability of holding specified temperatures could not be tested. And or functionality tests of the WIC/WIF could not be performed. Ensure units hold temp and the thermometers are reading accurately

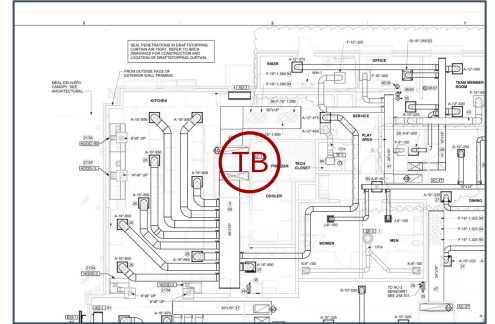
Sheet
M-101T

WIF door sweep is not sealed tightly with threshold when door is closed. No light should be present inspecting from the inside out with box lights off. Noticeable gap present

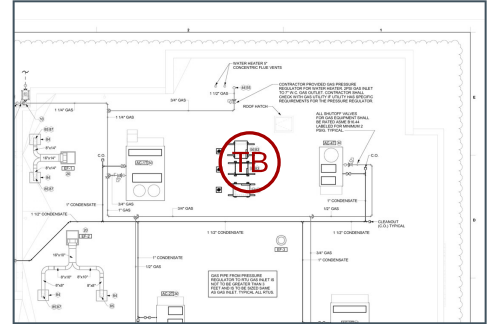
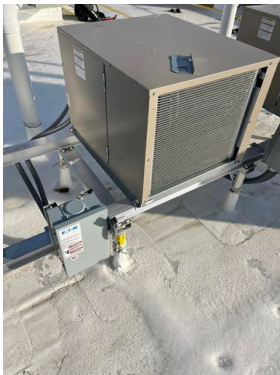
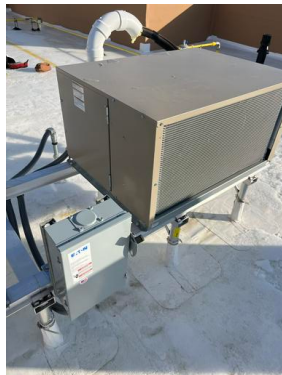
Sheet
M-102T

Description
Electrical disconnects are not properly labeled.

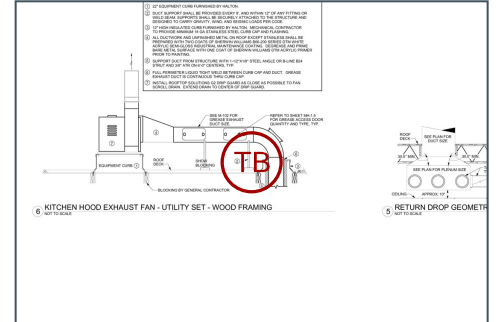
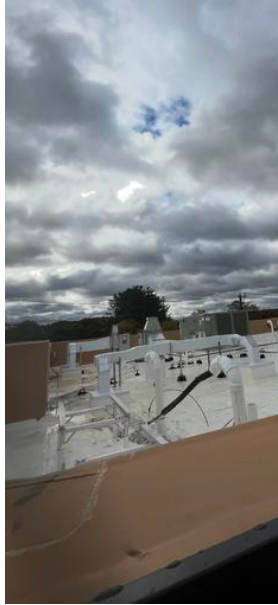
Sheet
M-501

Exhaust duct is to be supported per kitchen hood exhaust fan detail on 6'0" centers.

Miro guard spec was used thus a support at each drop to the space is also needed
