**Report: TAB REPORT  
Function: Test, Adjust, & Balance  
Date: 01/06/2023**

**06-05-23 WALGREENS #4619 - SEBASTIAN,  
FL**

Project: 06-05-23 WALGREENS #4619 - SEBASTIAN, FL

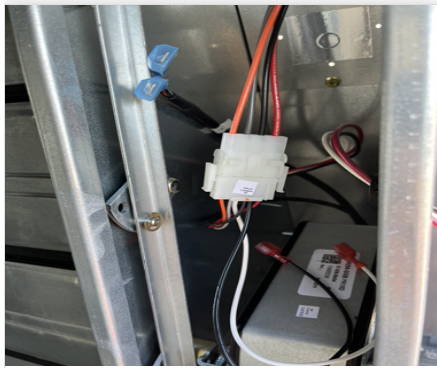
**Economizer  
01/04/2023**

**Issue Name :** Economizers do not have power on all units.  
**Description :** (RESOLVED) Cables that power the Economizer itself are not plugged in. Cannot find any female cables to power Economizer. Temporarily set the OA by manually setting the damper but once resolved, the damper needs to be permanently set through the controller.  
**Created By :** National TAB                      **Assigned To :** National TAB - Will Turnbough  
**Status :** Closed  
**Originated Date :** 01/04/2023 - Ian Fuller - National TAB

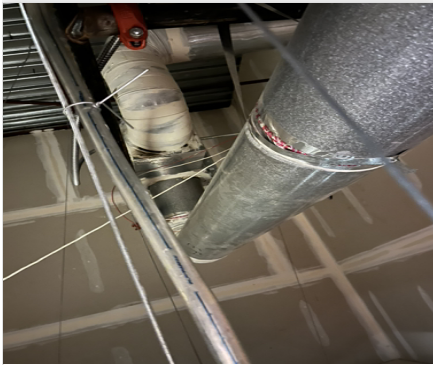
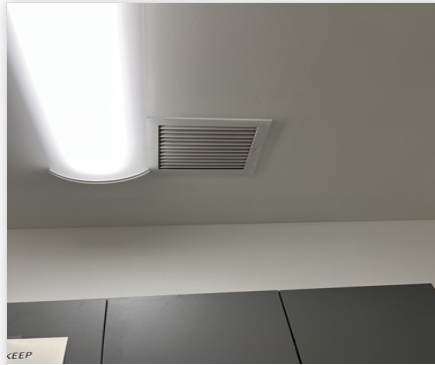
**Issue Name :** EF#1 & EF#2 currently are not functioning  
**Description :** (RESOLVED) No airflow measured.  
**Created By :** National TAB                      **Assigned To :** National TAB - Will Turnbough  
**Status :** Closed  
**Originated Date :** 01/05/2023 - Ian Fuller - National TAB

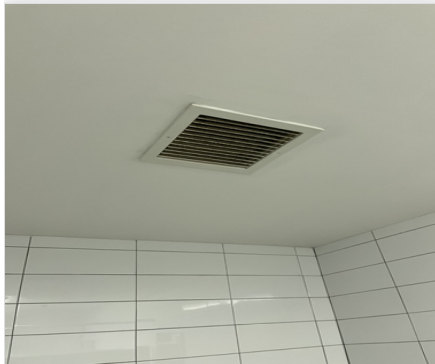
**EF3**  
01/05/2023

**Issue Name :** EF#3 & 4 are below design.  
**Description :** EF3 is at 241 cfm out of designed 300. EF4 is at 264 out a designed 300. Could not reach fans to see if airflow could be sped up to design. Would require a roughly a 12' ladder and removing ceiling grid to access.  
**Created By :** National TAB                      **Assigned To :** National TAB - Will Turnbough  
**Status :** Open  
**Originated Date :** 01/05/2023 - Ian Fuller - National TAB

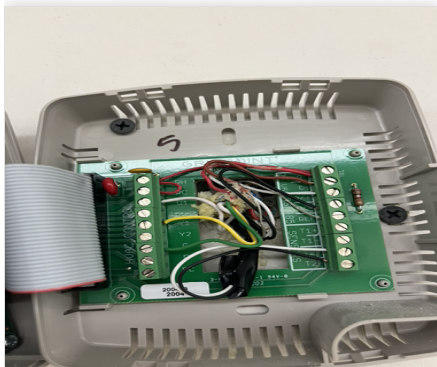
**SpaceSensor**  
01/03/2023

**Issue Name :** RTU#5 has alarm that indicates it is using return temp sensor instead of space temp sensor.

**Description :** Alarm shown on HMI screen. Needs to be resolved for unit to accurately read temperature.

RTU5 IS USING RETURN TEMPERATURE SENSOR INSTEAD OF SPACE TEMPERATURE SENSOR.
