**National TAB
1329 E. KEMPER ROAD
SUITE 4210
CINCINNATI, OH 45246**

**Report: TAB REPORT
Function: Test, Adjust, & Balance
Date: 05/20/2024**

**PROJECT
05-13-24 FREDDY'S - Independence, MO**

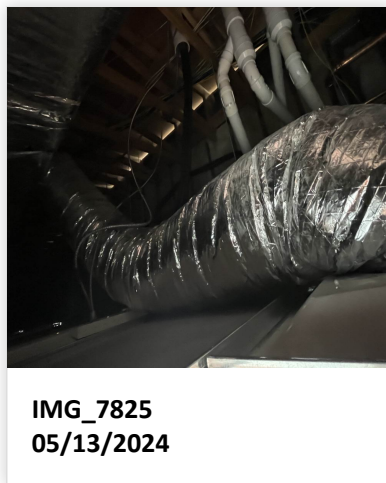
Issue Name : DOAS diffuser 6 low on flow, flex duct sagging
Description : DOAS diffuser 6 is low on flow and flex duct is sagging preventing airflow from getting to the diffuser. Recommend lifting and stretching duct to get more air to diffuser.
Created By : National TAB **Assigned To :** National TAB - Jacob Davidson
Status : Open
Priority : Medium **Asset Tag :**
Originated Date : 05/13/2024 - Jacob Davidson - National TAB

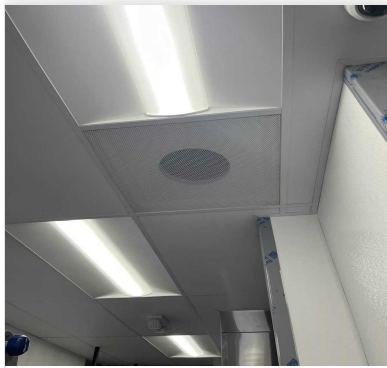
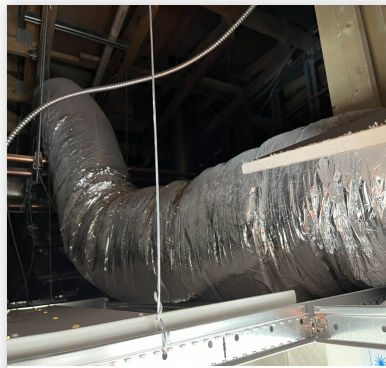
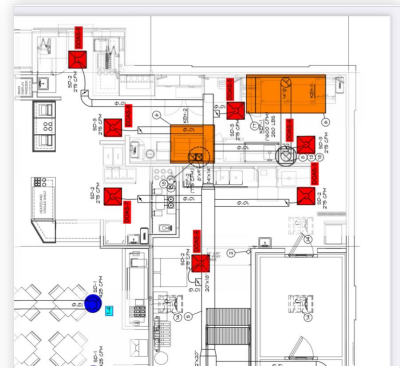
Issue Name : DOAS diffuser 8 low on flow, flex sagging
Description : Diffuser 8 on DOAS is low on flow and the flex duct above ceiling is sagging which could be restricting the airflow. Recomment lifting and stretching the duct above ceiling to get optimal flow.
Created By : National TAB **Assigned To :** National TAB - Jacob Davidson
Status : Open
Priority : Medium **Asset Tag :**
Originated Date : 05/13/2024 - Jacob Davidson - National TAB

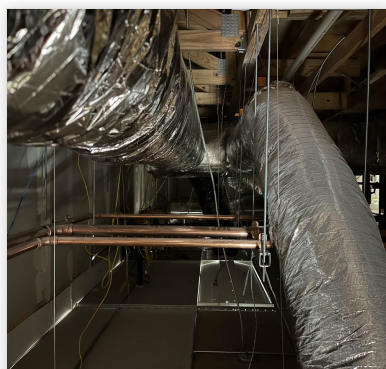
Issue Name : DOAS diffuser 9 high on flow. Unable to get to damper
Description : Diffuser 9 is high on flow and tech is unable to get to the damper due to ceiling obstruction.
Created By : National TAB **Assigned To :** National TAB - Jacob Davidson
Status : Open
Priority : Medium **Asset Tag :**
Originated Date : 05/13/2024 - Jacob Davidson - National TAB

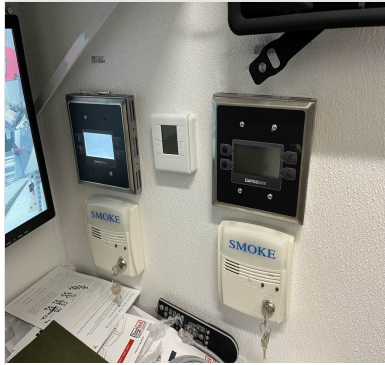
Issue Name : RTU1 HMI in space not operating
Description : HMI in the space is not operating for operation of RTU1 so settings can only be changed from the roof currently. Spoke to CAS tech and they believe the issue is the CAT5 cable.
Created By : National TAB **Assigned To :** National TAB - Jacob Davidson
Status : Open
Priority : High **Asset Tag :**
Originated Date : 05/16/2024 - Jacob Davidson - National TAB

UNABLE TO PROGRAM DINING ROOM HMI
