Report: TAB REPORT
Function: Test, Adjust, & Balance
Date: 05/20/2024

05-13-24 FREDDY'S - Independence, MO

Freddy's Frozen Custard & Steakburgers (CORPORATE)
260 N Rock Rd
Suite 200
Wichita, KS 67206

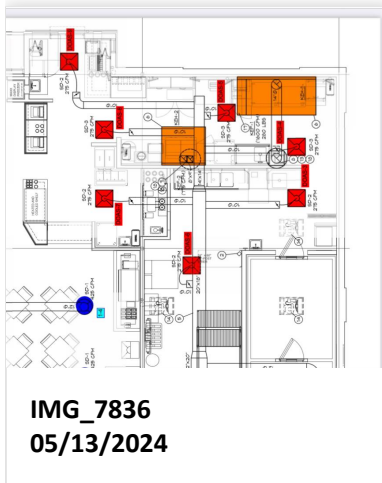
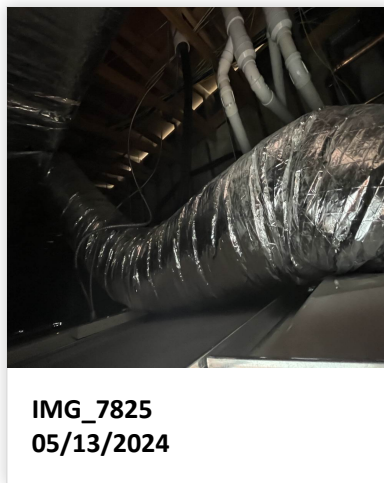
Issue Name : DOAS diffuser 6 low on flow, flex duct sagging
Description : DOAS diffuser 6 is low on flow and flex duct is sagging preventing airflow from getting to the diffuser. Recommend lifting and stretching duct to get more air to diffuser.
Created By : National TAB **Assigned To :** National TAB - Jacob Davidson
Status : Open
Priority : Medium **Asset Tag :**
Originated Date : 05/13/2024 - Jacob Davidson - National TAB

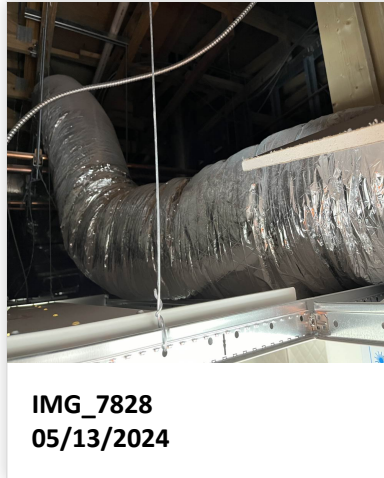
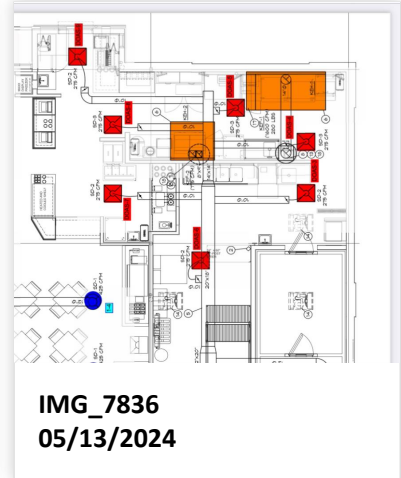
Issue Name : DOAS diffuser 8 low on flow, flex sagging
Description : Diffuser 8 on DOAS is low on flow and the flex duct above ceiling is sagging which could be restricting the airflow. Recommen lifting and stretching the duct above ceiling to get optimal flow.
Created By : National TAB **Assigned To :** National TAB - Jacob Davidson
Status : Open
Priority : Medium **Asset Tag :**
Originated Date : 05/13/2024 - Jacob Davidson - National TAB

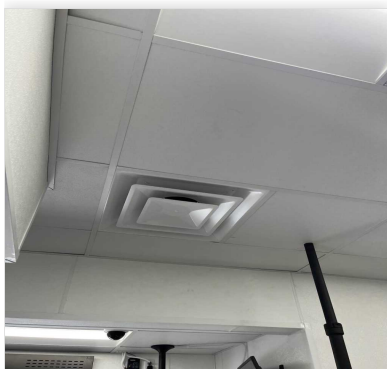
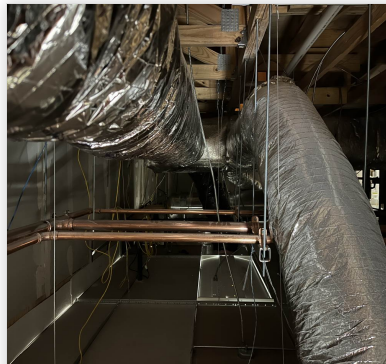
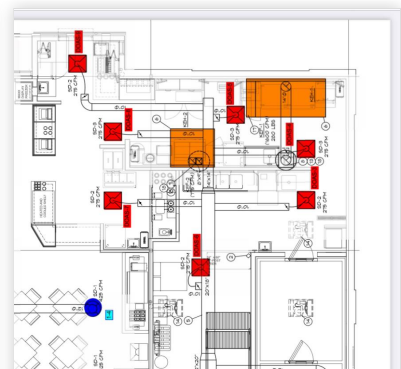
Issue Name : DOAS diffuser 9 high on flow. Unable to get to damper
Description : Diffuser 9 is high on flow and tech is unable to get to the damper due to ceiling obstruction.
Created By : National TAB **Assigned To :** National TAB - Jacob Davidson
Status : Open
Priority : Medium **Asset Tag :**
Originated Date : 05/13/2024 - Jacob Davidson - National TAB

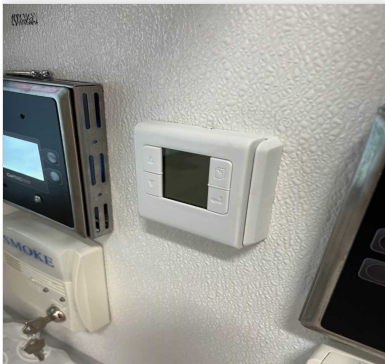
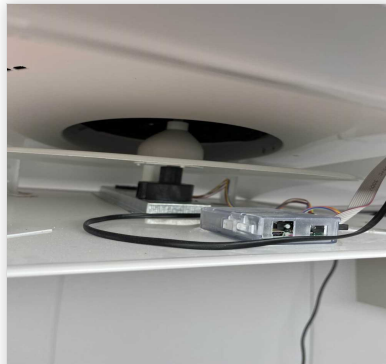
Issue Name : DOAS office VAV diffuser not powered
Description : Office VAV diffuser is not powered and tech is unable to get the diffuser open to balance.
Created By : National TAB **Assigned To :** National TAB - Jacob Davidson
Status : Open
Priority : Medium **Asset Tag :**
Originated Date : 05/13/2024 - Jacob Davidson - National TAB

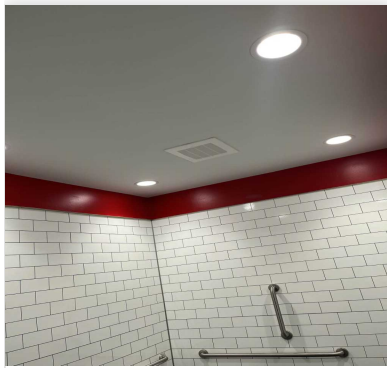
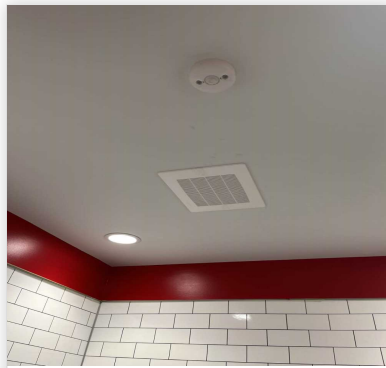
Issue Name : EF1/EF2 for restrooms are overamping
Description : Units are overamping at 0.52 of 0.40 FLA for EF2 and 0.40 of 0.22A on EF1. There is no way to reduce amperage on the units as they don't have speed control. Recommend checking the wiring.
Created By : National TAB **Assigned To :** National TAB - Jacob Davidson
Status : Open
Priority : Urgent **Asset Tag :**
Originated Date : 05/13/2024 - Jacob Davidson - National TAB

Notes:
FAN HAS HIGH AMPERAGE DRAW

Notes:
FAN HAS HIGH AMPERAGE DRAW.

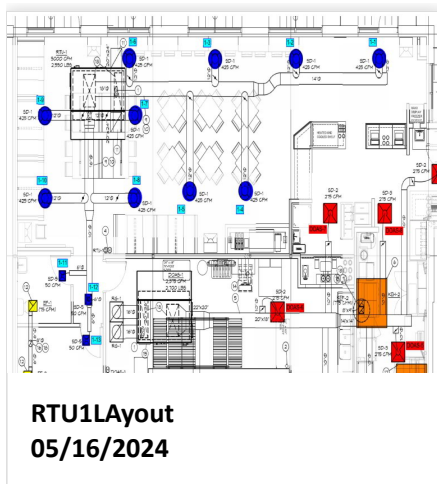
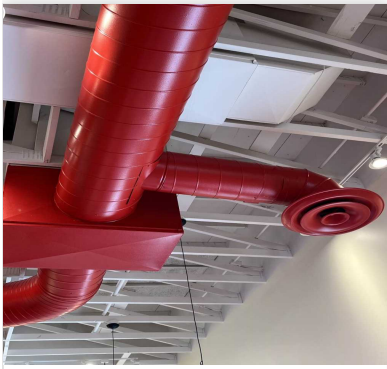
Issue Name : RTU1 diffuser 6 low flow, unable to push more air to diffuser
Description : Diffuser 6 is low as it comes off the takeoff and immediately takes a 90 degree turn. Tech is unable to push more air to diffuser. It is in an open area where it is not anticipated to cause comfort issues.

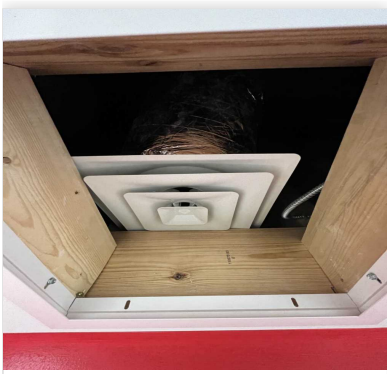
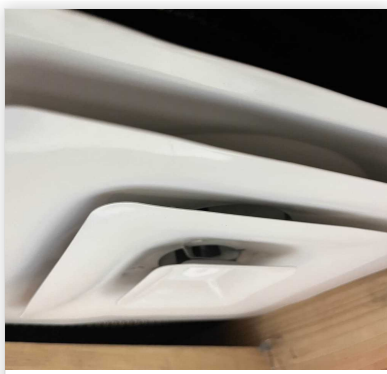
Issue Name : RTU1 diffusers for restroom and hallway missing OBD
Description : RTU1 diffusers for the restroom and hallway were supposed to have OB dampers installed to adjust airflow. Tech is unable to find any dampers for diffusers.
Created By : National TAB **Assigned To :** National TAB - Brianna Biggs
Status : Open
Priority : High **Asset Tag :**
Originated Date : 05/16/2024 - Jacob Davidson - National TAB

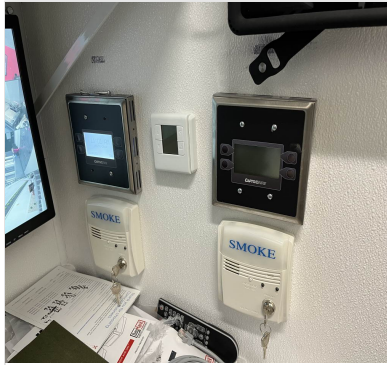
IMG_7875
05/16/2024

Issue Name : RTU1 HMI in space not operating
Description : HMI in the space is not operating for operation of RTU1 so settings can only be changed from the roof currently. Spoke to CAS tech and they believe the issue is the CAT5 cable.
Created By : National TAB **Assigned To :** National TAB - Jacob Davidson
Status : Open
Priority : High **Asset Tag :**
Originated Date : 05/16/2024 - Jacob Davidson - National TAB

UNABLE TO PROGRAM DINING ROOM HMI
