National TAB
1329 E. KEMPER ROAD
SUITE 4210
CINCINNATI, OH 45246

Report: TAB REPORT
Function: Test, Adjust, & Balance
Date: 10/30/2023

08-14-23 CULVERS LEE SUMMIT, MO REVIVE

MPH Dinning

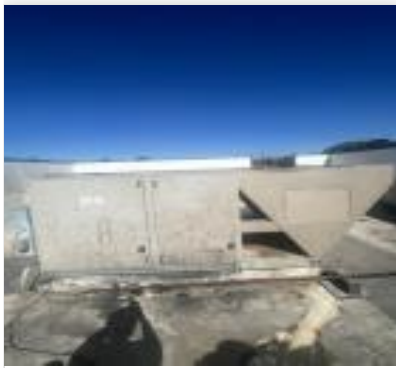
Rtu2(1)
08/16/2023

Issue Name : HIGH PRIORITY – Humidity sensor not communicating on RTU-2.
Description : Humidity sensor not communicating on RTU-2. No voltage measured on the sensor. The unit is flashing alarm 76 which is a humidity sensor issue. Checked the wiring and it appears to be correct. Recommend a service company contact Lennox technical support to resolve.

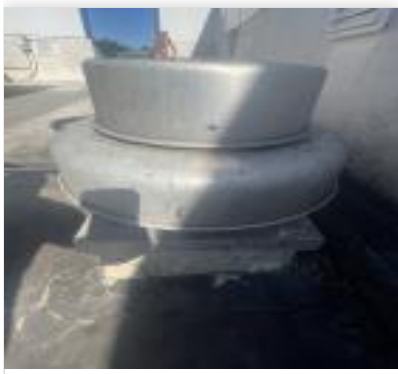
Prv1
08/16/2023

Issue Name : LOW PRIORITY – Restroom exhaust fan is not operational.
Description : Restroom exhaust fan is not operational. Recommend having the fan serviced.
Created By : National TAB **Assigned To :** National TAB - Wale Odofin
Status : Open
Originated Date : 10/30/2023 - Jacob Davidson - National TAB

Test Data		
	Design	Actual
CFM	-	0
Fan RPM	-	NA
Fan Rotation	-	NA
Motor RPM	-	NA
System SetPt	-	NA
RL Voltage	-	NA
RL Amperage	-	NA
Total ESP	-	NA
Fan Inlet SP	-	NA
Fan Discharge SP	-	NA
