TAB Punch List CFA 05925 Broadview Heights FSU

Prepared by Cody Collett

Feb 16, 2026

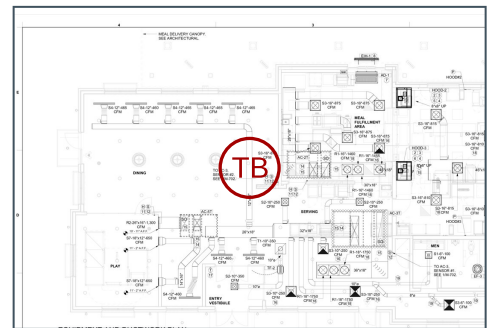
#59 [DUCT 498] [NEW] CRITICAL (DESIGN) – AC-3 Duct undersized.

AC-3 12x14 is undersized for the design CFM and would require 1988 FPM to meet design CFM. Unit took 3 speed increases and 3 balancing passes to get the entire branch as close to design as possible.
