# Pre-Grid Punch List CFA 02258

Prepared by Will Turnbough

Jun 13, 2025

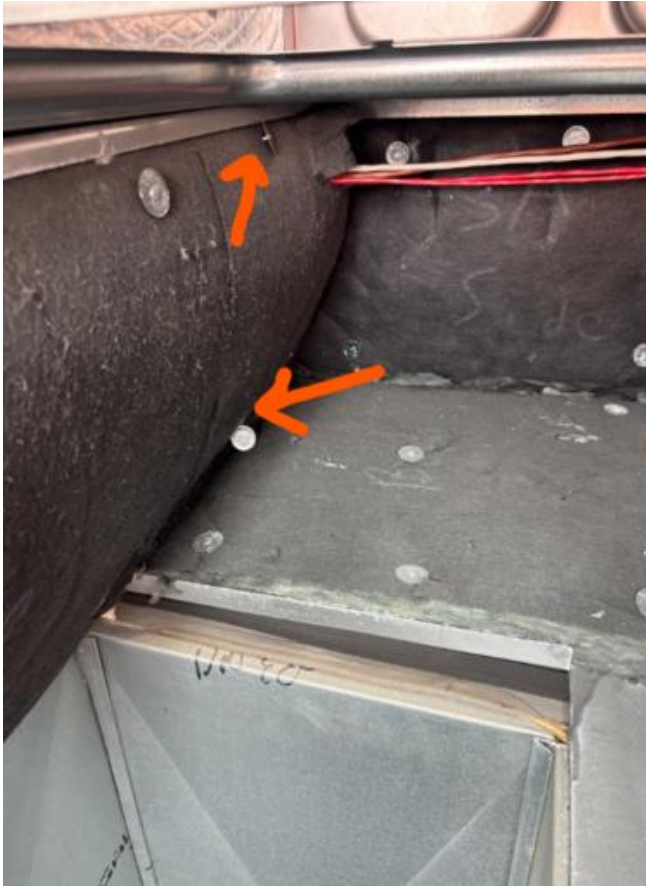
Screenshot 2025-06-13 144729

## #32 [UNIT 999] [NEW] - Curb insulation stick pins

Stick pins are loose on AC-4 curb adapter and need to be resecured.

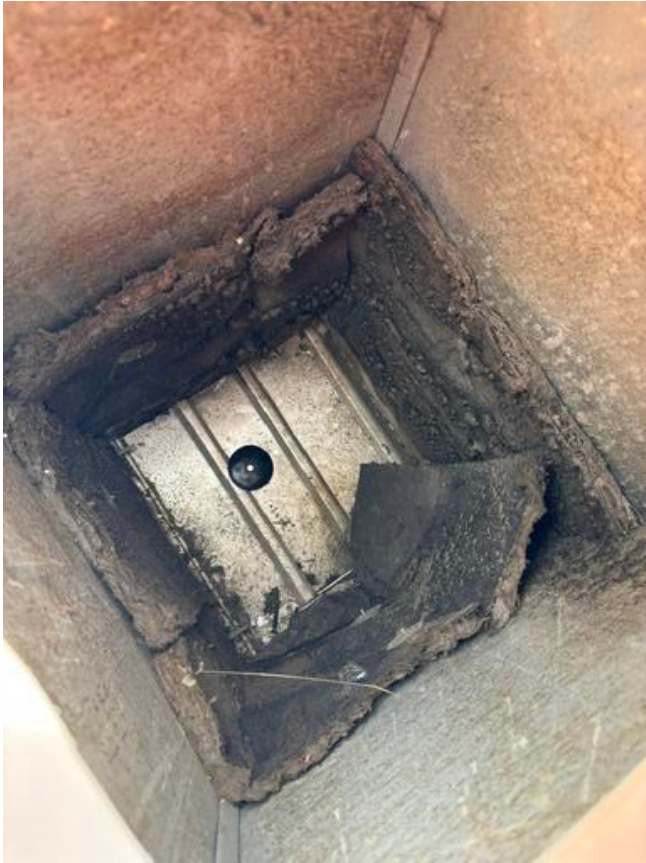
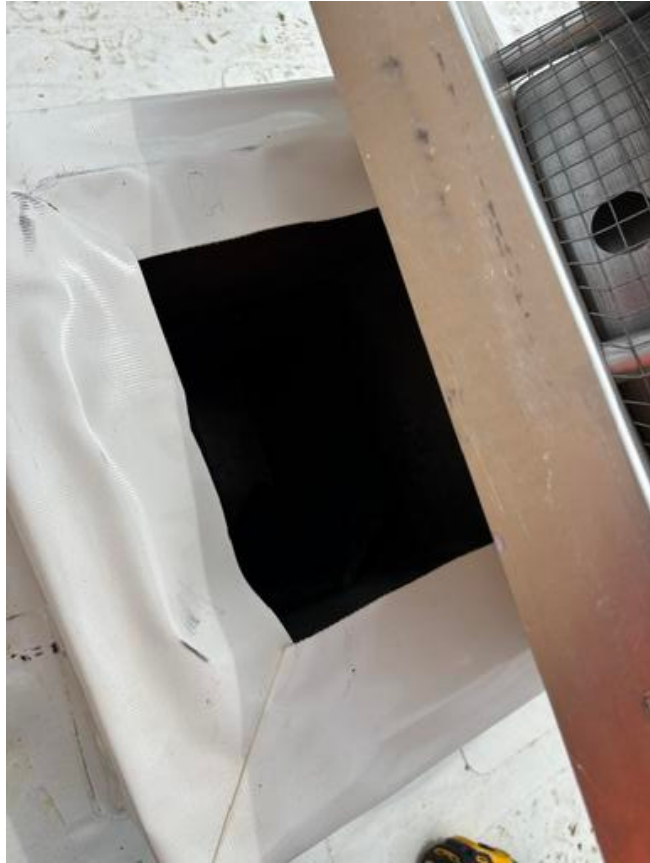
### #31 [EXHA 999] [EXIST] - Restroom exhaust fan

Debris needs to be removed from inside the restroom exhaust fan duct, insulation needs to be repaired, and the roofing material needs to be cut away.

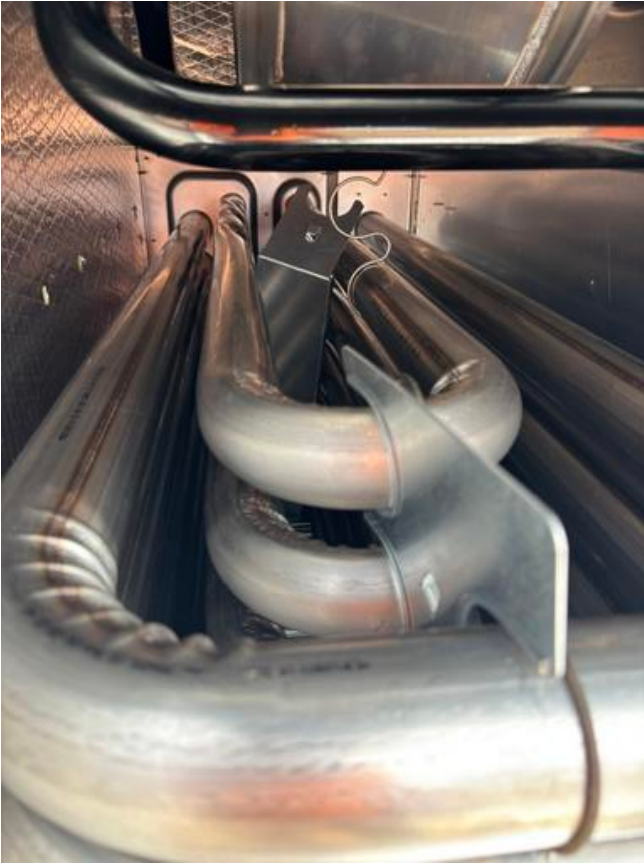
IMG\_2727

## #30 [UNIT 499] [NEW] CRITICAL - Heat Exchanger Bracket AC-3

AC-3 heat exchanger bracket has come loose and needs to be repaired.

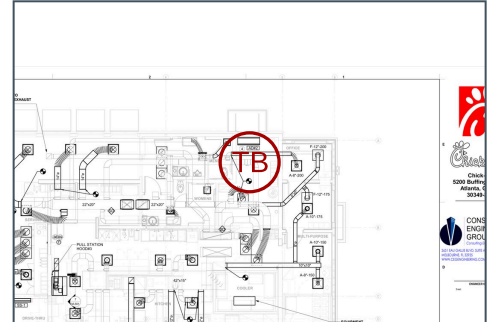
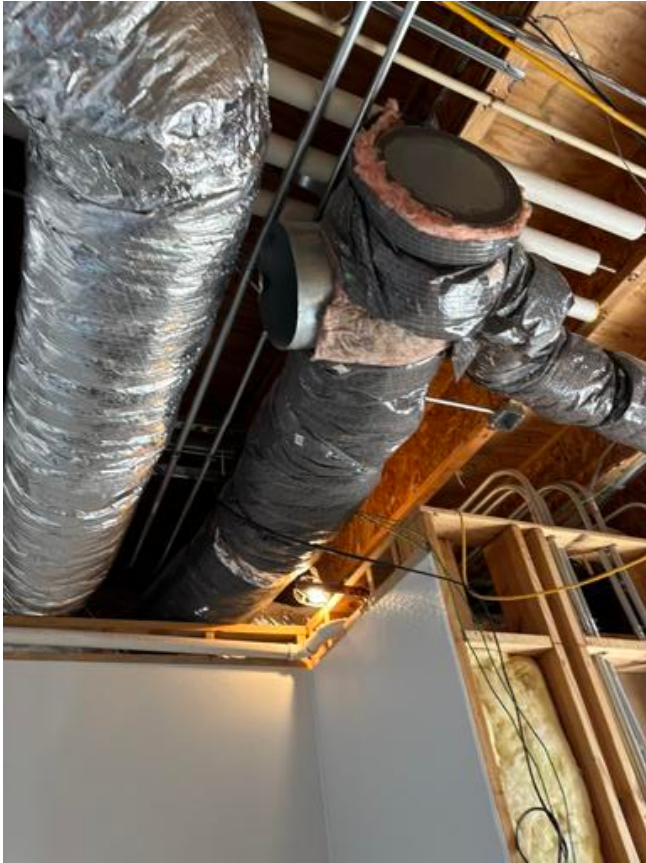
M-201

### #29 [DUCT 499] [EXIST] CRITICAL (MISC) - AC-4 existing duct

Duct run in back of the house has multiple issues. The duct run going to the office has an additional transition which will impact airflow. The takeoff that will serve that BOH area cannot be installed due to interference with another duct. The insulation is also damaged and missing from the end cap. Recommend this duct run be reinstalled.

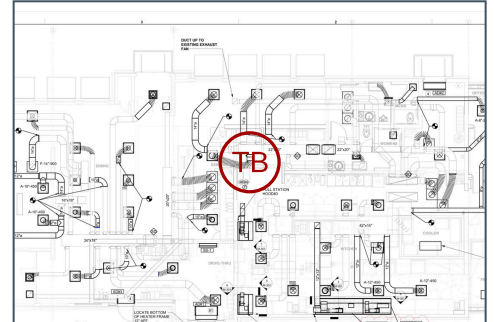
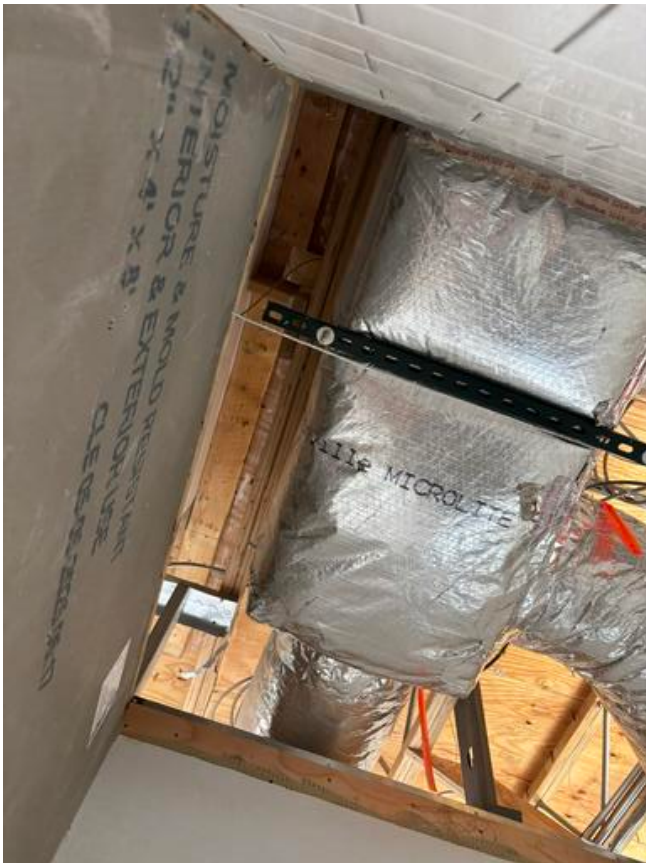
M-201

### #28 [DUCT 017] [NEW] CRITICAL – Duct not installed per plans.

AC-2 is missing a takeoff that is shown on the plans.

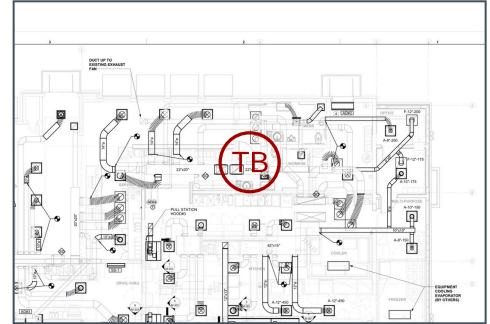
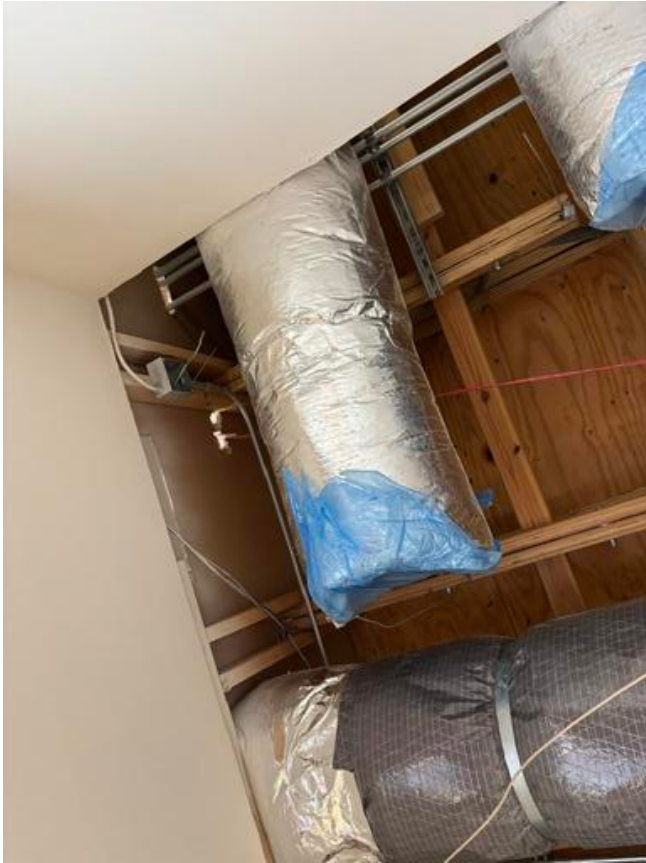
M-201

## #27 [DUCT 498] [NEW] CRITICAL (DESIGN) - AC-2 return above ceiling

There is a return duct shown terminating above ceiling for AC-2 which is unusual for Chick-fil-A design. Consult engineer of record to ensure this is not an error and to confirm the purpose.

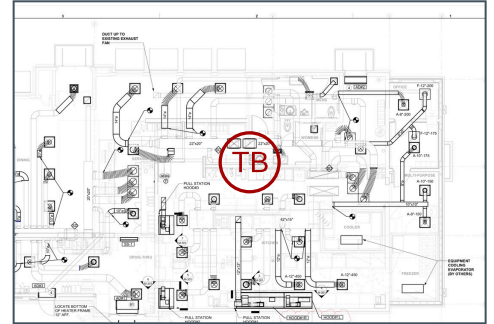
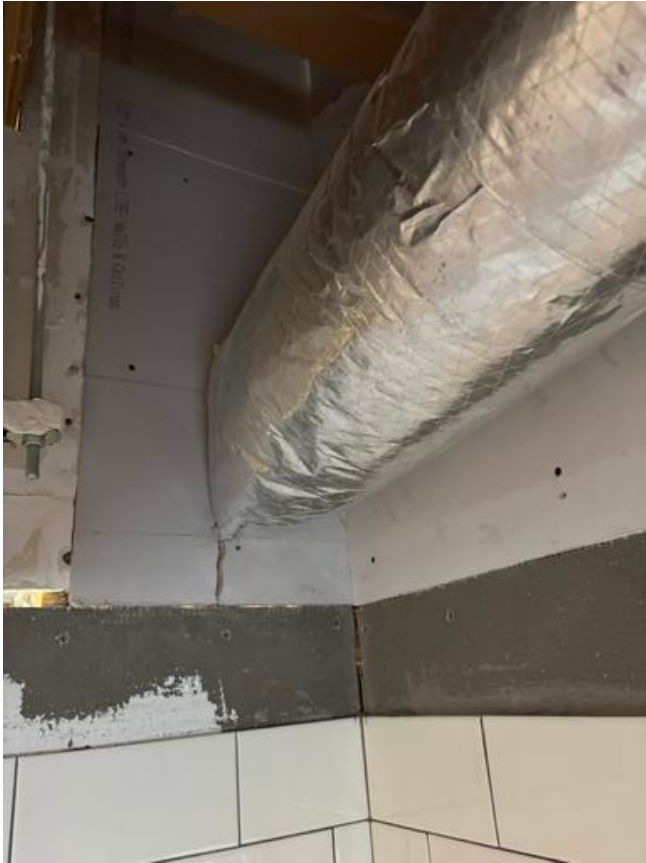
M-201

### #26 [DUCT 016] [NEW] CRITICAL – Duct is restricted – dimensional.

Duct on AC-2 serving the women's restroom is pinched as it is passing through the wall.

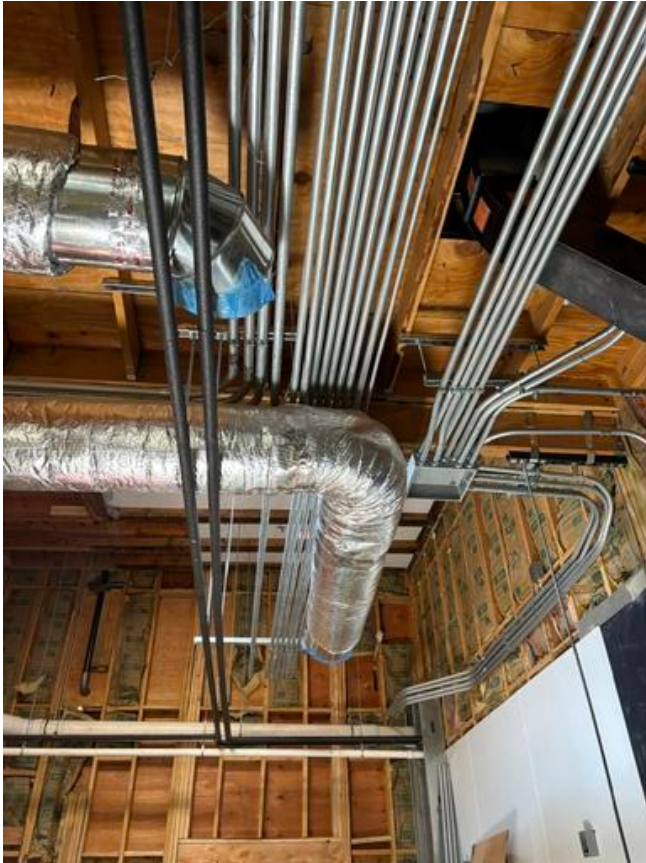
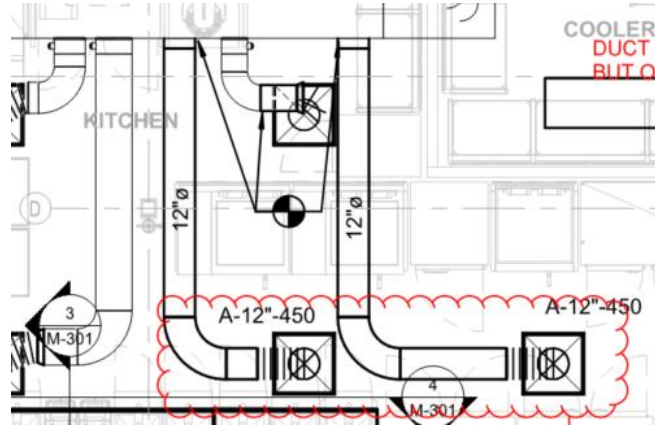
**#25 [DUCT 017] [NEW] CRITICAL – Duct not installed per plans.**

AC-1 has ducts that are not aligned as shown on the plan. Ensure they are ducted per plan so that the diffusers can be aligned in the grid without additional transitions in the duct.

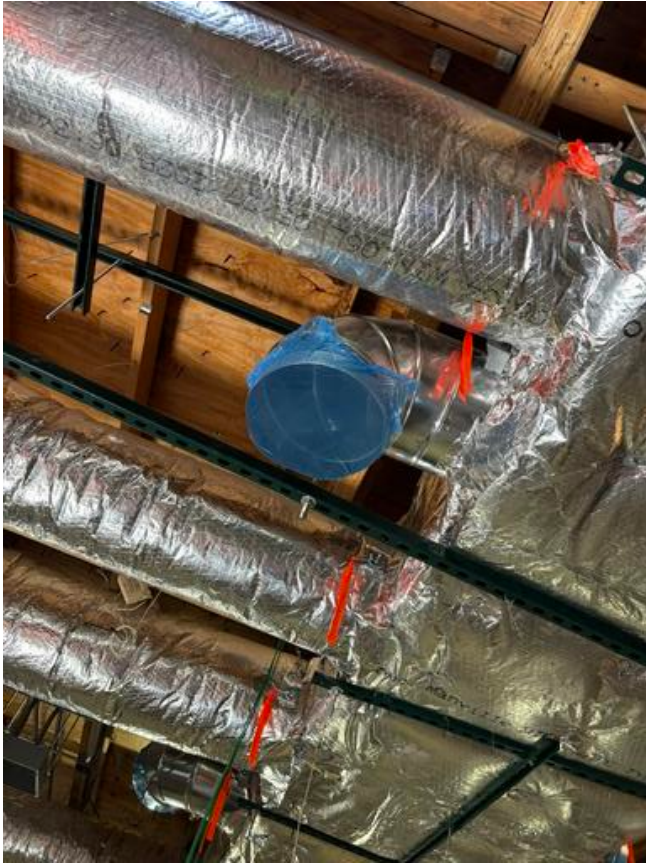
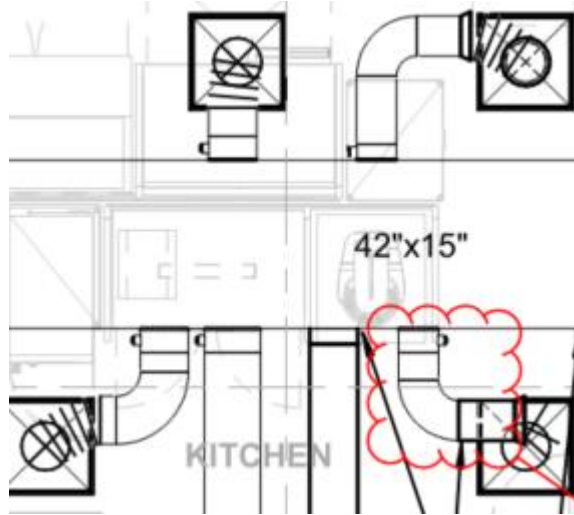
**#24 [DUCT 017] [NEW] CRITICAL – Duct not installed per plans.**

AC-1 has a takeoff that appears it can't be installed per design and will not allow for flex duct for vibration isolation. Consult engineer of record as required.

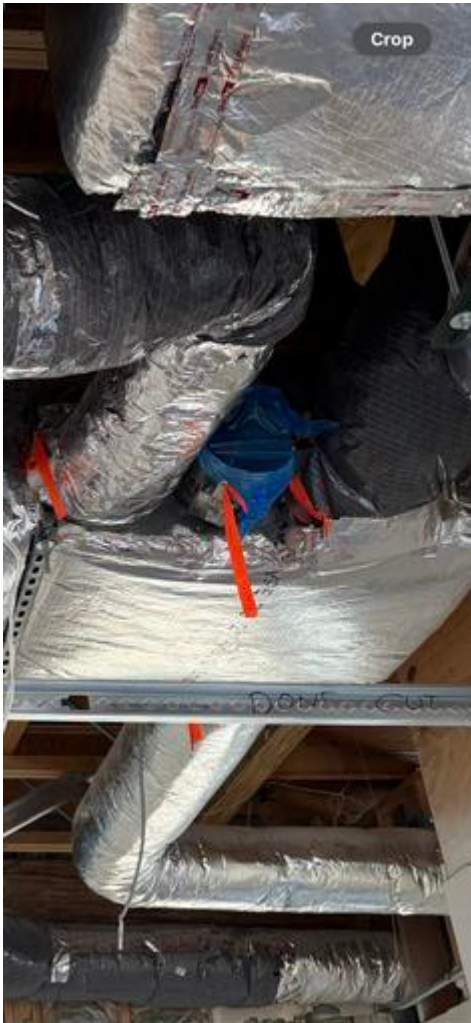
## #23 [DUCT 008] [NEW] CRITICAL – Start collar damper orientation.

AC-3 has a start collar where the damper handle is nearly vertical. However, the existing ductwork did not match the engineered drawings and there is not enough room to install as specified. No further action is required but noting for transparency.

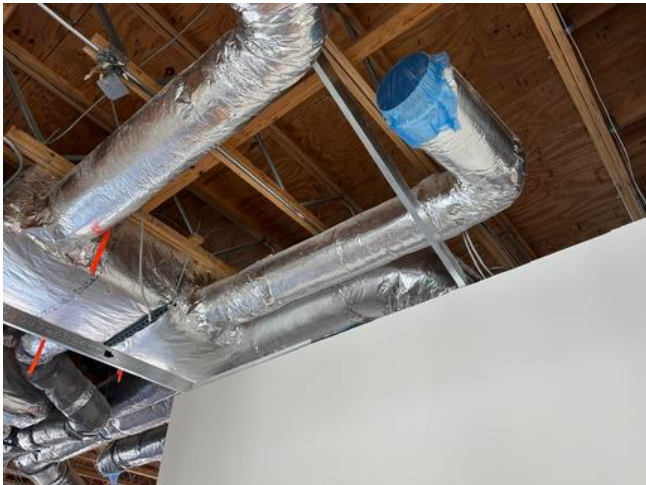
IMG\_2659

## #20 [DUCT 503] [NEW] Damper flags.

Dampers are not flagged and exposed on AC-3 per specification.

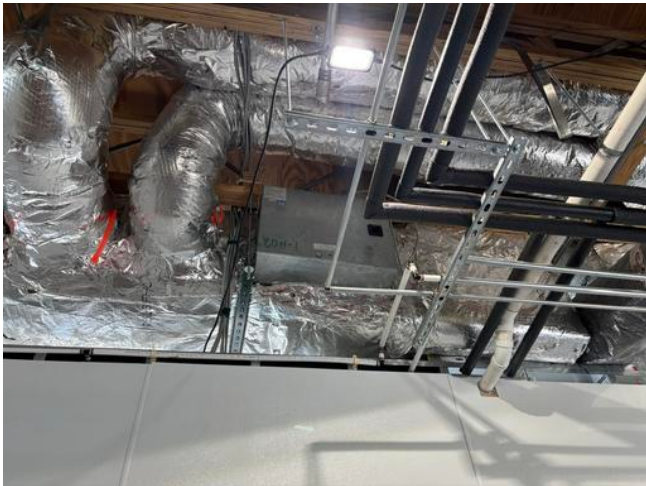
IMG\_2660

## #19 [DUCT 999] [EXIST] - EDH AC-3

AC-3 has an existing duct heater that is not shown on the plans. Consult the engineer of record to confirm if it is to be abandoned.

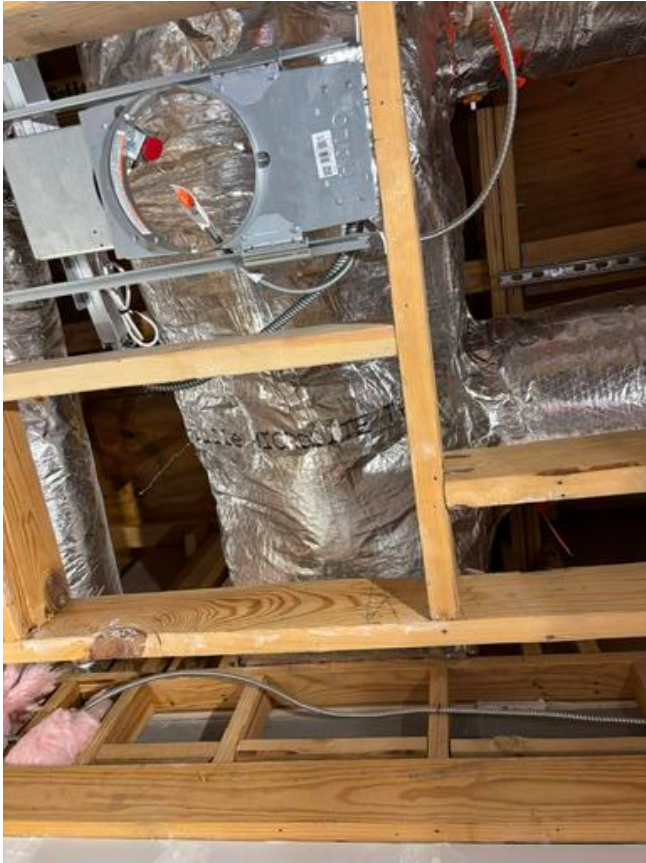
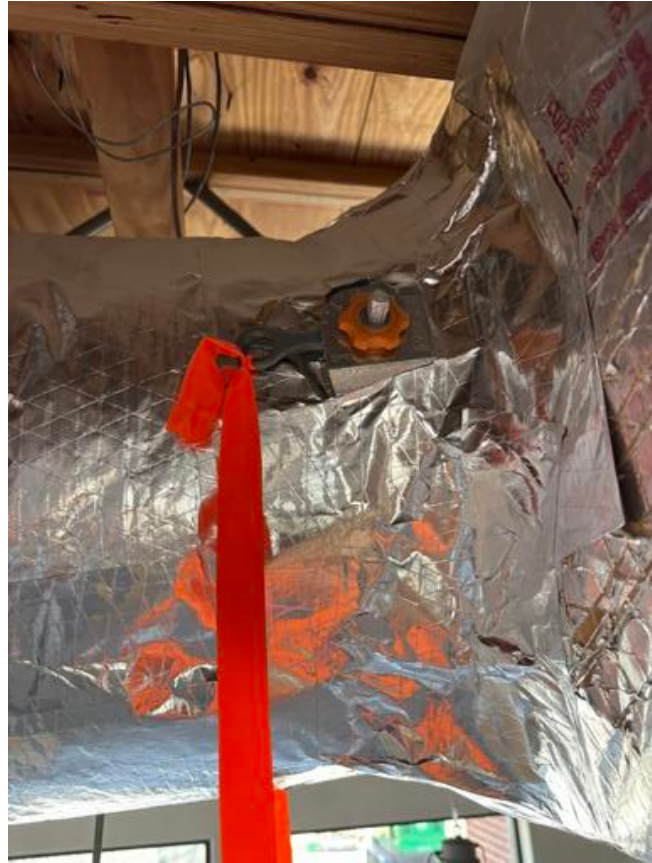
## #18 [DUCT 009] [NEW] CRITICAL – Damper incorrect type.

AC-2 and AC-4 noted to have incorrect style of damper on a couple takeoffs. Review all dampers

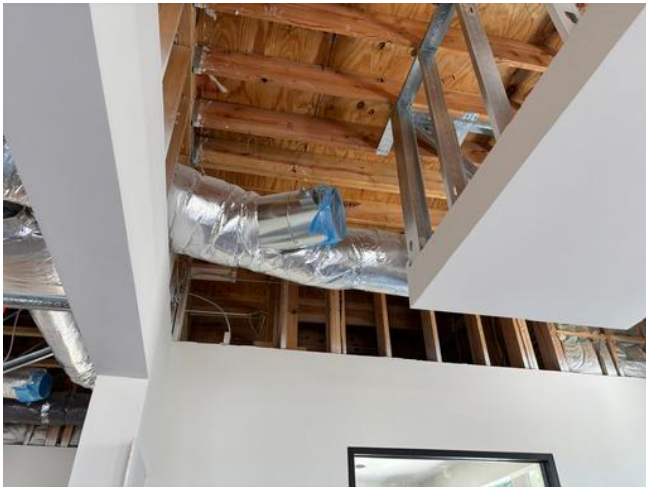
IMG\_2653

## #17 [DUCT 017] [NEW] CRITICAL – Duct not installed per plans.

AC4 ductwork is not installed per drawings. Y fittings added that are not shown

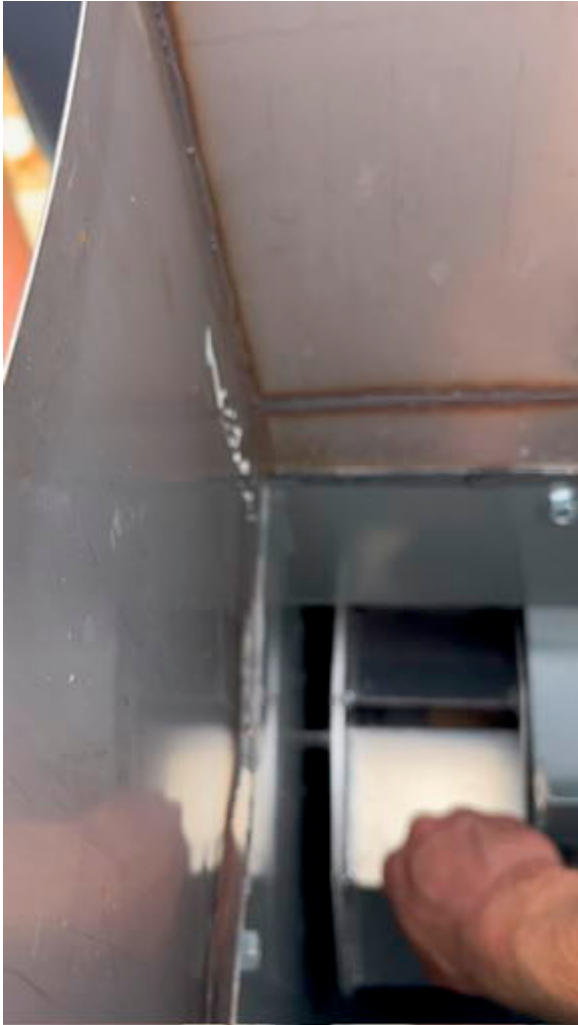
IMG\_2763

**#16 [EXHA 009] [NEW] CRITICAL – EF blade.**

The fan wheel for EF-2 cannot spin freely. It is getting bound and needs to be corrected before powering up the fan.

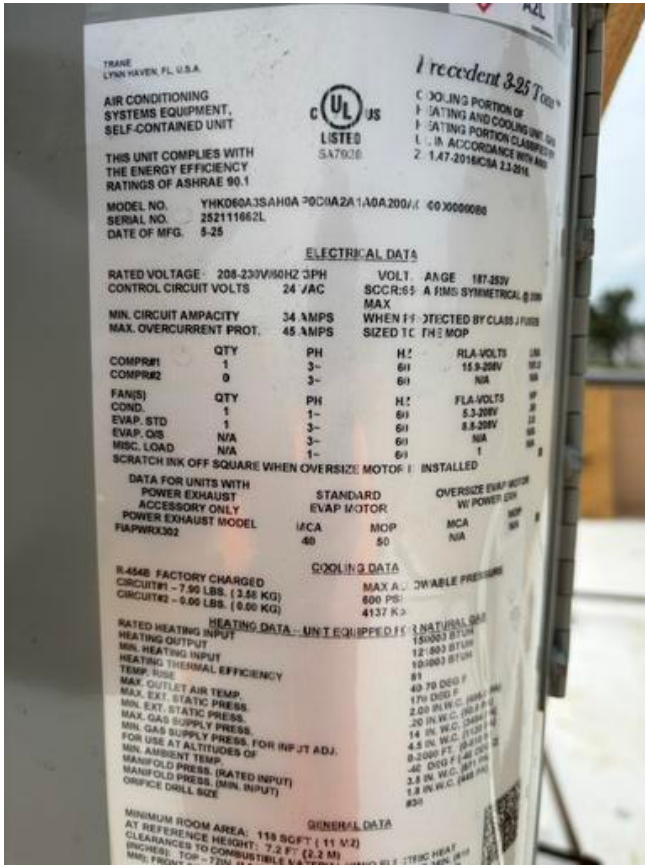
**#15 [UNIT 006] [NEW] CRITICAL – Incorrect unit tonnage or type.**

AC-4 model does not match the scheduled unit. It is a YHK060A3 but is scheduled as YHC067E3.

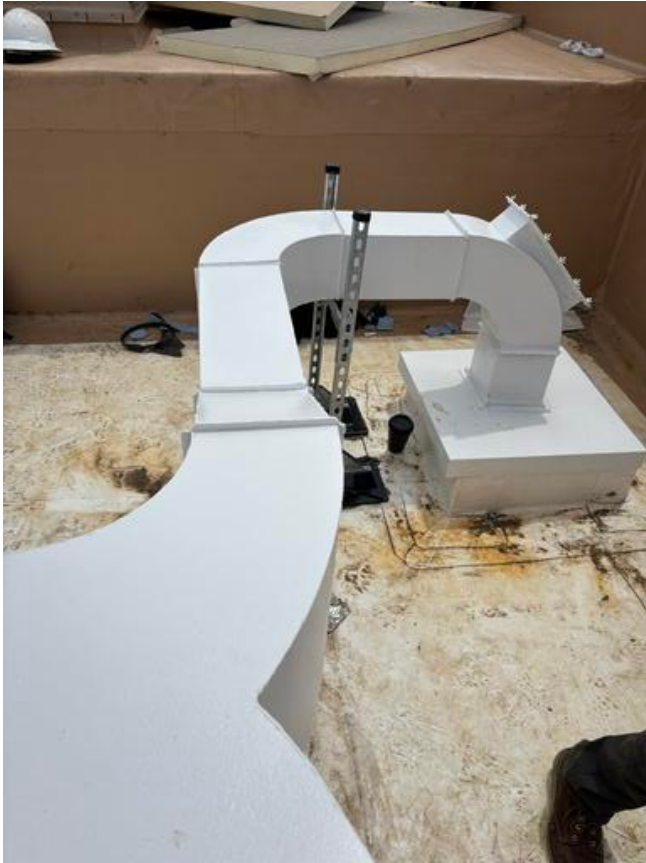
IMG\_2705

## #14 [EXHA 510] [NEW] Grease exhaust duct supports.

EF-1 will need an additional support so that there is a support at each penetration into the space and that they are also 6' apart.

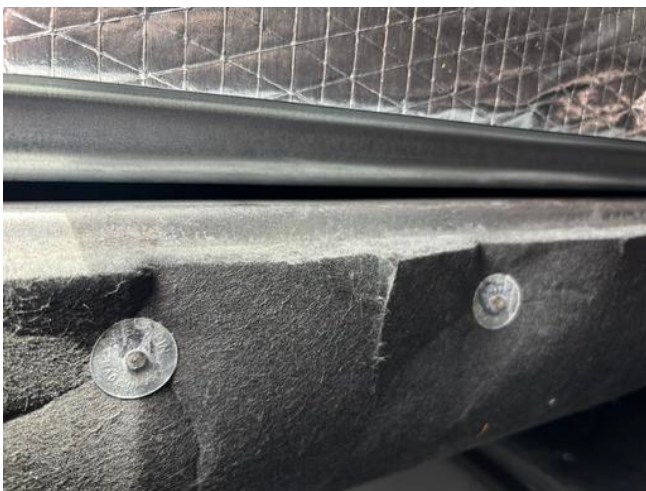
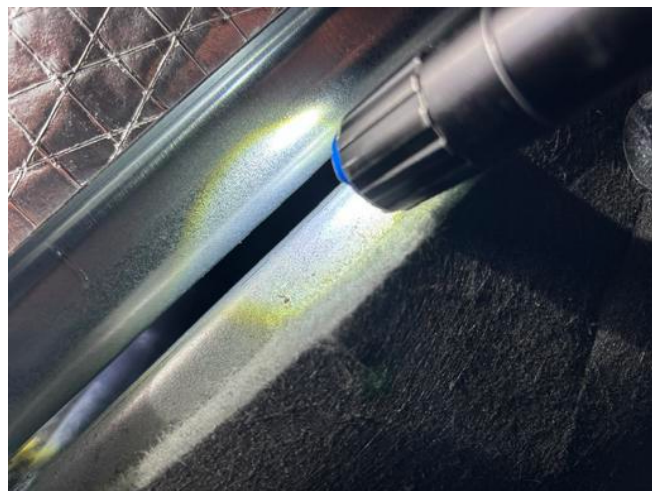
### #13 [UNIT 014] [NEW] CRITICAL – Equipment curb/RTU alignment.

All RTU's have significant gaps around the SA and RA openings at the units which will cause significant leakage. Gasket is missing which is partially the issue but gap is large enough that there could be something causing units not to sit flush on curb. Review all

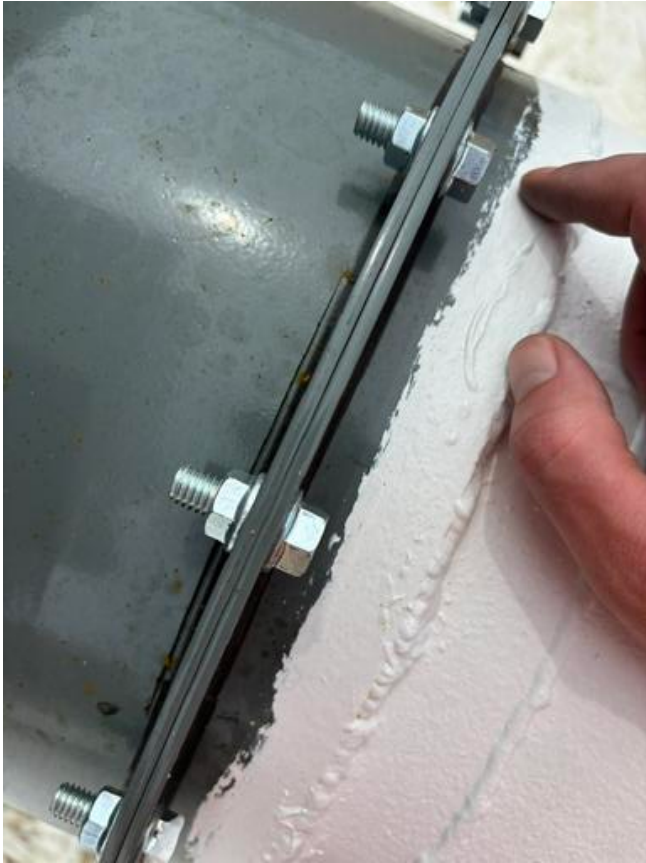
IMG\_2764

**#12 [EXHA 505] [NEW] Exhaust fan 1500F gasketing.**

Exhaust fan is missing  
1500°F rated field at intake  
flange.

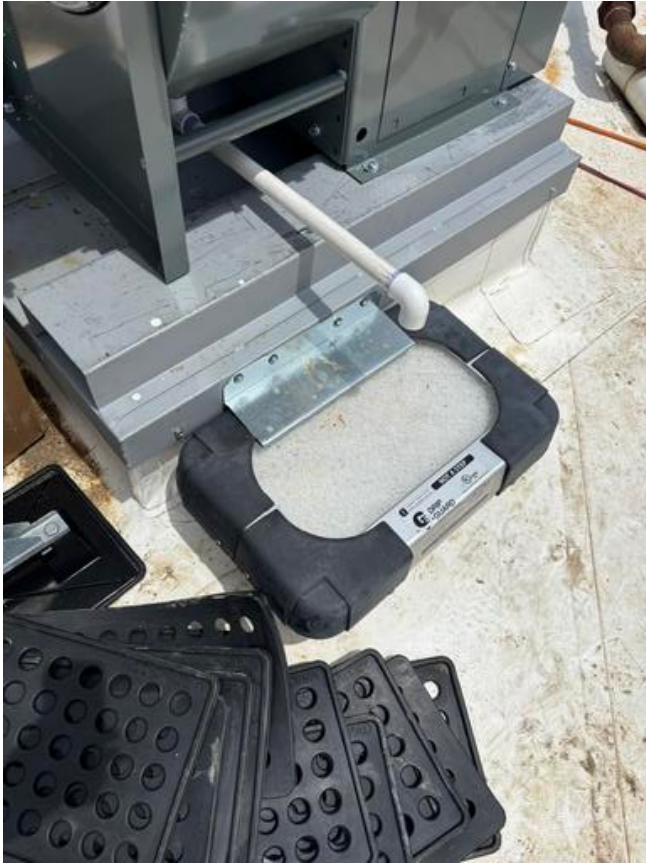
IMG\_2697

**#11 [EXHA 507] [NEW] Exhaust fan drain line.**

Exhaust fan drain needs to be piped down to the center of the drip guard

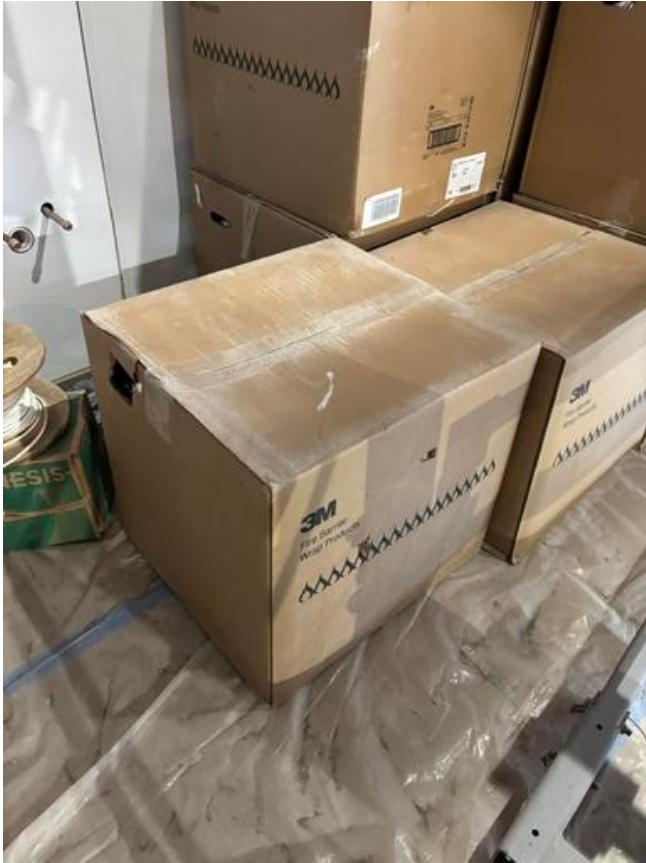
IMG\_2687

## #10 [EXHA 499] [NEW] CRITICAL - Grease duct wrap manufacturer

Specified grease duct wrap is Fyrewrap but 3M boxes were seen on site.

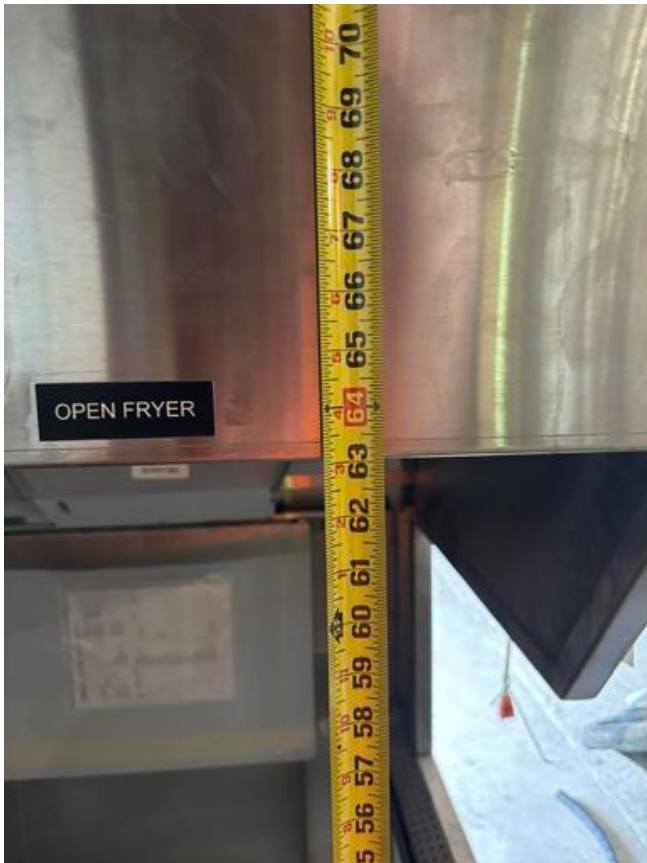
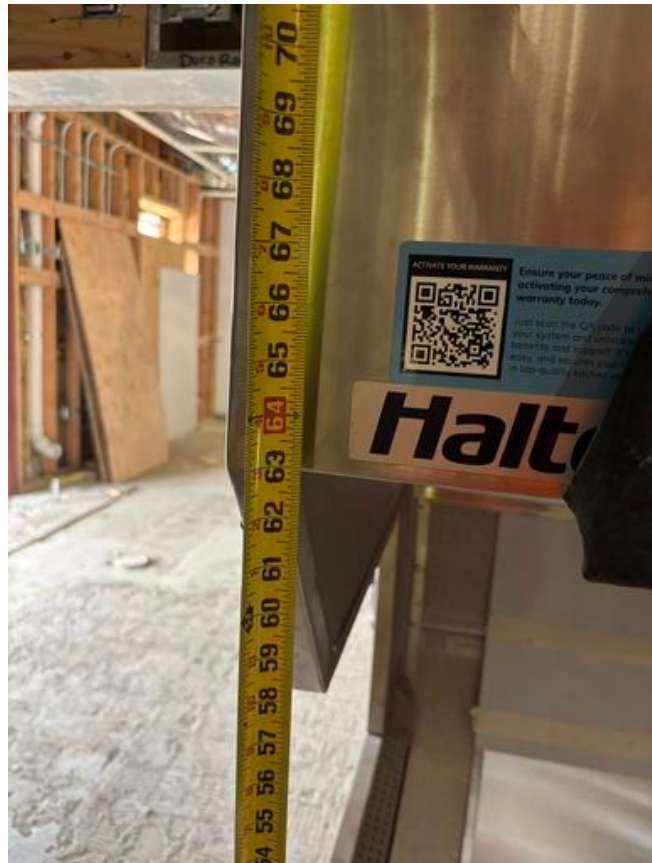
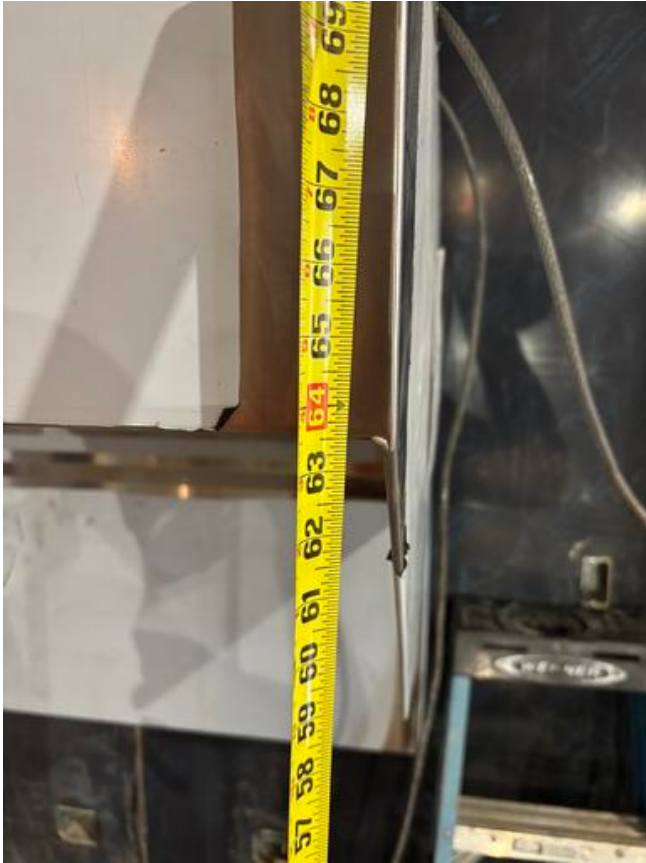
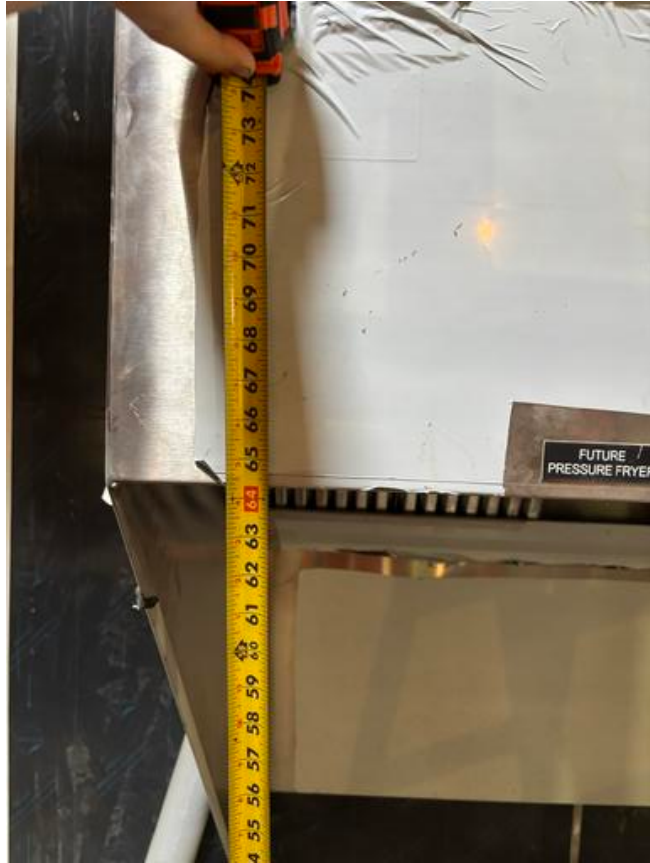
### #9 [HOOD 006] [NEW] CRITICAL – Improper hood height.

Hoods are not all hung 64"  
AFF

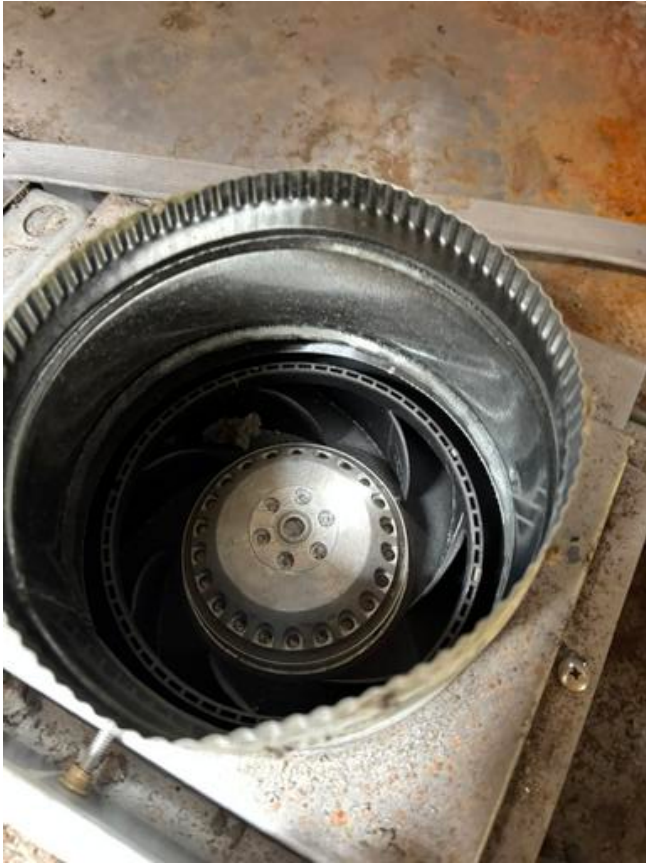
IMG\_2690

## #8 [HOOD 999] [NEW] Capture Jet debris

There is debris inside the capture jets. Ensure this is removed before piping them.

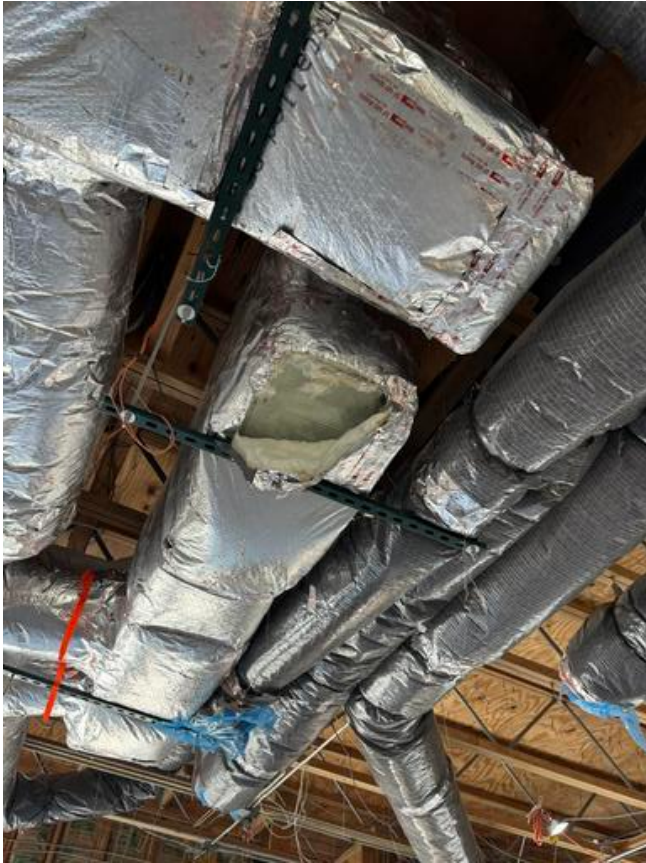
IMG\_2655

**#7 [DUCT 506] [EXIST] Incorrect, missing, or damaged insulation.**

AC4 insulation at the drop is falling off and appears to be holding water. It should be replaced. AC-3 return duct insulation is excessively sagging.

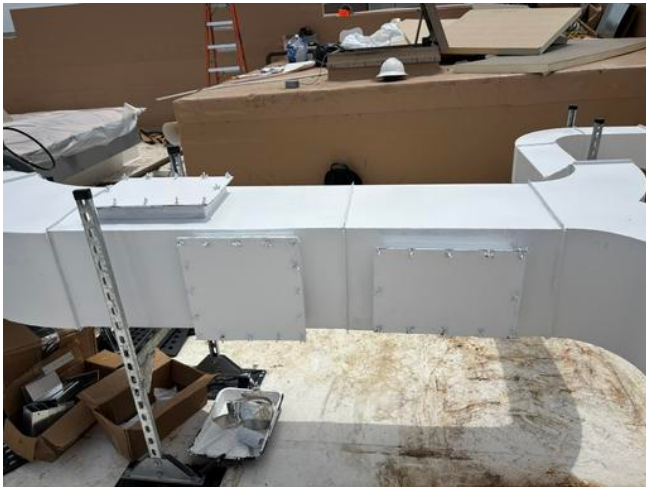
IMG\_2702

## #6 [EXHA 001] [NEW] CRITICAL – Grease duct access doors.

For EF-1 access door C is switched with one of the A doors.

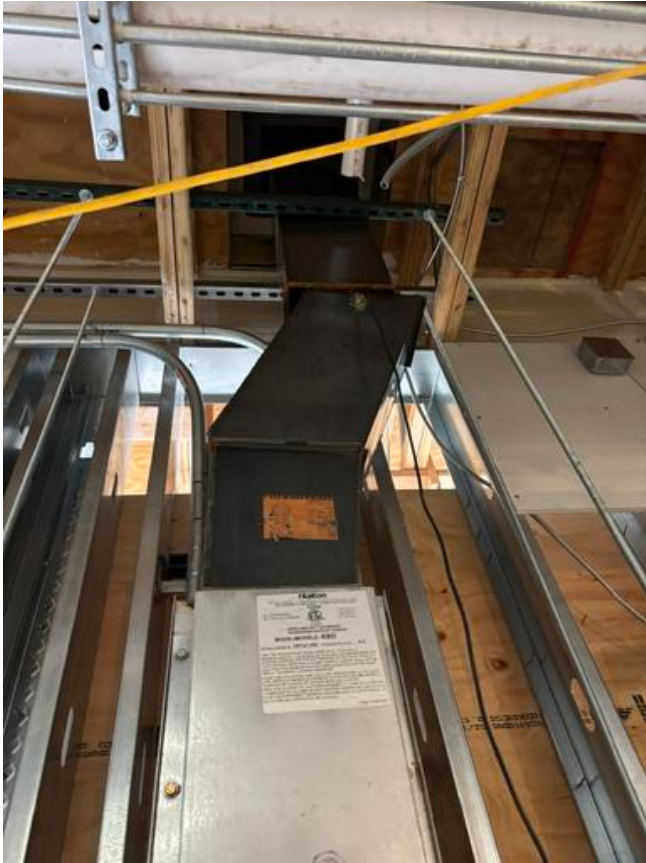
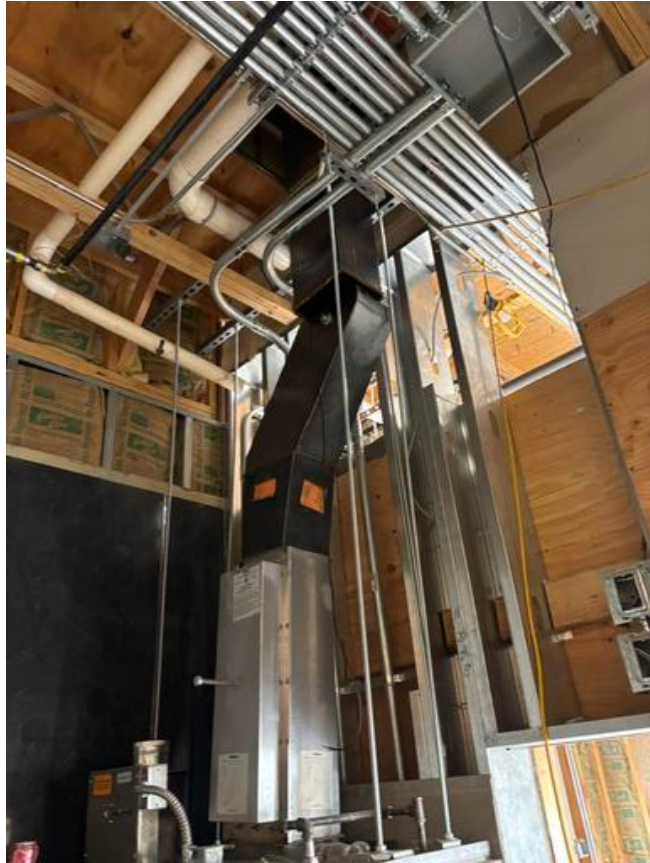
## #5 [EXHA 003] [NEW] CRITICAL – Incorrect grease exhaust duct ells.

Grease ductwork for hood 2 and 3 not constructed with long radius centerline  $R=3W/2$  fittings per specification. Short radius, mitered ells, and offsets greater than 45 degrees are not allowed.

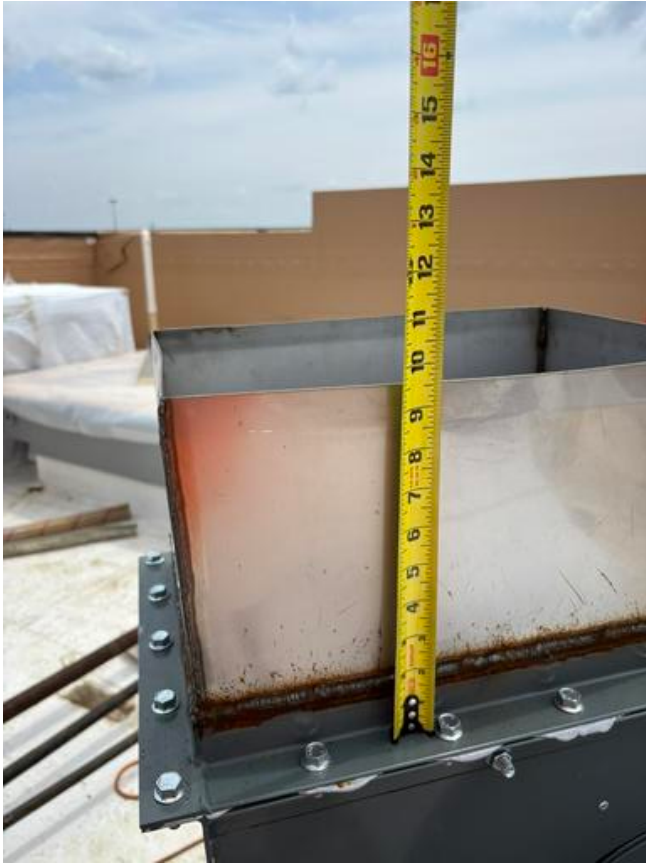
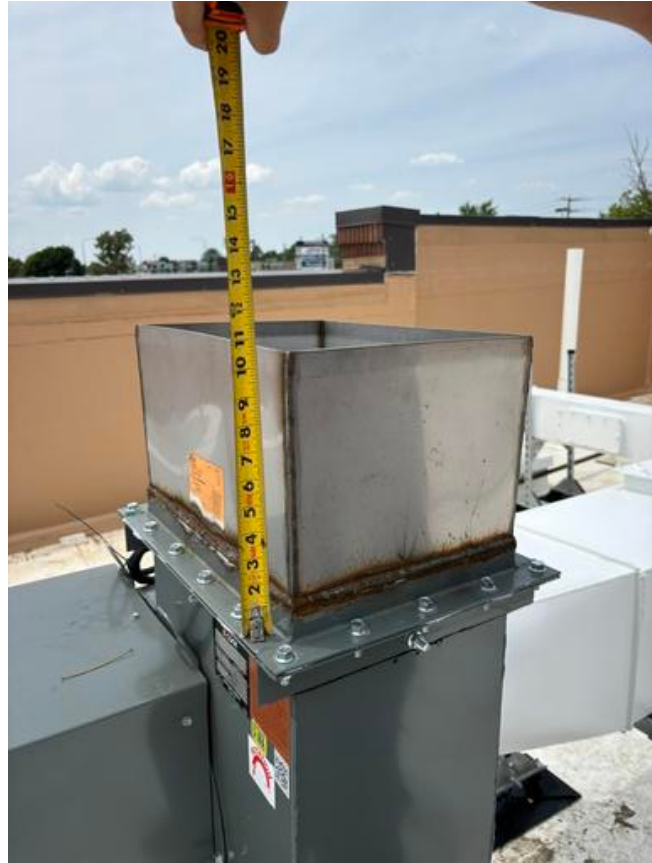
#### #4 [EXHA 506] [NEW] Exhaust fan discharge nozzle.

Nozzle does not meet the specification. It is not 12" tall minimum. But likely these will need to be extended taller to meet the requirement of being at least 2" above any AC's, parapet, or condensers within 10'. Not all equipment is installed so unable to confirm.

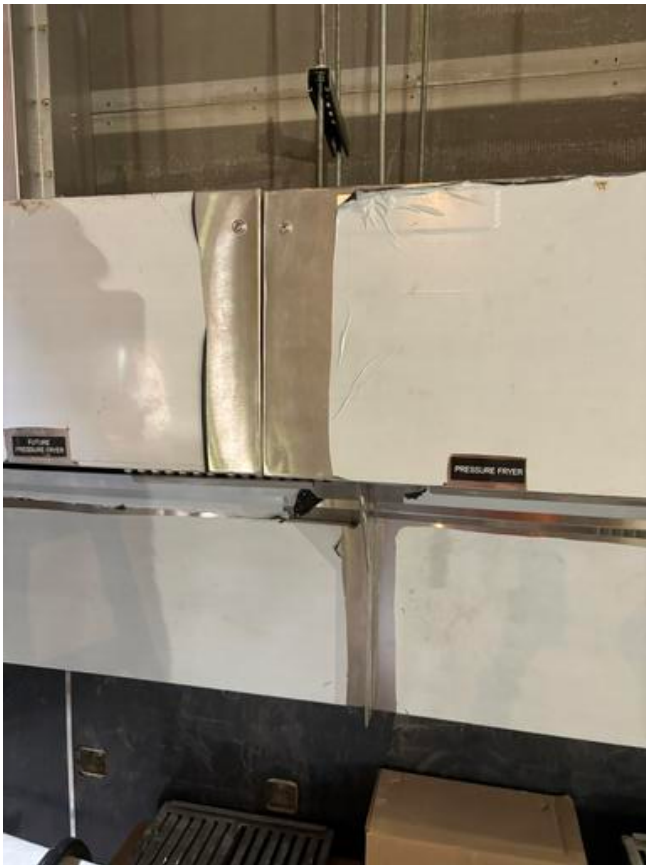
IMG\_2691

### #3 [HOOD 999] [NEW] Hood Splice Bracket is not installed

Needs to be installed

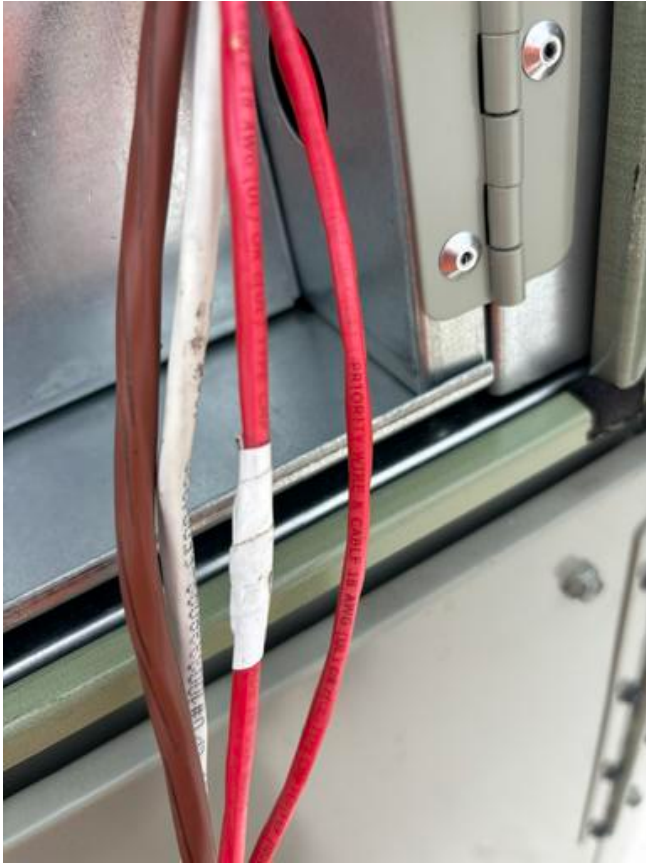
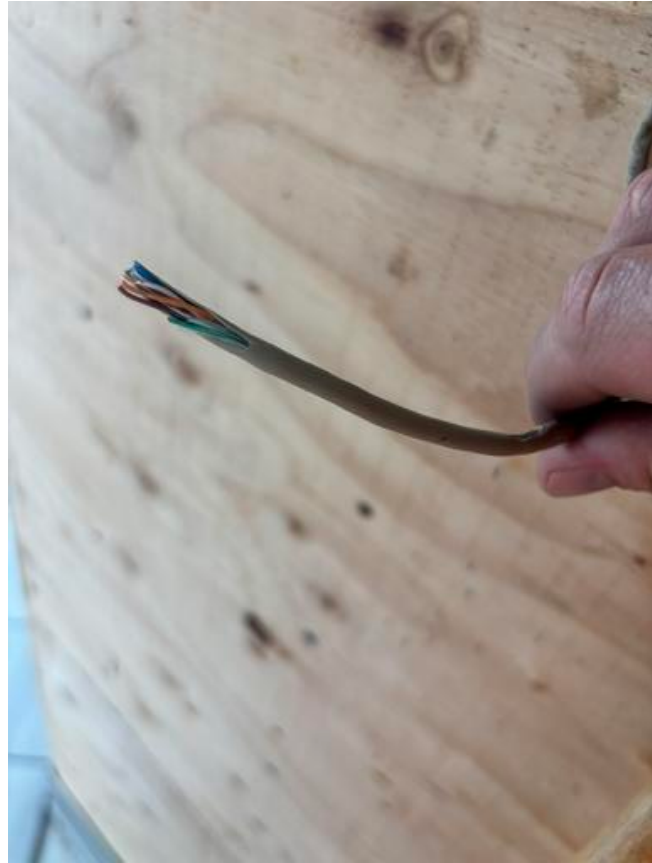
## #2 [CNTL 003] [NEW] CRITICAL – Wiring specifications.

Wiring specification for temperature and humidity sensors states ConnectAir wire however, this wire is no longer available. Provide temperature/humidity sensor wiring make and model to the engineer of record for approval.
