# PlanGrid Task Report - Apr 17, 2025

Prepared by Ian Fuller

6 tasks in this report.

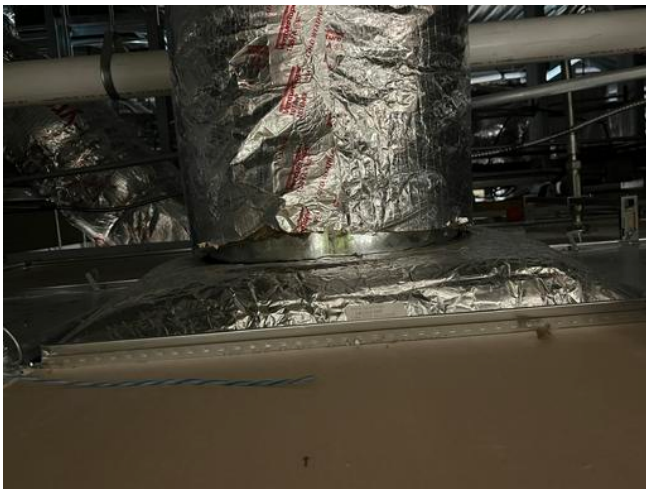
IMG\_9964

## #295 [DUCT 507] [NEW] Ductwork is not fully insulated.

Ductwork has exposed metal ductwork in some areas needs to be fully wrapped.

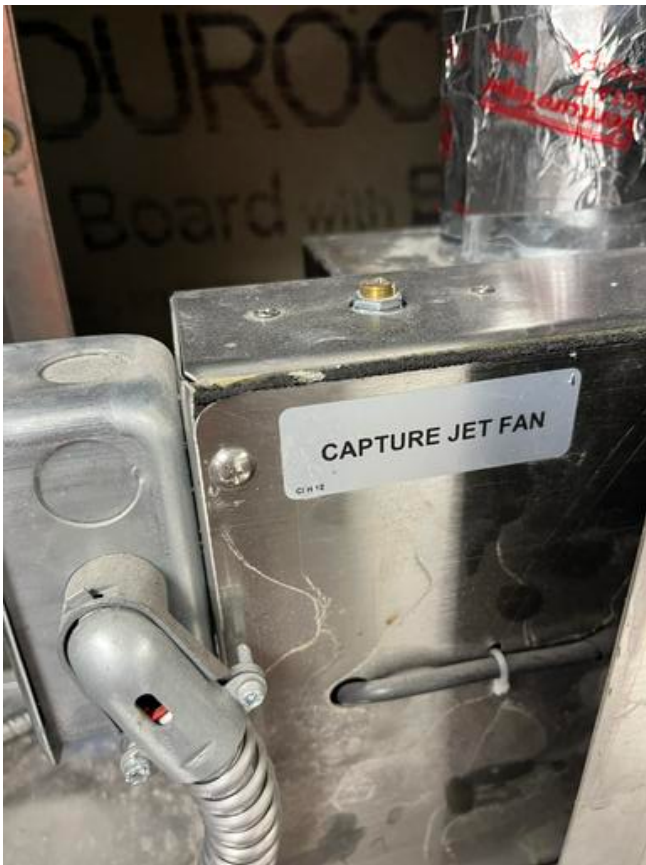
IMG\_9930

## #292 [HOOD 004] [NEW] CRITICAL - CaptureJet speed controller.

CaptureJet or Side  
CaptureJet speed controller  
not modulating device.  
Replace speed controller.

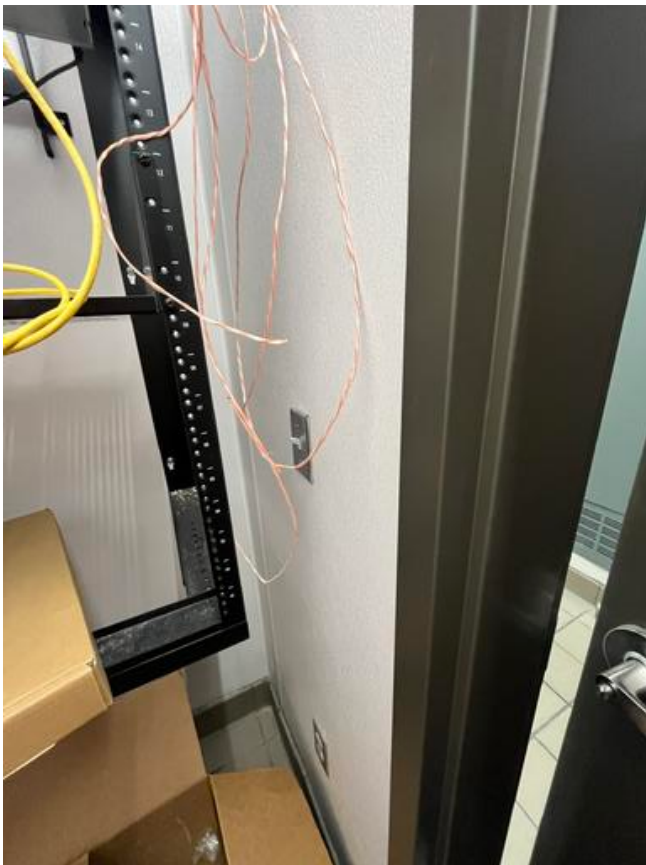
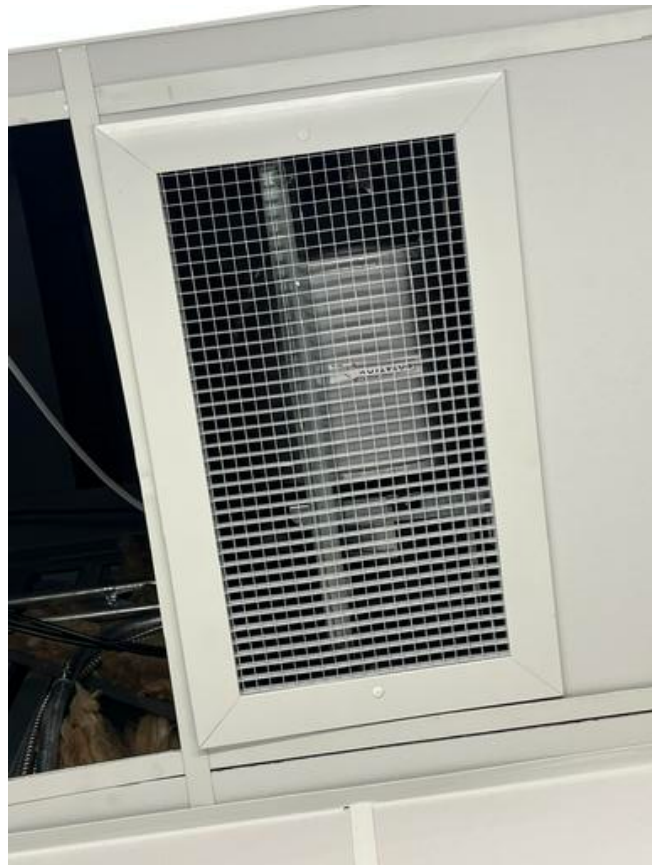
## #290 [CNTL 503] [NEW] DTT Stat not operational.

DTT thermostat / fan is not powered, operational, or does not turn on / off according to set point at time of TAB inspection.

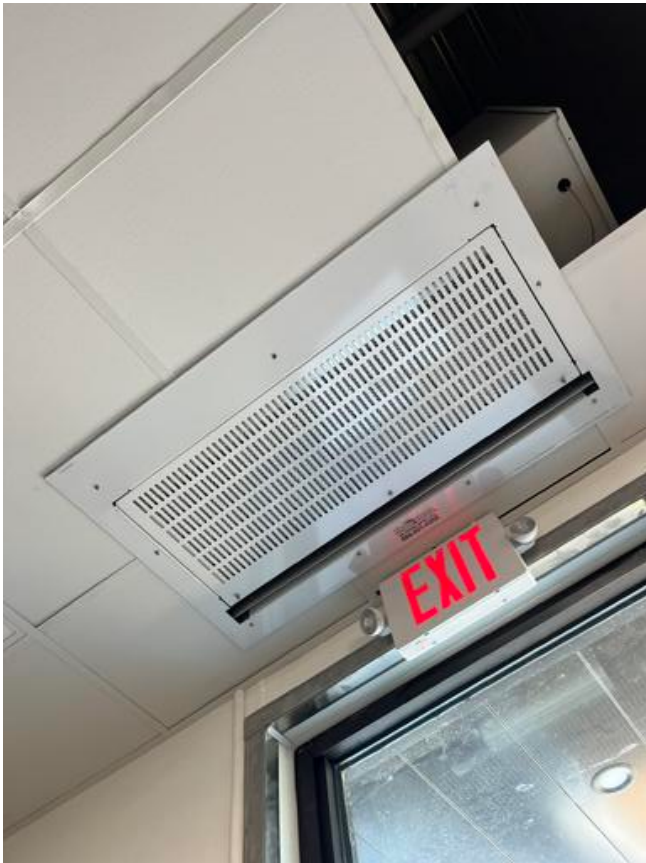
IMG\_9962

## #288 [CURT 501] [NEW] Air curtain power.

Air curtain power does not cycle properly from local disconnect at time of TAB inspection.
