Report: TAB REPORT
Function: Test, Adjust, & Balance
Date: 09/18/2025
Completed By: National TAB

09-15-25 WAWA #6306 LEESBURG, GA

Project: 09-15-25 WAWA #6306 LEESBURG, GA

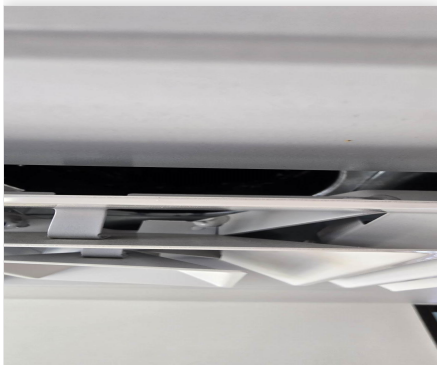
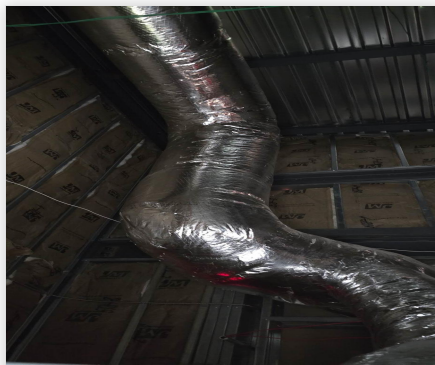
Issue Name : DIFFUSER 3-1 MISSING OBD
Description : Diffuser 3-1 is missing an OBD for balancing. The branch damper is too high in the ceiling to reach. Airflow is 362 CFM out of design of 250 CFM.
Created By : National TAB **Assigned To :** National TAB - Will Turnbough
Status : Open
Priority : Medium **Asset Tag :** SGRD1
Originated Date : 09/17/2025 - Sagar Patel - National TAB

[1] DIFFUSER 1 DOES NOT HAVE OBD INSTALLED, BRANCH DAMPER IS 20 FT HIGH MAKING IT UNACCESSIBLE.

Asset	Notes	Date	Written By
SGRD1	[1] NO ACCESSIBLE DAMPER	10/07/2025	Tyler Youells

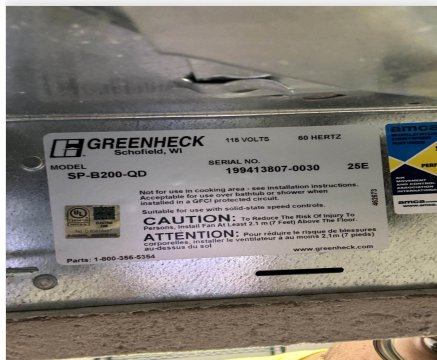
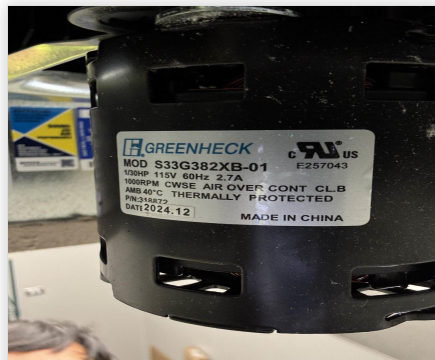
Issue Name : EF-3 AIRFLOW LOW
Description : EF3 serving trash room is low on flow. Airflow is 80 CFM out of design of 200 CFM. It needs to be verified that the internal backdraft damper can fully open. It should also be noted that the HP does not match design. Design horsepower is $1/6 = 0.167$. The current motor installed has a horsepower of $1/30 = 0.033$.
Created By : National TAB **Assigned To :** National TAB - Will Turnbough
Status : Open
Priority : Medium **Asset Tag :** EF3
Originated Date : 09/17/2025 - Sagar Patel - National TAB

Notes:
FLOW IS LOW DUE TO INCORRECT MOTOR SIZE

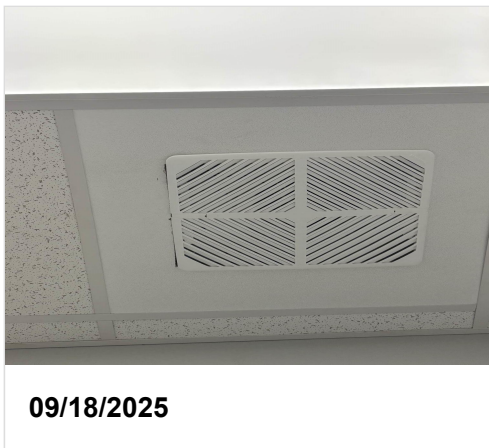
Test Data		
	Design	Actual
CFM	200	80
Fan Rotation	-	CCW
System SetPt	-	HIGH
RL Voltage	-	[1]
RL Amperage	-	[1]

Motor Data		
	Design	Actual
Motor MFG	-	GREENHECK
Frame	-	N/L
Horsepower	0.167	0.033
Motor Rpm	-	1000
Phase	1	1
Voltage (rated)	120	115
Amperage (rated)	-	2.7
Service Factor	-	N/L
