Report: TAB Report
Function: Test, Adjust, & Balance
Date: 01/28/2026
Completed By: National TAB

02-16-26 WHATABURGER #1687 LUTZ, FL

25340 Sierra Center Blvd

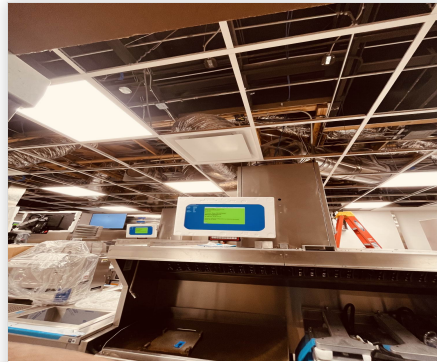
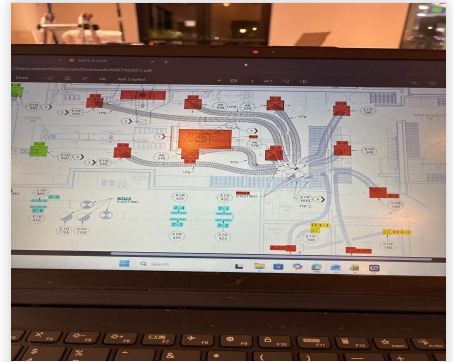
Issue Name : Exhaust fans - Incorrect Locations
Description : Exhaust fans are mounted on wrong curbs. Unable to balance fans in current state. EF-1 (larger fan) also leaks around curb.
Created By : National TAB **Assigned To :** National TAB - Will Turnbough
Status : Open
Priority : Urgent **Asset Tag :**
Originated Date : 02/19/2026 - Jackson Gunnels - National TAB

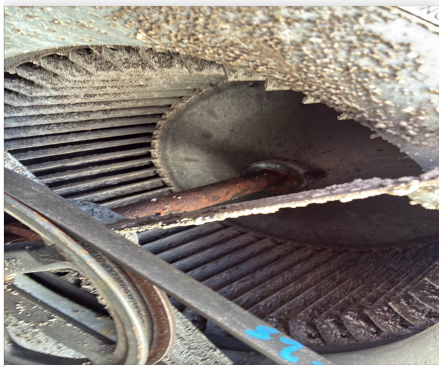
Issue Name : RTU 3 Debris
Description : RTU 3 send debris into space whenever the ducts are disturbed, or the blower stops and restarts.
Created By : National TAB **Assigned To :** National TAB - Brianna Biggs
Status : Closed
Priority : High **Asset Tag :**
Originated Date : 02/19/2026 - Jackson Gunnels - National TAB

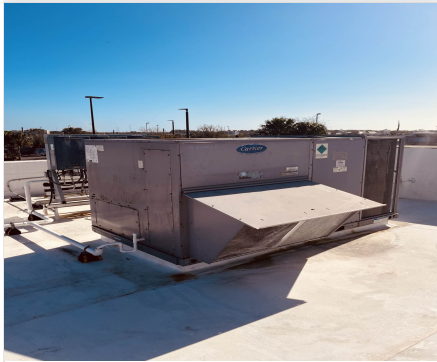
Issue Name : RTU 3 pulley alignment
Description : RTU 3 Fan sheave pulley is further forward than motor pulley. This increases belt wear. Re-alignment recommended.
Created By : National TAB **Assigned To :** National TAB - Will Turnbough
Status : Open
Priority : Low **Asset Tag :**
Originated Date : 02/19/2026 - Jackson Gunnels - National TAB

Notes:
Fan sheave sits further out than motor sheave
