Report: TAB Report
Function: Test, Adjust, & Balance
Date: 01/28/2026
Completed By: National TAB

02-16-26 WHATABURGER #1687 LUTZ, FL

Project: 02-16-26 WHATABURGER #1687 LUTZ, FL

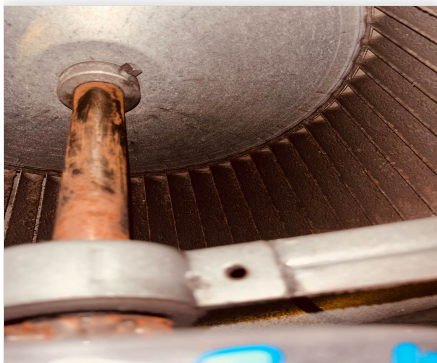
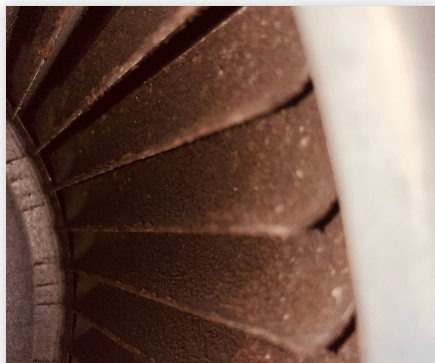
Issue Name : RTU 2 Blower Wheel Dirty
Description : RTU 2 Blower wheel shows moderate accumulation of debris. Not as severe as RTU 3, unit still met design. Cleaning recommended.
Created By : National TAB **Assigned To :** National TAB - Will Turnbough
Status : Closed
Priority : Medium **Asset Tag :**
Originated Date : 02/19/2026 - Jackson Gunnels - National TAB

- **03/24/2026 National TAB - Stephen Tassinaro**
 - Blower cleaned by MC, airflow at design.
