**Report: TAB Report**  
**Function: Test, Adjust, & Balance**  
**Date: 01/28/2026**  
**Completed By: National TAB**

## 02-16-26 WHATABURGER #1687 LUTZ, FL

25340 Sierra Center Blvd

Lutz, FL

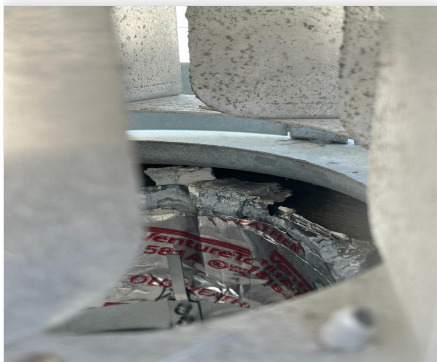
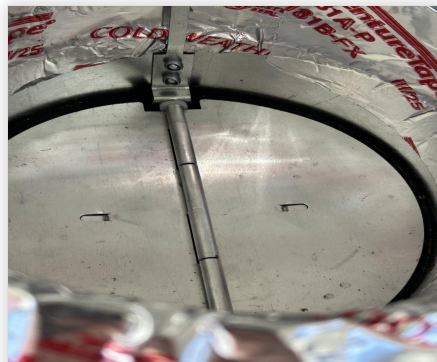
**Issue Name :** EF 4 Low Flow  
**Description :** EF 4 (restrooms) is currently at 68% design airflow. Fan is running at max speed (wired directly). Airflow appears to be restricted by the installed backdraft damper, which is heavily spring loaded and cannot open fully during operation. Fan is also not fully sealed to the curb due to placement of conduit. Recommend service.  
**Created By :** National TAB                      **Assigned To :** National TAB - Will Turnbough  
**Status :** Open  
**Priority :** Urgent                                      **Asset Tag :**  
**Originated Date :** 03/19/2026 - Mark Johnson - National TAB

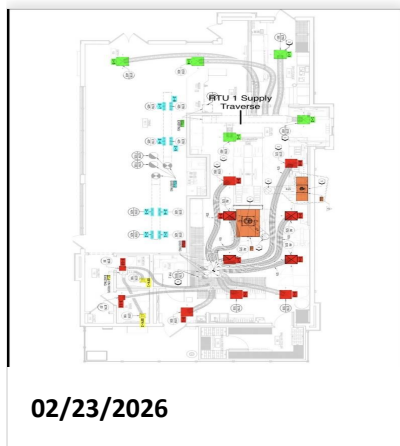
Screenshot of the GRD marked up with supply and return traverse locations for RTU-1 (Add picture here)

Return traverse not possible.
