Report: TAB Report
Function: Test, Adjust, & Balance
Date: 01/28/2026
Completed By: National TAB

02-16-26 WHATABURGER #1687 LUTZ, FL

Project: 02-16-26 WHATABURGER #1687 LUTZ, FL

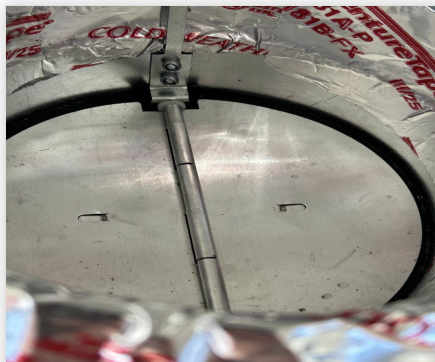
Issue Name : EF 4 Low Flow
Description : EF 4 (restrooms) is currently at 68% design airflow. Fan is running at max speed (wired directly). Airflow appears to be restricted by the installed backdraft damper, which is heavily spring loaded and cannot open fully during operation. Fan is also not fully sealed to the curb due to placement of conduit. Recommend service.
Created By : National TAB **Assigned To :** National TAB - Will Turnbough
Status : Open
Priority : Urgent **Asset Tag :**
Originated Date : 03/19/2026 - Mark Johnson - National TAB

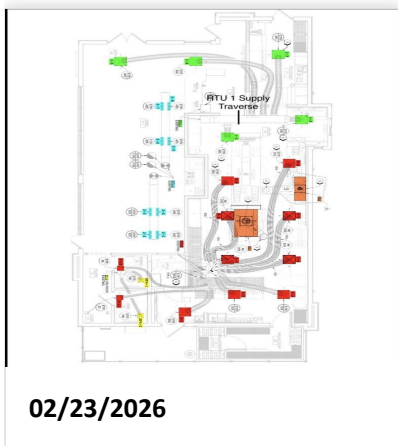
Screenshot of the GRD marked up with supply and return traverse locations for RTU-1 (Add picture here)

Return traverse not possible.
