**Report: Deficiency Report**  
**Function: Test, Adjust, & Balance**  
**Date: 02/17/2026**  
**Completed By: National TAB**

## 02-16-26 WHATABURGER #1687 LUTZ, FL

25340 Sierra Center Blvd

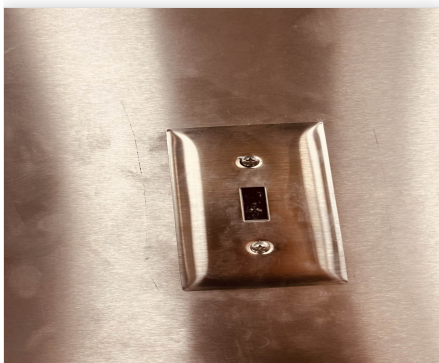
**Issue Name :** Hood 2 power switch  
**Description :** Hood 2 power switch is damaged.  
**Created By :** National TAB                      **Assigned To :** National TAB - Will Turnbough  
**Status :** Open  
**Priority :** Low                                      **Asset Tag :**  
**Originated Date :** 02/19/2026 - Jackson Gunnels - National TAB

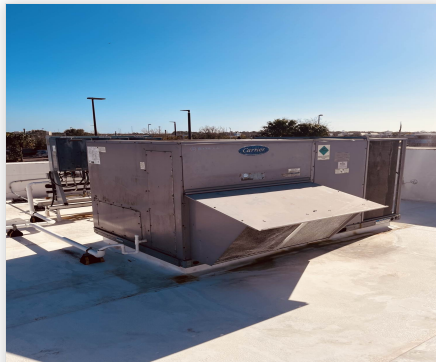
**Issue Name :** RTUs 1 and 3OAs Not Reaching Design  
**Description :** Unable to reach design outside air on units with damper full open. RTU 1 601/700CFM design. RTU-3 1000/1635CFM design.  
**Created By :** National TAB                      **Assigned To :** National TAB - Brianna Biggs  
**Status :** Open  
**Priority :** Urgent                                      **Asset Tag :**  
**Originated Date :** 02/18/2026 - Jackson Gunnels - National TAB
