Report: TAB Report
Function: Test, Adjust, & Balance
Date: 01/28/2026
Completed By: National TAB

02-16-26 WHATABURGER #1687 LUTZ, FL

25340 Sierra Center Blvd

Lutz, FL

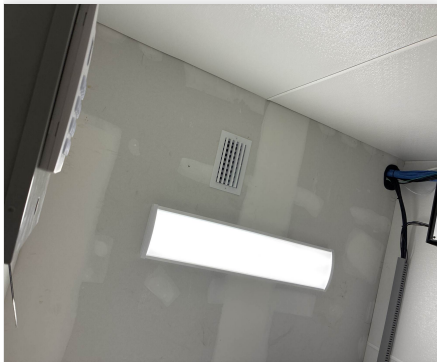
Issue Name : Additional Diffuser - RTU 3 office
Description : An additional diffuser was installed in office. There was an existing supply flex duct run blowing above ceiling in which the MC tapped into. Currently, damper is fully closed and grill reads 75 CFM. Unable to balance without a CFM target. Recommend engineer review.
Created By : National TAB **Assigned To :** National TAB - Will Turnbough
Status : Open
Priority : Urgent **Asset Tag :**
Originated Date : 02/19/2026 - Jackson Gunnels - National TAB

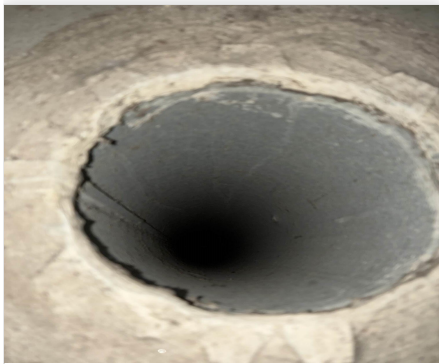
Issue Name : Backdraft damper
Description : No backdraft damper installed in restroom exhaust.
Created By : National TAB **Assigned To :** National TAB - Will Turnbough
Status : Open
Priority : Low **Asset Tag :**
Originated Date : 02/19/2026 - Jackson Gunnels - National TAB

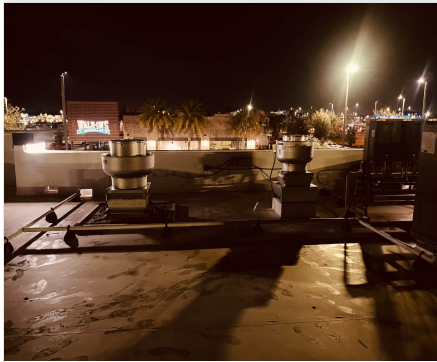
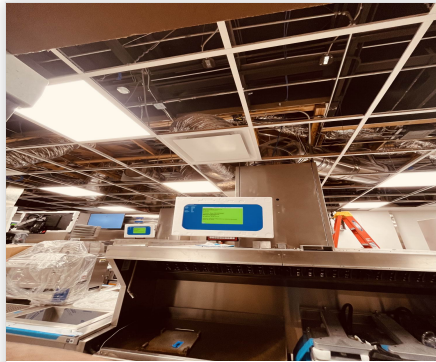
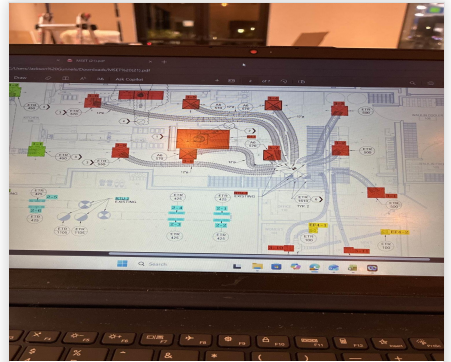
Issue Name : Exhaust fans - Incorrect Locations
Description : Exhaust fans are mounted on wrong curbs. Unable to balance fans in current state. EF-1 (larger fan) also leaks around curb.
Created By : National TAB **Assigned To :** National TAB - Will Turnbough
Status : Open
Priority : Urgent **Asset Tag :**
Originated Date : 02/19/2026 - Jackson Gunnels - National TAB

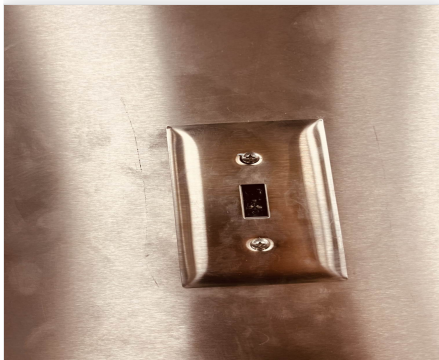
Issue Name : Hood 2 power switch
Description : Hood 2 power switch is damaged.
Created By : National TAB **Assigned To :** National TAB - Will Turnbough
Status : Open
Priority : Low **Asset Tag :**
Originated Date : 02/19/2026 - Jackson Gunnels - National TAB

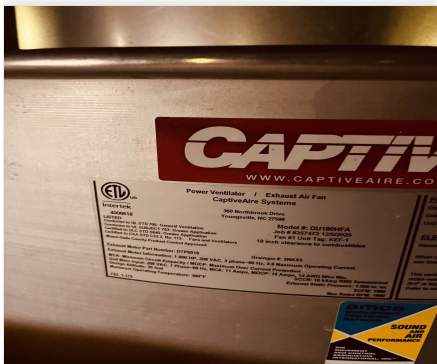
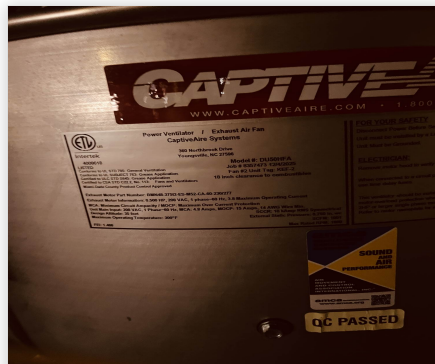
Issue Name : KEFs make and model
Description : MSET indicates Greenheck Units to be installed. Current units are Captive Aire models DU180HFA and DU50HFA
Created By : National TAB **Assigned To :** National TAB - Brianna Biggs
Status : Closed
Priority : InfoOnly **Asset Tag :**
Originated Date : 02/19/2026 - Jackson Gunnels - National TAB

- **02/19/2026 National TAB - Stephen Tassinaro**
 - Substitution matches design criteria

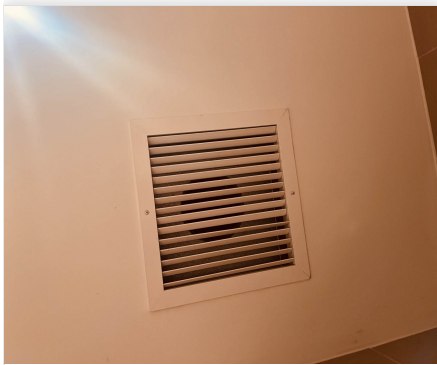
Issue Name : Restroom Exhaust Dampers
Description : Restrooms do not have any face accessible dampers installed. Unable to proportionally balance grills.
Created By : National TAB **Assigned To :** National TAB - Will Turnbough
Status : Open
Priority : High **Asset Tag :**
Originated Date : 02/19/2026 - Jackson Gunnels - National TAB

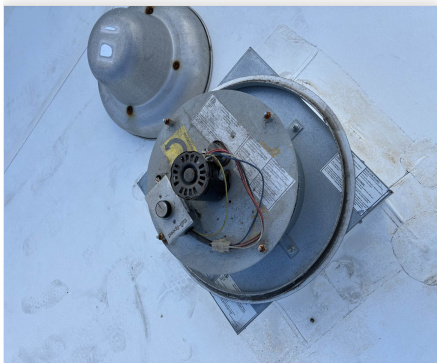
Issue Name : Restroom Exhaust Fan Not Running
Description : Unable to run restroom exhaust fan for balancing. Confirmed breaker is open and restroom was occupied.
Created By : National TAB **Assigned To :** National TAB - Will Turnbough
Status : Open
Priority : Urgent **Asset Tag :**
Originated Date : 02/18/2026 - Jackson Gunnels - National TAB

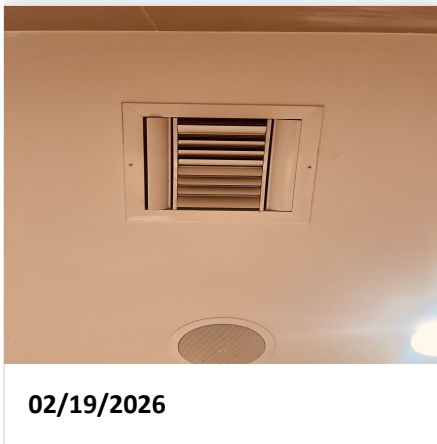
Issue Name : Restroom supply dampers
Description : Parallel blade dampers installed in restroom supply only reduce airflow by half when fully closed, recommend OBDs be installed.
Created By : National TAB **Assigned To :** National TAB - Will Turnbough
Status : Open
Priority : Urgent **Asset Tag :**
Originated Date : 02/19/2026 - Jackson Gunnels - National TAB

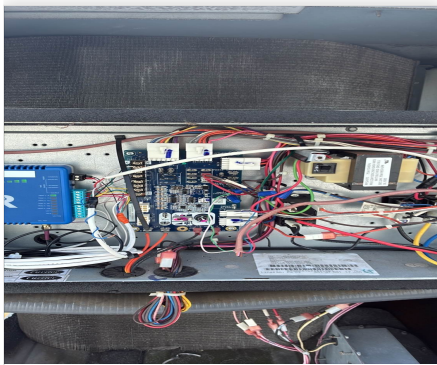
Issue Name : RTU 1 Fan Speed
Description : RTU 1 did not respond to attempts to adjust fan speed. Runs at maximum. Unable to reduce unit total flow below %112. Fan needs to be reduced to 2140 rpm to meet design.
Created By : National TAB **Assigned To :** National TAB - Will Turnbough
Status : Open
Priority : Urgent **Asset Tag :**
Originated Date : 02/18/2026 - Jackson Gunnels - National TAB

Unable to slow unit 1 down, currently at %112. Fan needs to be set to 2140 rpm to meet design.

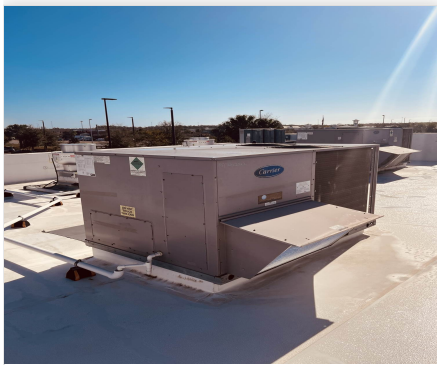
Issue Name : RTU 2 Required Jumpers to Run
Description : RTU 2 blower does not run unless manually jumped. Unit is jumped for testing, will be removed when balance is completed.
Created By : National TAB **Assigned To :** National TAB - Will Turnbough
Status : Open
Priority : High **Asset Tag :**
Originated Date : 02/18/2026 - Jackson Gunnels - National TAB

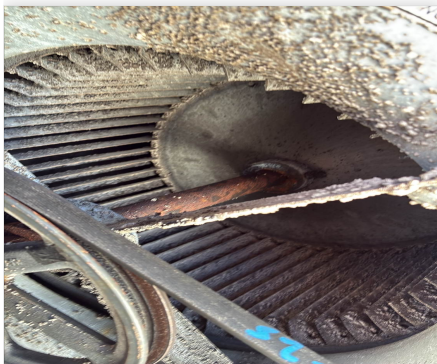
Issue Name : RTU 3 Debris
Description : RTU 3 send debris into space whenever the ducts are disturbed, or the blower stops and restarts.
Created By : National TAB **Assigned To :** National TAB - Brianna Biggs
Status : Closed
Priority : High **Asset Tag :**
Originated Date : 02/19/2026 - Jackson Gunnels - National TAB

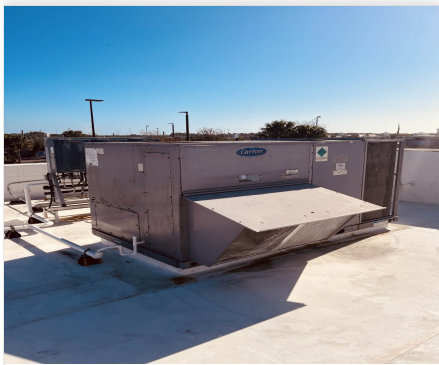
Issue Name : RTU 3 pulley alignment
Description : RTU 3 Fan sheave pulley is further forward than motor pulley. This increases belt wear. Re-alignment recommended.
Created By : National TAB **Assigned To :** National TAB - Will Turnbough
Status : Open
Priority : Low **Asset Tag :**
Originated Date : 02/19/2026 - Jackson Gunnels - National TAB

Notes:
Fan sheave sits further out than motor sheave

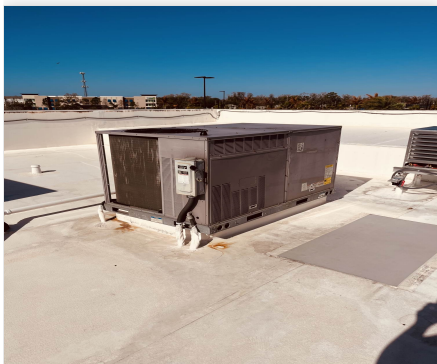
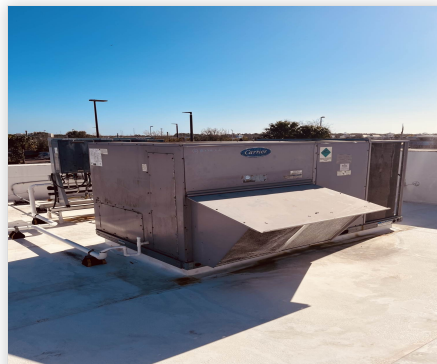
Issue Name : RTUs 1 and 3OAs Not Reaching Design
Description : Unable to reach design outside air on units with damper full open. RTU 1 601/700CFM design. RTU-3 1000/1635CFM design.
Created By : National TAB **Assigned To :** National TAB - Brianna Biggs
Status : Open
Priority : Urgent **Asset Tag :**
Originated Date : 02/18/2026 - Jackson Gunnels - National TAB

OA dampers on all units full open, unable to reach design airflow

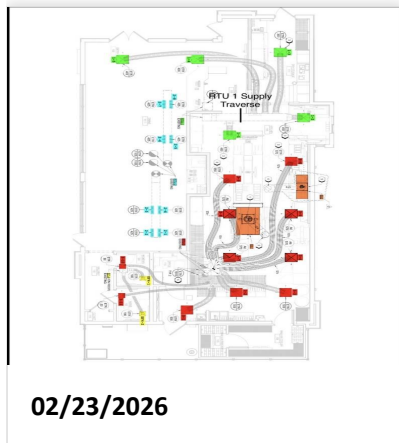
Return traverse not possible.
