Report: TAB Report
Function: Test, Adjust, & Balance
Date: 01/28/2026
Completed By: National TAB

02-16-26 WHATABURGER #1687 LUTZ, FL

Project: 02-16-26 WHATABURGER #1687 LUTZ, FL

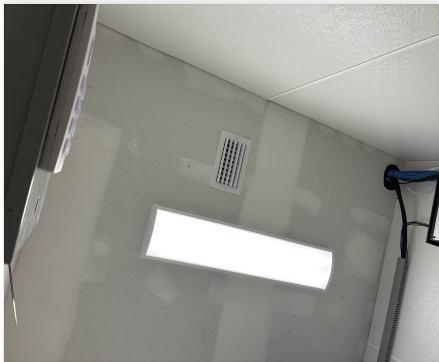
Issue Name : Additional Diffuser - RTU 3 office
Description : An additional diffuser was installed in office. There was an existing supply flex duct run blowing above ceiling in which the MC tapped into. Currently, damper is fully closed and grill reads 75 CFM. Unable to balance without a CFM target. Recommend engineer review.
Created By : National TAB **Assigned To :** National TAB - Will Turnbough
Status : Open
Priority : Urgent **Asset Tag :**
Originated Date : 02/19/2026 - Jackson Gunnels - National TAB

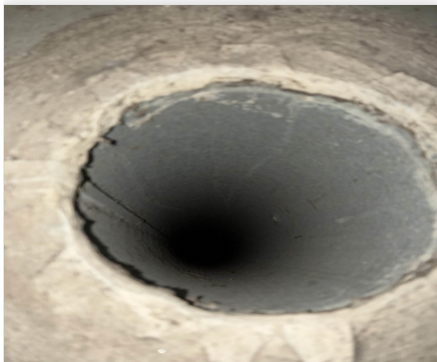
Issue Name : Backdraft damper
Description : No backdraft damper installed in restroom exhaust.
Created By : National TAB **Assigned To :** National TAB - Will Turnbough
Status : Open
Priority : Low **Asset Tag :**
Originated Date : 02/19/2026 - Jackson Gunnels - National TAB

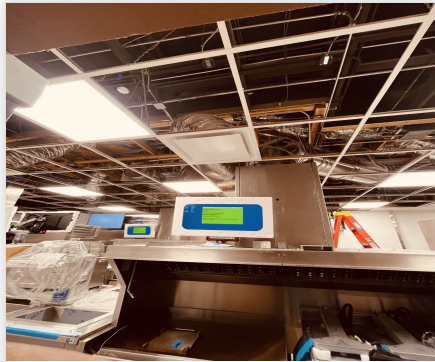
Issue Name : Exhaust fans - Incorrect Locations
Description : Exhaust fans are mounted on wrong curbs. Unable to balance fans in current state. EF-1 (larger fan) also leaks around curb.
Created By : National TAB **Assigned To :** National TAB - Will Turnbough
Status : Open
Priority : Urgent **Asset Tag :**
Originated Date : 02/19/2026 - Jackson Gunnels - National TAB

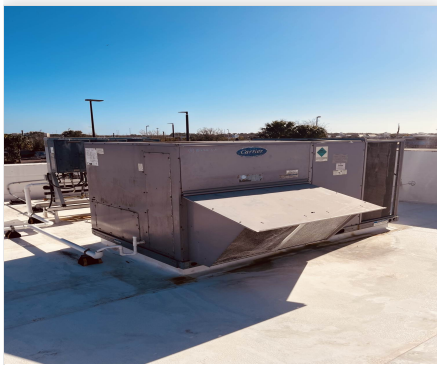
Issue Name : RTU 3 pulley alignment
Description : RTU 3 Fan sheave pulley is further forward than motor pulley. This increases belt wear. Re-alignment recommended.
Created By : National TAB **Assigned To :** National TAB - Will Turnbough
Status : Open
Priority : Low **Asset Tag :**
Originated Date : 02/19/2026 - Jackson Gunnels - National TAB

Notes:
Fan sheave sits further out than motor sheave

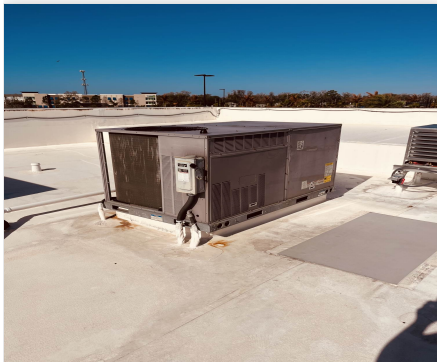
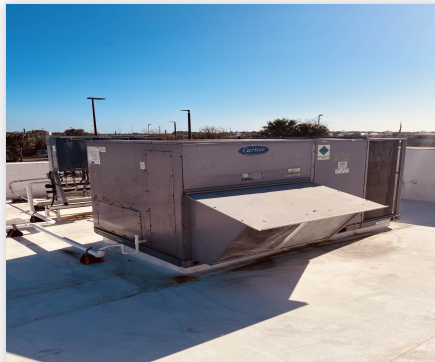
Issue Name : RTUs 1 and 3OAs Not Reaching Design
Description : Unable to reach design outside air on units with damper full open. RTU 1 601/700CFM design. RTU-3 1000/1635CFM design.
Created By : National TAB **Assigned To :** National TAB - Brianna Biggs
Status : Open
Priority : Urgent **Asset Tag :**
Originated Date : 02/18/2026 - Jackson Gunnels - National TAB

OA dampers on all units full open, unable to reach design airflow
