Report: TAB Report
Function: Test, Adjust, & Balance
Date: 01/28/2026
Completed By: National TAB

02-16-26 WHATABURGER #1687 LUTZ, FL

Project: 02-16-26 WHATABURGER #1687 LUTZ, FL

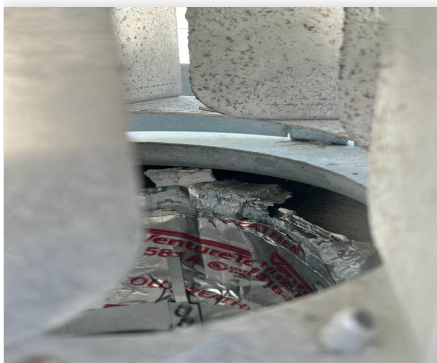
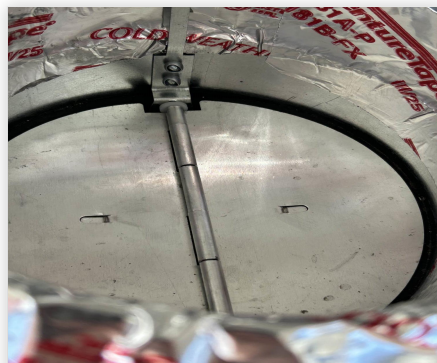
Issue Name : EF 4 Low Flow
Description : EF 4 (restrooms) is currently at 68% design airflow. Fan is running at max speed (wired directly). Airflow appears to be restricted by the installed backdraft damper, which is heavily spring loaded and cannot open fully during operation. Fan is also not fully sealed to the curb due to placement of conduit. Recommend service.
Created By : National TAB **Assigned To :** National TAB - Will Turnbough
Status : Open
Priority : Urgent **Asset Tag :**
Originated Date : 03/19/2026 - Mark Johnson - National TAB

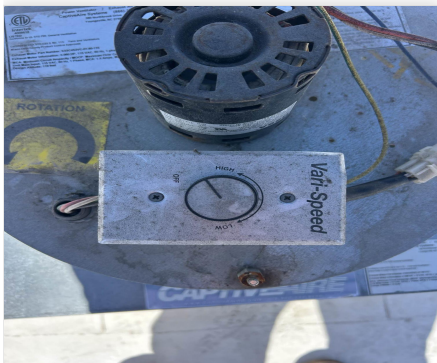
Issue Name : EF 4 Speed Controller
Description : EF 4's speed controller is not functional, neither as an on/off switch nor to adjust speed. Fan appears to be wired directly to power, bypassing the speed controller. Recommend a replacement speed controller in case of future balancing.
Created By : National TAB **Assigned To :** National TAB - Will Turnbough
Status : Open
Priority : High **Asset Tag :**
Originated Date : 03/19/2026 - Mark Johnson - National TAB

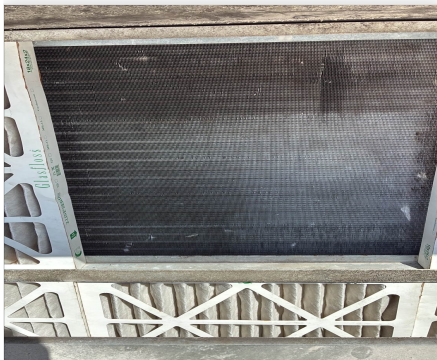
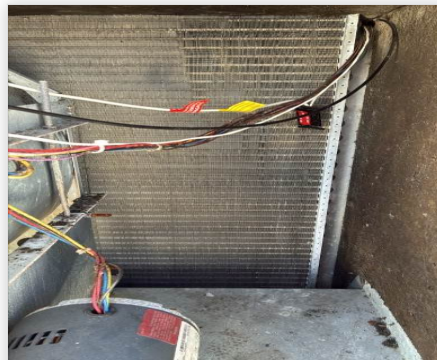
Issue Name : Evaporator coils, all RTUs
Description : Evaporator coils on all units are dirty and need to be cleaned.
Created By : National TAB **Assigned To :** National TAB - Will Turnbough
Status : Open
Priority : Urgent **Asset Tag :**
Originated Date : 02/18/2026 - Jackson Gunnels - National TAB

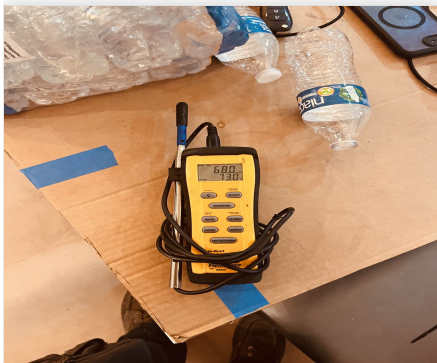
Issue Name : High Humidity Recorded
Description : Space is very humid, measured at %68 relative humidity. NTi noticed units were not cooling the space effectively. Cleaning evaporator coils may improve their efficiency.
Created By : National TAB **Assigned To :** National TAB - Will Turnbough
Status : Open
Priority : InfoOnly **Asset Tag :**
Originated Date : 02/19/2026 - Jackson Gunnels - National TAB

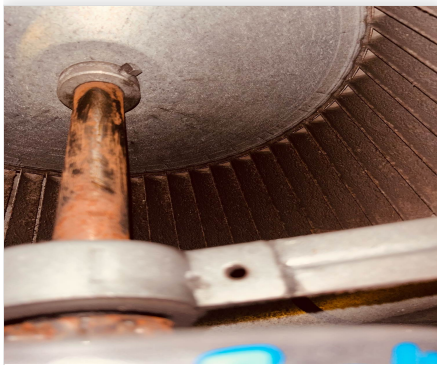
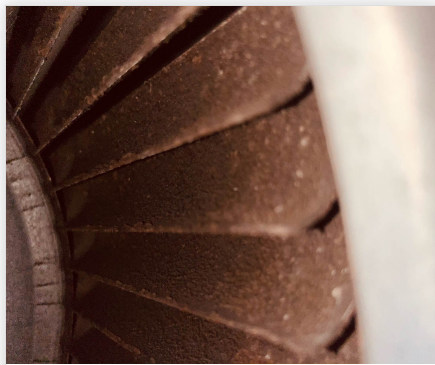
Issue Name : RTU 2 Blower Wheel Dirty
Description : RTU 2 Blower wheel shows moderate accumulation of debris. Not as severe as RTU 3, unit still met design. Cleaning recommended.
Created By : National TAB **Assigned To :** National TAB - Will Turnbough
Status : Open
Priority : Medium **Asset Tag :**
Originated Date : 02/19/2026 - Jackson Gunnels - National TAB

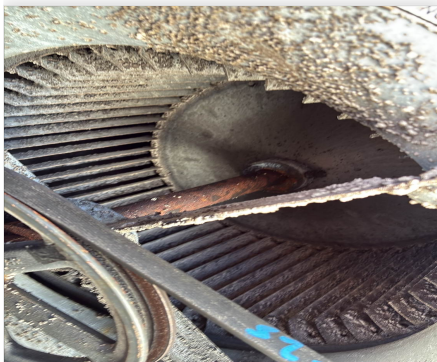
Issue Name : RTU 3 Blower wheel
Description : Blower wheel on RTU 3 shows significant accumulation of debris. Profile of fan blades is affected enough that any damper balancing on unit causes significant total air loss. Opened all dampers, and set unit total to preserve comfort. Blower wheel needs to be cleaned or replaced and unit rebalanced.

- **02/19/2026 National TAB - Stephen Tassinaro**
 - Per technician: RTU 3 send debris into space whenever the ducts are disturbed, or the blower stops and restarts.

- **03/19/2026 National TAB - Mark Johnson**
 - RTU 3 supply increased to 100% design after opening OA damper. Diffuser rebalance may be possible, but unable to access dampers at the time of return visit.

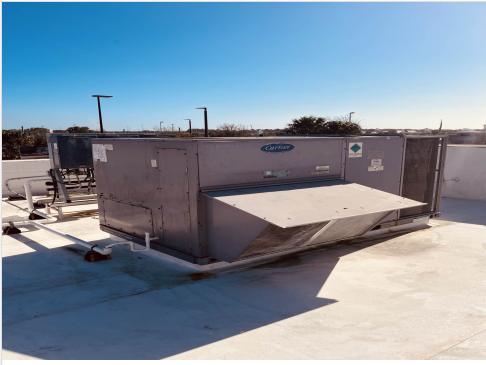
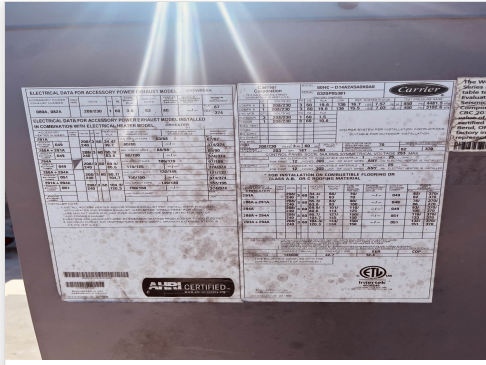
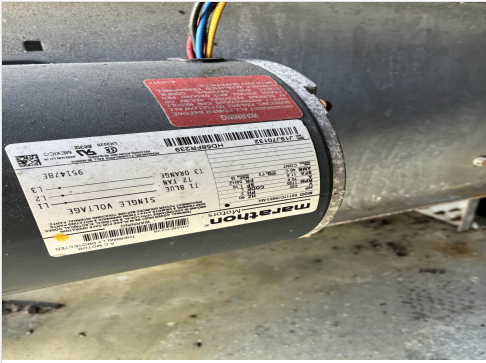
Notes:
Fan sheave sits further out than motor sheave

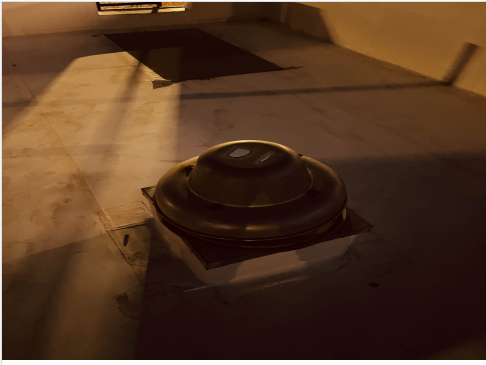
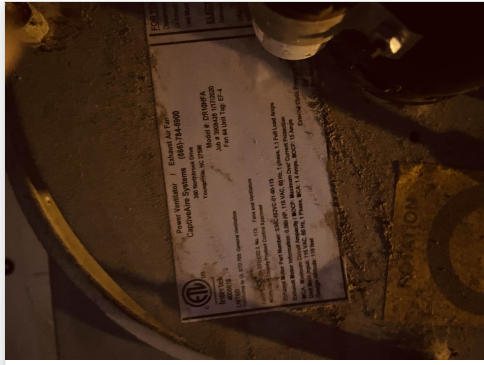
Fan not running. Unable to balance.
