Report: Deficiency Report
Function: Test, Adjust, & Balance
Date: 02/17/2026
Completed By: National TAB

02-16-26 WHATABURGER #1687 LUTZ, FL

Project: 02-16-26 WHATABURGER #1687 LUTZ, FL

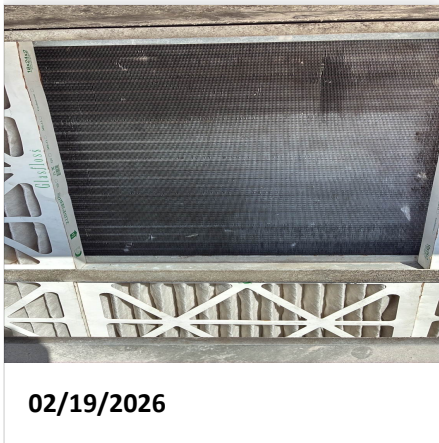
Issue Name : Evaporator coils, all RTUs
Description : Evaporator coils on all units are dirty and need to be cleaned.
Created By : National TAB **Assigned To :** National TAB - Will Turnbough
Status : Open
Priority : Urgent **Asset Tag :**
Originated Date : 02/18/2026 - Jackson Gunnels - National TAB

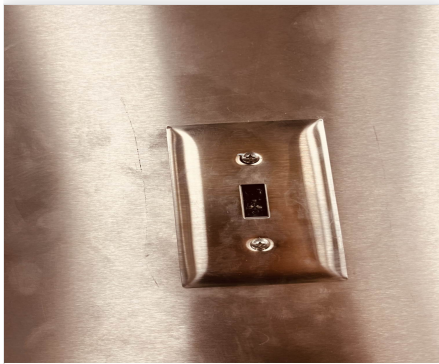
Issue Name : Hood 2 power switch
Description : Hood 2 power switch is damaged.
Created By : National TAB **Assigned To :** National TAB - Will Turnbough
Status : Open
Priority : Low **Asset Tag :**
Originated Date : 02/19/2026 - Jackson Gunnels - National TAB

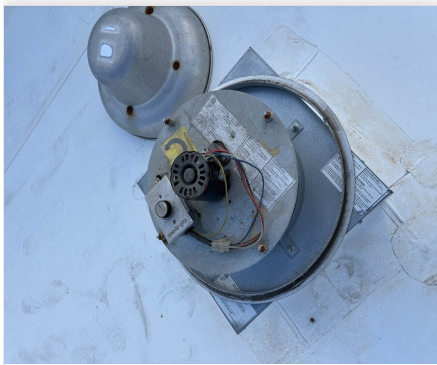
Issue Name : Restroom Exhaust Fan Not Running
Description : Unable to run restroom exhaust fan for balancing. Confirmed breaker is open and restroom was occupied.
Created By : National TAB **Assigned To :** National TAB - Will Turnbough
Status : Open
Priority : Urgent **Asset Tag :**
Originated Date : 02/18/2026 - Jackson Gunnels - National TAB

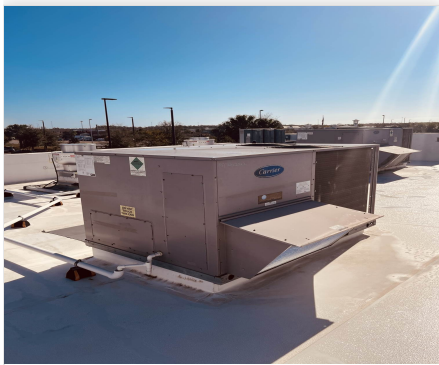
Issue Name : RTU 2 Required Jumpers to Run
Description : RTU 2 blower does not run unless manually jumped. Unit is jumped for testing, will be removed when balance is completed.
Created By : National TAB **Assigned To :** National TAB - Will Turnbough
Status : Open
Priority : High **Asset Tag :**
Originated Date : 02/18/2026 - Jackson Gunnels - National TAB

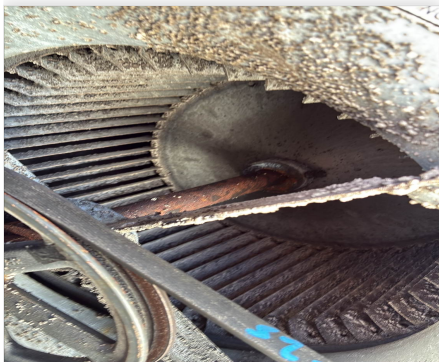
Issue Name : RTU 3 Blower wheel
Description : Blower wheel on RTU 3 shows significant accumulation of debris. Profile of fan blades is affected enough that any damper balancing on unit causes significant total air loss. Opened all dampers, and set unit total to preserve comfort. Blower wheel needs to be cleaned or replaced and unit rebalanced.

- **02/19/2026 National TAB - Stephen Tassinaro**
 - Per technician: RTU 3 send debris into space whenever the ducts are disturbed, or the blower stops and restarts.
