Report: TAB Report
Function: Test, Adjust, & Balance
Date: 02/25/2026
Completed By: National TAB

PROJECT
02-16-26 CHOPT COLUMBIA, SC

Founders Table Restaurant Group

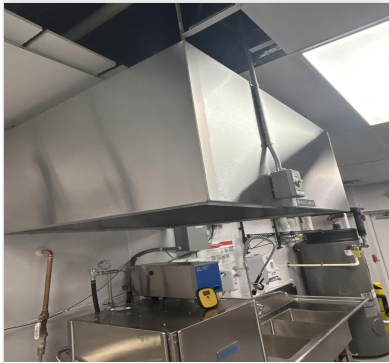
Issue Name : DEF 1 high flow
Description : Dishwasher hood currently at 162% of design. Unable to access roof.
Created By : National TAB **Assigned To :** National TAB - Dan Hertenstein
Status : Open
Priority : Urgent **Asset Tag :** DEF1
Originated Date : 02/19/2026 - Jearod Ferrette - National TAB

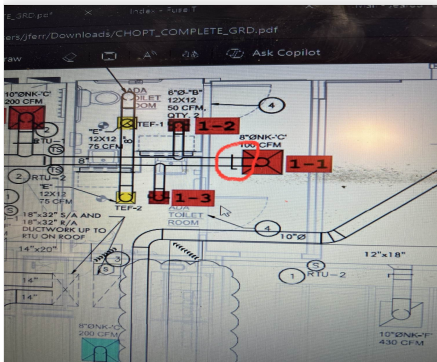
Issue Name : Missing damper RTU 1
Description : Missing face damper on SGRD 1-1
Created By : National TAB **Assigned To :** National TAB - Dan Hertenstein
Status : Open
Priority : Medium **Asset Tag :** SGRD1
Originated Date : 02/19/2026 - Jearod Ferrette - National TAB

Asset	Notes	Date	Written By
SGRD1	NO FACE DAMPER	02/19/2026	Jearod Ferrette

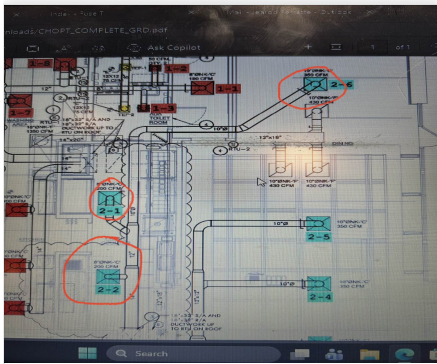
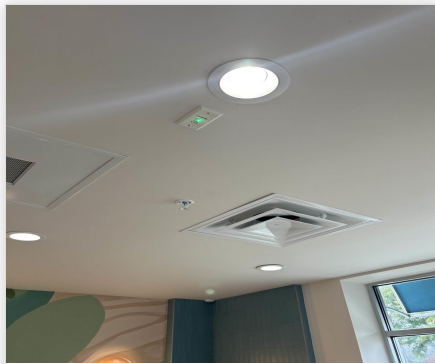
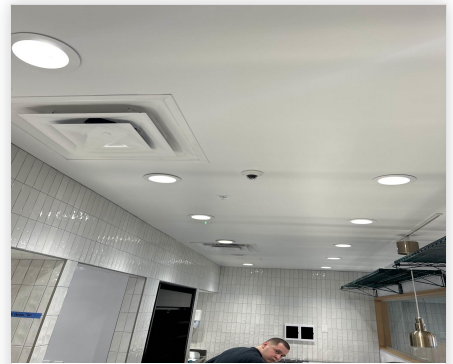
Issue Name : Missing dampers on RTU 2
Description : Missing face dampers. Unable to proportionally balance.
Created By : National TAB **Assigned To :** National TAB - Dan Hertenstein
Status : Open
Priority : Medium **Asset Tag :** RTU2
Originated Date : 02/19/2026 - Jearod Ferrette - National TAB

Asset	Notes	Date	Written By
SGRD1	NO FACE DAMPER	02/19/2026	Jearod Ferrette
SGRD2	NO FACE DAMPER	02/19/2026	Jearod Ferrette
SGRD6	NO FACE DAMPER	02/19/2026	Jearod Ferrette

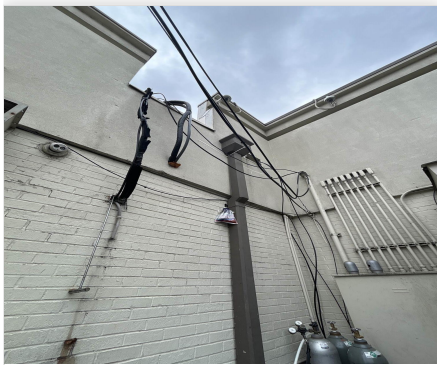
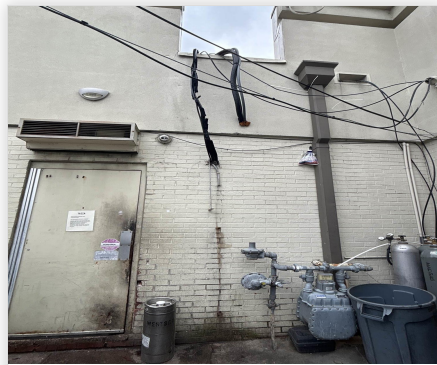
Issue Name : No roof access
Description : Facilities does not have roof access or ladder to access roof. Unable to access RTUs safely.
Created By : National TAB **Assigned To :** National TAB - Dan Hertenstein
Status : Open
Priority : Urgent **Asset Tag :** HVAC EQUIPMENT 1
Originated Date : 02/19/2026 - Jearod Ferrette - National TAB

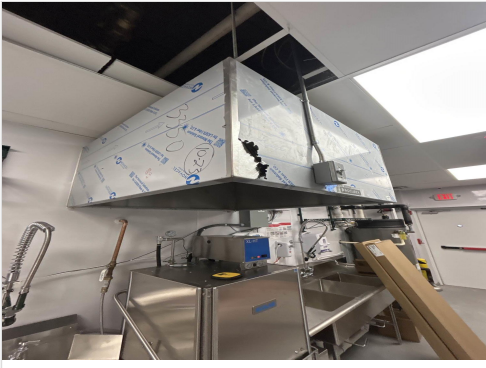
Asset: HD1

Test Data		
	Design	Actual
Exhaust CFM	600	972
