Report: TAB Report
Function: Test, Adjust, & Balance
Date: 05/29/2025
Completed By: National TAB

PROJECT
05-26-25 CAVA WARWICK, RI

Project: 05-26-25 CAVA WARWICK, RI

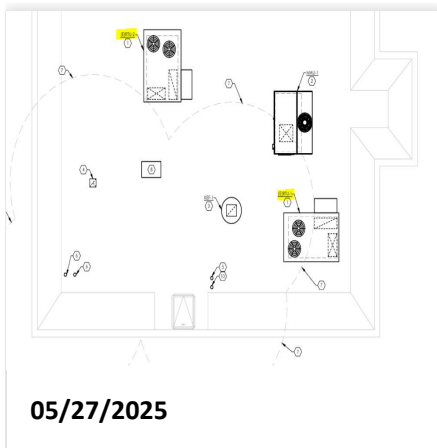
Issue Name : 1. RTUs On Incorrect Curbs

Description : The "48FCD09" unit is serving the Dining Area and the "48FCDN12" unit is serving the Kitchen. Per the mechanical plans, the larger unit is supposed to serve the Dining Area. To achieve proper cooling of the space, these units will need to be swapped.

- **05/27/2025 National TAB - Stephen Tassinaro**
 - Currently both units will be balanced to 400CFM/Ton respectively. This will not match the designs shown on the mechanical plans since there is now 4000CFM in the kitchen instead of 3400CFM. And 3400CFM in the dining room, instead of the original 4000CFM. All diffusers will be proportionally balanced.

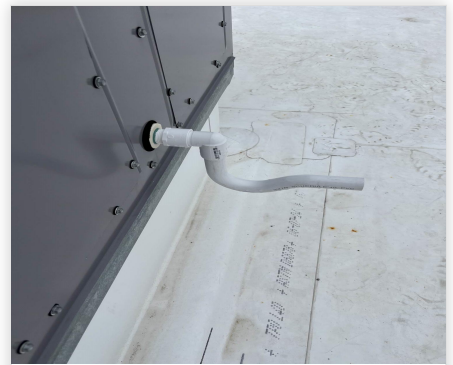
Issue Name : Condensate Drains
Description : All condensate drains on the rooftop terminate immediately after the P-Traps. The RTU P-Traps do not match the drawing on M401.
Created By : National TAB **Assigned To :** National TAB - Will Turnbough
Status : Open
Priority : Low **Asset Tag :**
Originated Date : 05/29/2025 - Stephen Tassinaro - National TAB

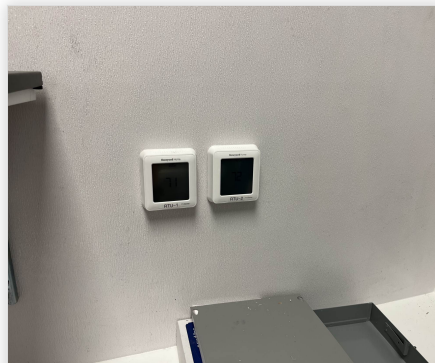
Issue Name : Incorrect Thermostats
Description : The currently installed thermostats are not the correct model and do not have all the desired functions (occupancy, humidity, remote sensors, exc). The current thermostats are can schedule just temperature setpoints.
Created By : National TAB **Assigned To :** National TAB - Will Turnbough
Status : Open
Priority : High **Asset Tag :**
Originated Date : 05/28/2025 - Stephen Tassinaro - National TAB

- **05/29/2025 National TAB - Stephen Tassinaro**
 - Both new and original thermostats do not have an OCC terminal. Default Carrier RTU setup puts unit into occupied mode whenever the blower is running.
- **05/29/2025 National TAB - Stephen Tassinaro**
 - One thermostat has been changed as of 5/29. MC to replace second thermostat 5/30.
