## **Issue List**

**05-26-25 CAVA WARWICK, RI**

## Project Issue Information

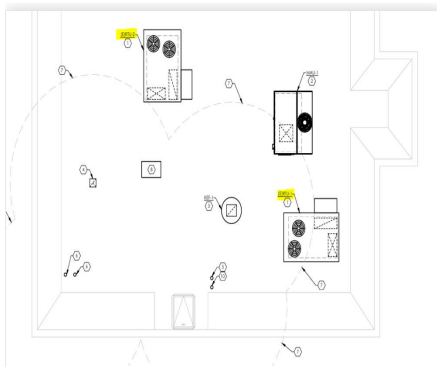
| <b>Issue Name :</b> | 1. RTUs On Incorrect Curbs | | |
| <b>Description :</b> | The "48FCD09" unit is serving the Dining Area and the "48FCDN12" unit is serving the Kitchen. Per the mechanical plans, the larger unit is supposed to serve the Dining Area. To achieve proper cooling of the space, these units will need to be swapped. | | |

- **05/27/2025      National TAB - Stephen Tassinaro**
  - Currently both units will be balanced to 400CFM/Ton respectively. This will not match the designs shown on the mechanical plans since there is now 4000CFM in the kitchen instead of 3400CFM. And 3400CFM in the dining room, instead of the original 4000CFM. All diffusers will be proportionally balanced.

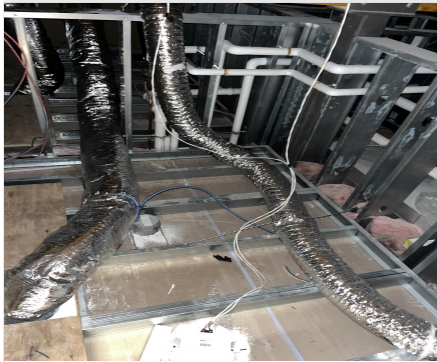
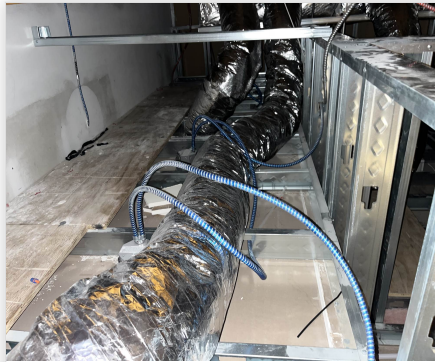
**Issue Name :** Excessive Flex Runs  
**Description :** The flex duct runs above the restrooms and adjacent hallway are beyond the 5' maximum.  
**Created By :** National TAB      **Assigned To :** National TAB - Will Turnbough  
**Status :** Open  
**Priority :** High      **Asset Tag :**  
**Originated Date :** 05/28/2025 - Stephen Tassinaro - National TAB

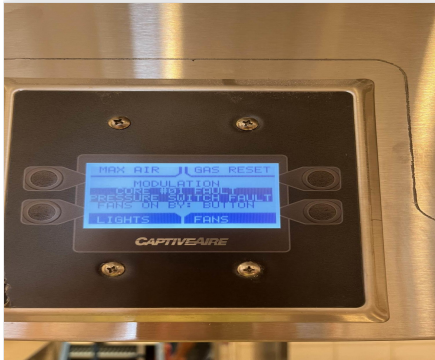
**Issue Name :** Hood "Core #01 Fault"  
**Description :** The kitchen hood HMI is displaying "Core #01 Fault". This did not effect the balancing of the hood.  
**Created By :** National TAB                      **Assigned To :** National TAB - Will Turnbough  
**Status :** Open  
**Priority :** InfoOnly                      **Asset Tag :**  
**Originated Date :** 05/27/2025 - Stephen Tassinaro - National TAB

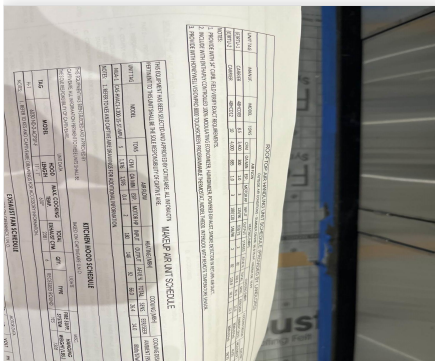
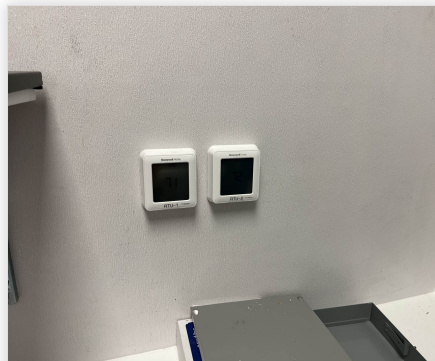
**Issue Name :** Incorrect Thermostats  
**Description :** The currently installed thermostats are not the correct model and do not have all the desired functions (occupancy, humidity, remote sensors, exc). The current thermostats are can schedule just temperature setpoints.  
**Created By :** National TAB **Assigned To :** National TAB - Will Turnbough  
**Status :** Open  
**Priority :** High **Asset Tag :**  
**Originated Date :** 05/28/2025 - Stephen Tassinaro - National TAB

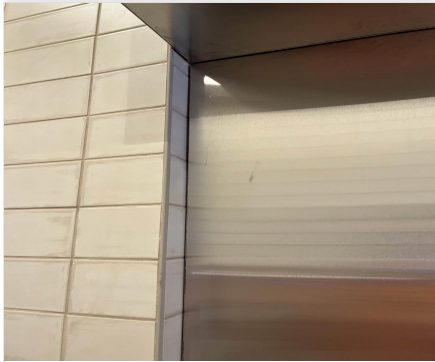
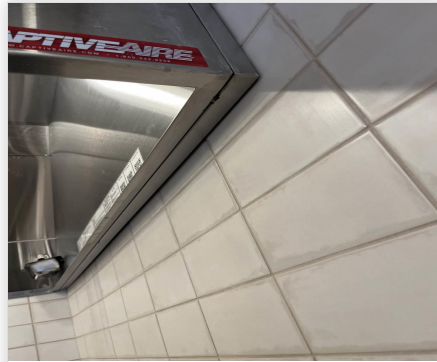
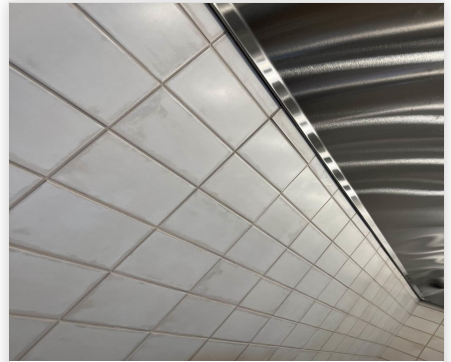
**Issue Name :** Kitchen Hood Not Caulked  
**Description :** The kitchen hood should be caulked at all points in which it touches the wall to prevent grease accumulation.  
**Created By :** National TAB      **Assigned To :** National TAB - Will Turnbough  
**Status :** Open  
**Priority :** Low      **Asset Tag :**  
**Originated Date :** 05/28/2025 - Stephen Tassinaro - National TAB

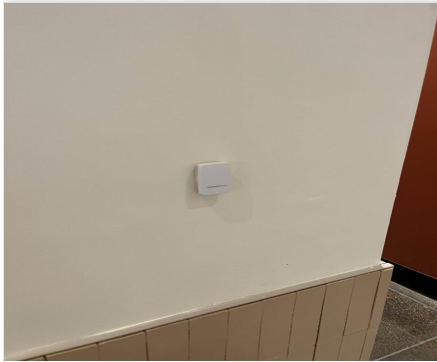
**Issue Name :** Remote Sensor Communication  
**Description :** The remote temperature sensors are not communicating with the thermostats. The stats are reading off their internal sensors only.  
**Created By :** National TAB      **Assigned To :** National TAB - Will Turnbough  
**Status :** Open  
**Priority :** High      **Asset Tag :**  
**Originated Date :** 05/28/2025 - Stephen Tassinaro - National TAB
