Issue List

05-26-25 CAVA WARWICK, RI

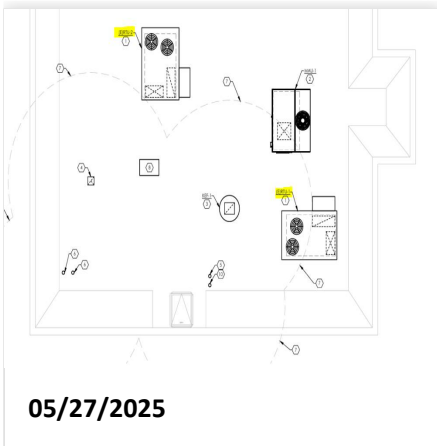
Issue Name : 1. RTUs On Incorrect Curbs

Description : The "48FCD09" unit is serving the Dining Area and the "48FCDN12" unit is serving the Kitchen. Per the mechanical plans, the larger unit is supposed to serve the Dining Area. To achieve proper cooling of the space, these units will need to be swapped.

- **05/27/2025 National TAB - Stephen Tassinaro**
 - Currently both units will be balanced to 400CFM/Ton respectively. This will not match the designs shown on the mechanical plans since there is now 4000CFM in the kitchen instead of 3400CFM. And 3400CFM in the dining room, instead of the original 4000CFM. All diffusers will be proportionally balanced.

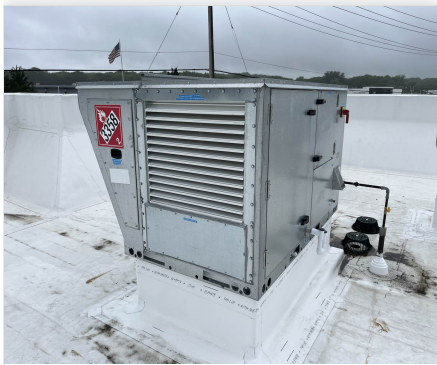
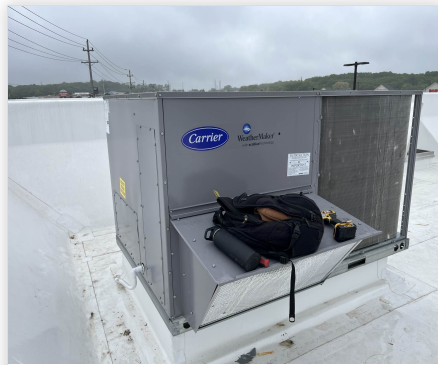
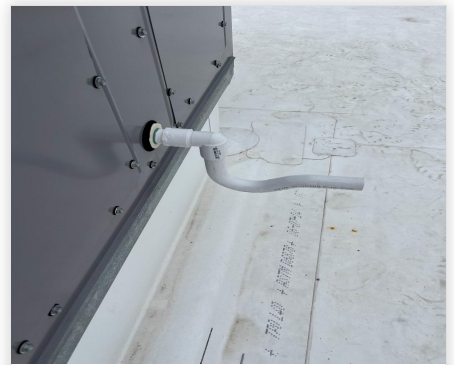
Issue Name : Condensate Drains
Description : All condensate drains on the rooftop terminate immediately after the P-Traps. The RTU P-Traps do not match the drawing on M401.
Created By : National TAB **Assigned To :** National TAB - Will Turnbough
Status : Open
Priority : Low **Asset Tag :**
Originated Date : 05/29/2025 - Stephen Tassinaro - National TAB

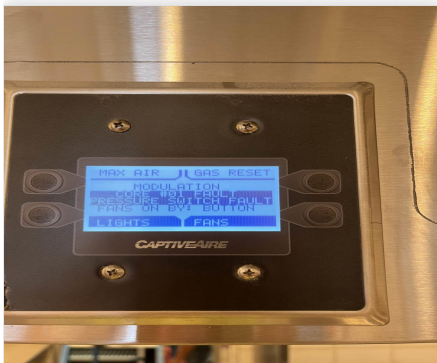
Issue Name : Hood "Core #01 Fault"
Description : The kitchen hood HMI is displaying "Core #01 Fault". This did not effect the balancing of the hood.
Created By : National TAB **Assigned To :** National TAB - Will Turnbough
Status : Open
Priority : InfoOnly **Asset Tag :**
Originated Date : 05/27/2025 - Stephen Tassinaro - National TAB

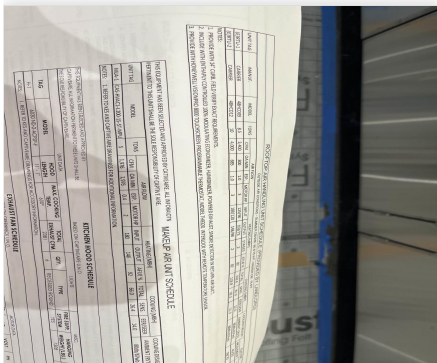
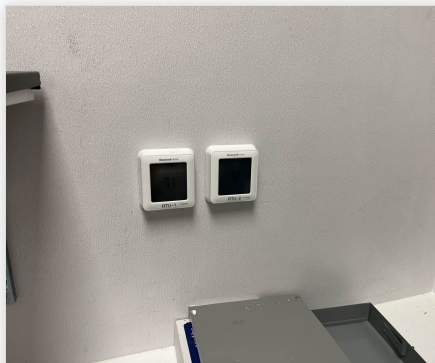
Issue Name : Incorrect Thermostats
Description : The currently installed thermostats are not the correct model and do not have all the desired functions (occupancy, humidity, remote sensors, exc). The current thermostats are can schedule just temperature setpoints.
Created By : National TAB **Assigned To :** National TAB - Will Turnbough
Status : Open
Priority : High **Asset Tag :**
Originated Date : 05/28/2025 - Stephen Tassinaro - National TAB

- **05/29/2025 National TAB - Stephen Tassinaro**
 - Both new and original thermostats do not have an OCC terminal. Default Carrier RTU setup puts unit into occupied mode whenever the blower is running.

- **05/29/2025 National TAB - Stephen Tassinaro**
 - One thermostat has been changed as of 5/29. MC to replace second thermostat 5/30.

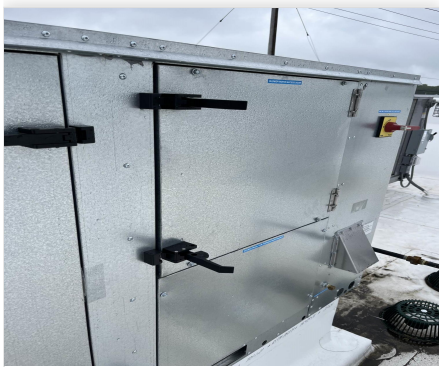
Issue Name : MAU Blower Access Door
Description : The MAU blower access door is stuck shut and not able to be opened without prying.
Created By : National TAB **Assigned To :** National TAB - Will Turnbough
Status : Open
Priority : Low **Asset Tag :**
Originated Date : 05/29/2025 - Stephen Tassinaro - National TAB

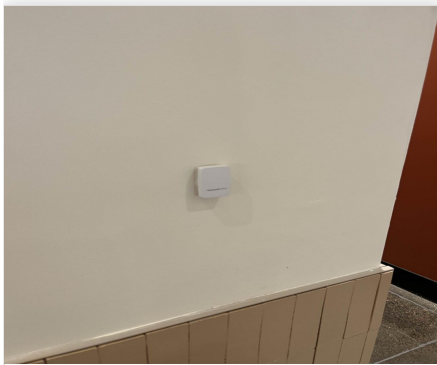
Issue Name : Remote Sensor Communication
Description : The remote temperature sensors are not communicating with the thermostats. The stats are reading off their internal sensors only.
Created By : National TAB **Assigned To :** National TAB - Will Turnbough
Status : Open
Priority : High **Asset Tag :**
Originated Date : 05/28/2025 - Stephen Tassinaro - National TAB

- **05/29/2025 National TAB - Stephen Tassinaro**
 - New RTU 1 thermostat is communicating. RTU 2 is not. Recommend retest once new thermostat is installed as the sensor wiring appears to be OK.
