Report: TAB Report
Function: Test, Adjust, & Balance
Date: 05/29/2025
Completed By: National TAB

PROJECT
05-26-25 CAVA WARWICK, RI

Project: 05-26-25 CAVA WARWICK, RI

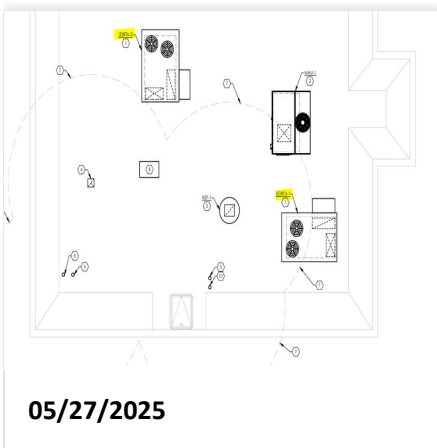
Description : The "48FCD09" unit is serving the Dining Area and the "48FCDN12" unit is serving the Kitchen. Per the mechanical plans, the larger unit is supposed to serve the Dining Area. To achieve proper cooling of the space, these units will need to be swapped.

- **05/27/2025 National TAB - Stephen Tassinaro**
 - Currently both units will be balanced to 400CFM/Ton respectively. This will not match the designs shown on the mechanical plans since there is now 4000CFM in the kitchen instead of 3400CFM. And 3400CFM in the dining room, instead of the original 4000CFM. All diffusers will be proportionally balanced.

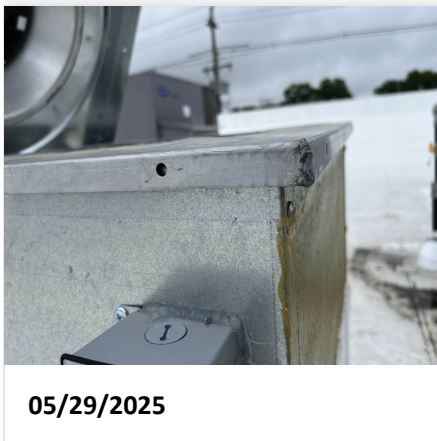
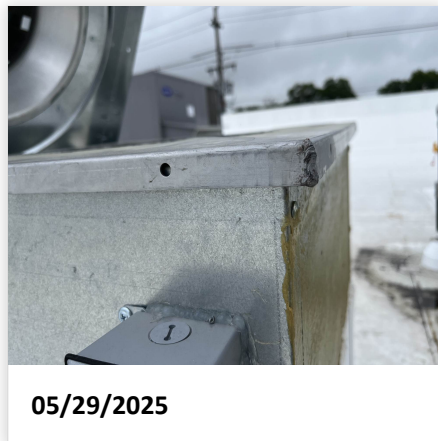
Issue Name : Grease Duct Not Secured to Curb
Description : Duct top plate flanges to the edges of the curb, but it is not secured. This allows for movement of the grease duct and grease will accumulate.
Created By : National TAB **Assigned To :** National TAB - Will Turnbough
Status : Open
Priority : Medium **Asset Tag :**
Originated Date : 05/29/2025 - Stephen Tassinaro - National TAB

Top plate is not secured to the curb.
