## Issue List

05-26-25 CAVA WARWICK, RI

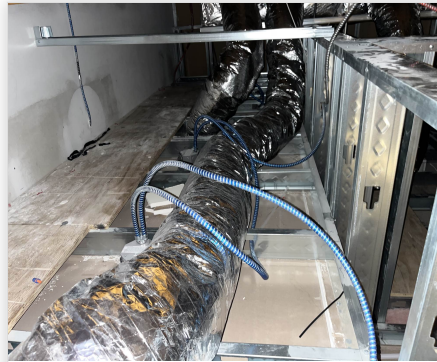
**Issue Name :** Excessive Flex Runs  
**Description :** The flex duct runs above the restrooms and adjacent hallway are beyond the 5' maximum.  
**Created By :** National TAB                      **Assigned To :** National TAB - Will Turnbough  
**Status :** Open  
**Priority :** High                                      **Asset Tag :**  
**Originated Date :** 05/28/2025 - Stephen Tassinaro - National TAB

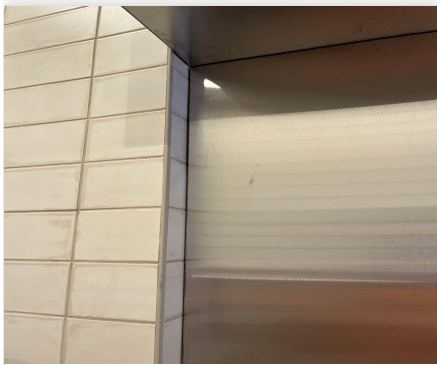
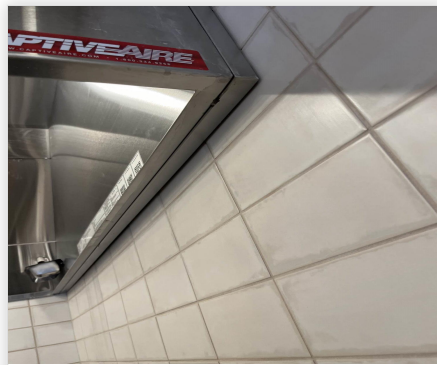
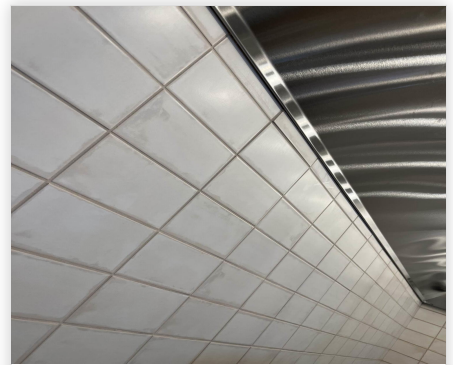
**Issue Name :** Kitchen Hood Not Caulked  
**Description :** The kitchen hood should be caulked at all points in which it touches the wall to prevent grease accumulation.  
**Created By :** National TAB      **Assigned To :** National TAB - Will Turnbough  
**Status :** Open  
**Priority :** Low      **Asset Tag :**  
**Originated Date :** 05/28/2025 - Stephen Tassinaro - National TAB
