**Report: TAB Punchlist**  
**Function: Test, Adjust, & Balance**  
**Date: 05/29/2025**  
**Completed By: National TAB**

**PROJECT**  
**05-26-25 FREDDYS ELKHART, IN**

Project: 05-26-25 FREDDYS ELKHART, IN

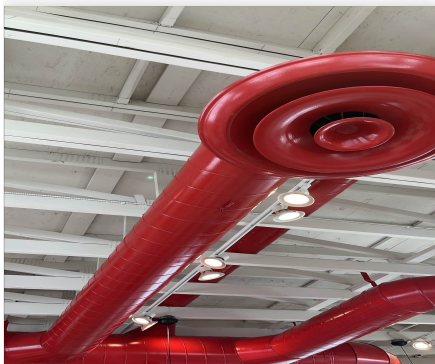
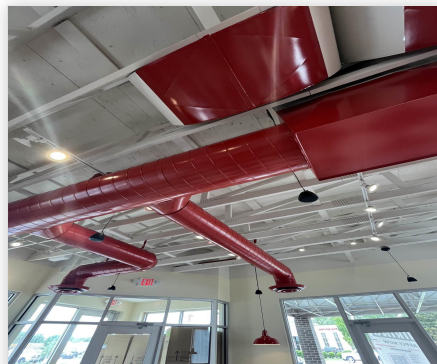
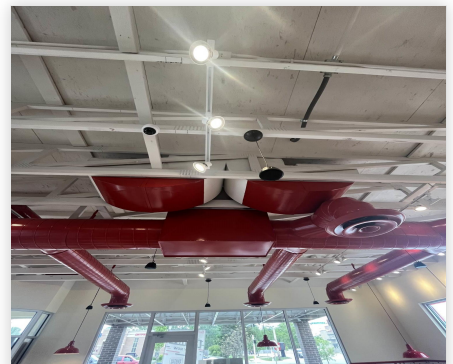
**Issue Name :** Diffuser 1-6 low on flow  
**Description :** RTU-1 diffuser 1-6 is low on flow, this could be to it being the first duct run closest to the supply drop causing airflow to shoot passed it, can install a scoop inside the ductwork to help direct airflow to this diffuser. Not anticipated to cause any issue.  
**Created By :** National TAB                      **Assigned To :** National TAB - Dylan Crisman  
**Status :** Open  
**Priority :** Medium                                      **Asset Tag :**  
**Originated Date :** 05/29/2025 - Dylan Crisman - National TAB

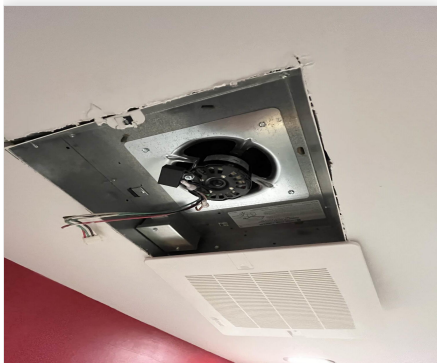
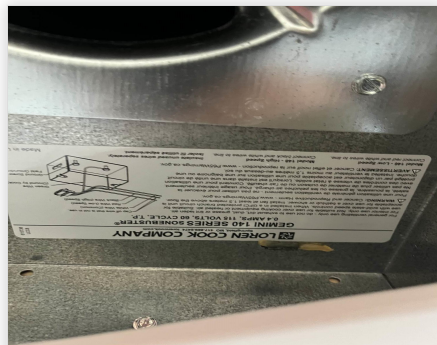
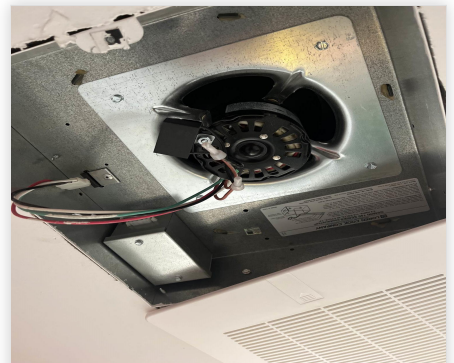
**Issue Name :** EF-1/EF-2 high on flow  
**Description :** EF-1/EF-2 are high on flow at 99/75CFM and 94/75CFM. Units have been rewired for low speed and cannot be reduced further. Not anticipated to cause any issue.  
**Created By :** National TAB                      **Assigned To :** National TAB - Dylan Crisman  
**Status :** Open  
**Priority :** High                                      **Asset Tag :**  
**Originated Date :** 05/29/2025 - Dylan Crisman - National TAB

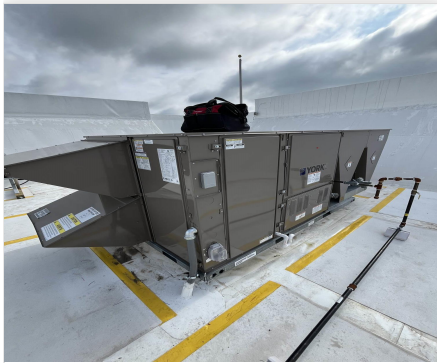
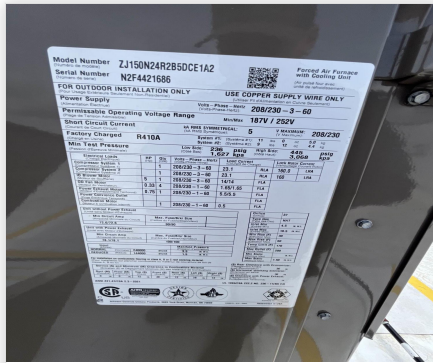
**Issue Name :** RTU-1 ALARM  
**Description :** RTU-1 alarm reads “using return air instead of space temp” recommend mechanical check wiring on space sensor and at unit for short/loose wire to correct.

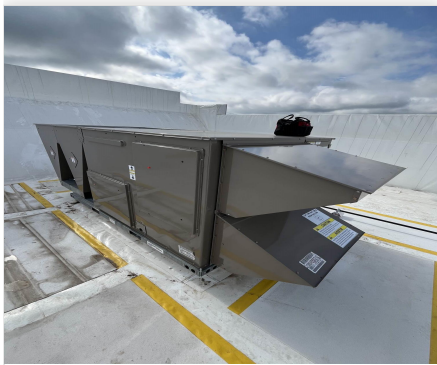
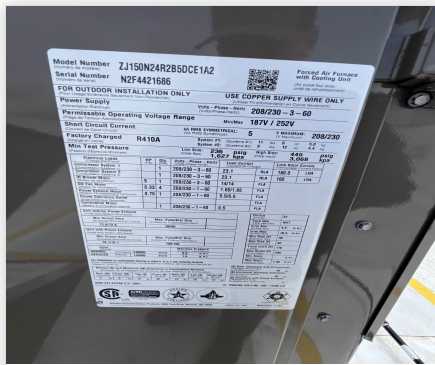
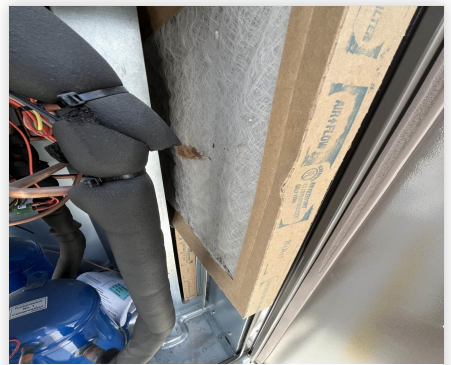
**Issue Name :** RTU-1 Final Filters  
**Description :** RTU-1 has construction filters installed. Recommend replacing with correct size (20x24x2) merv 8 rated pleated filters.  
**Created By :** National TAB                      **Assigned To :** National TAB - Dylan Crisman  
**Status :** Open  
**Priority :** Low                                      **Asset Tag :**  
**Originated Date :** 05/29/2025 - Dylan Crisman - National TAB

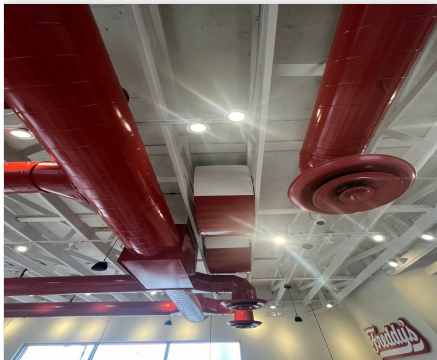
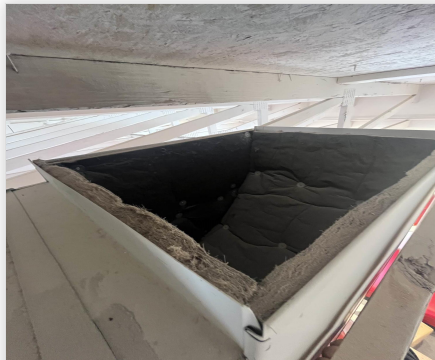
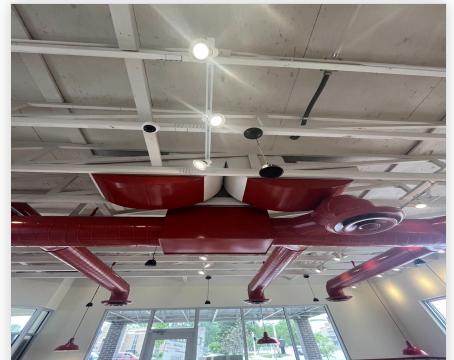
**Issue Name :** RTU-1 low on flow  
**Description :** RTU-1 is low on flow. Static pressures are high showing restriction in ductwork. Return drop ducts are looped back up towards the ceiling shortly after entry to the dining room pointed up at the ceiling with only 11 inches of clearance. This could be causing the restriction in ductwork. Unit is at 4296/5000CFM. Balanced proportionally low.
