TAB PUNCHLIST - Nov 27, 2024

L04604_Raymore FSU (MO)

1918 West Foxwood Drive, Raymore, Missouri

L1020004604

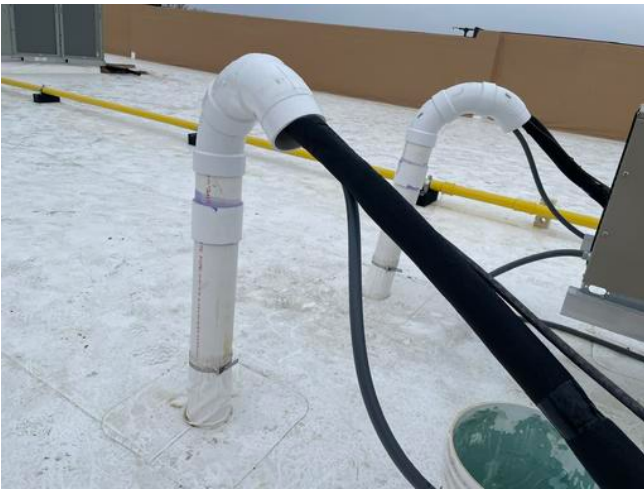
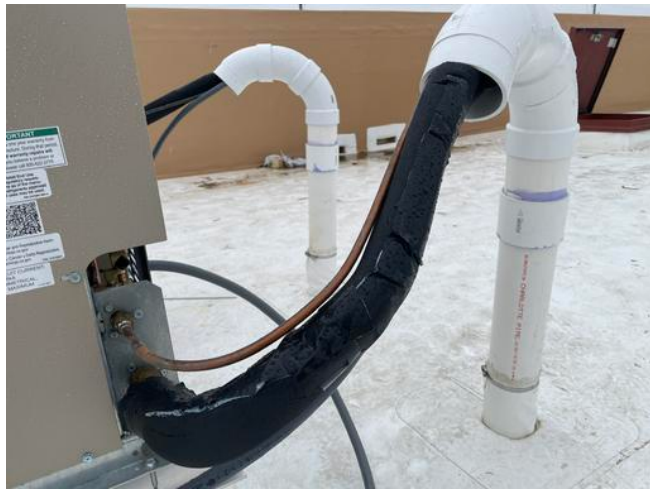
#42 [REFG 511] [NEW] PVC pipe chase (gooseneck) installation.

PVC pipe chase risers is not sealed with spray foam to prevent weather/pest infiltration.

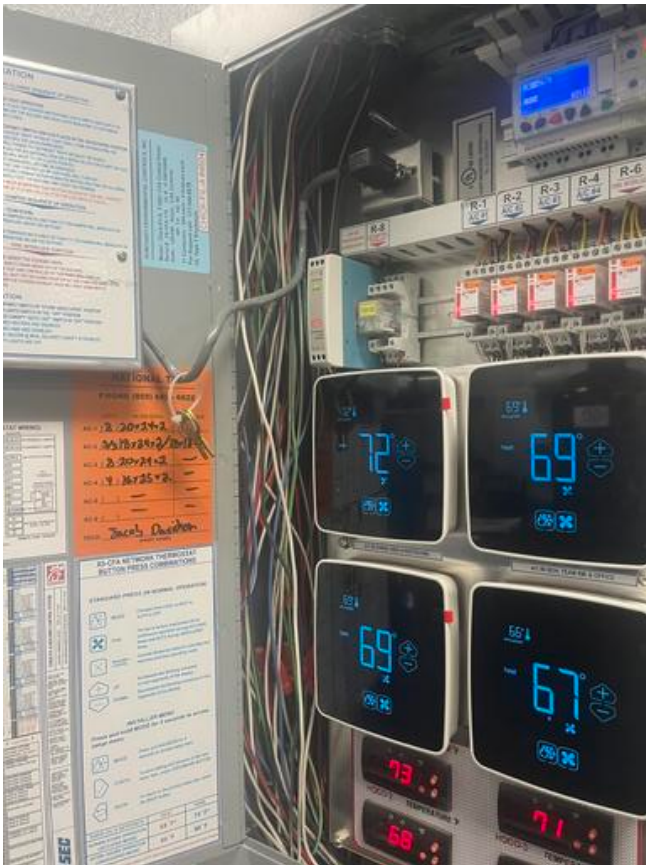
#41 [CNTL 512] [NEW] SEC Line voltage cover.

Line voltage cover in SEC low voltage panel is missing and needs to be installed (EC).

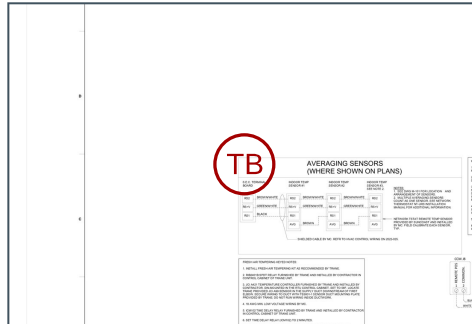
M-701

(Averaging) Sensors not communicating properly on AC4, check for correct terminations, correct dip switch / jumper settings, and shorts to ground.

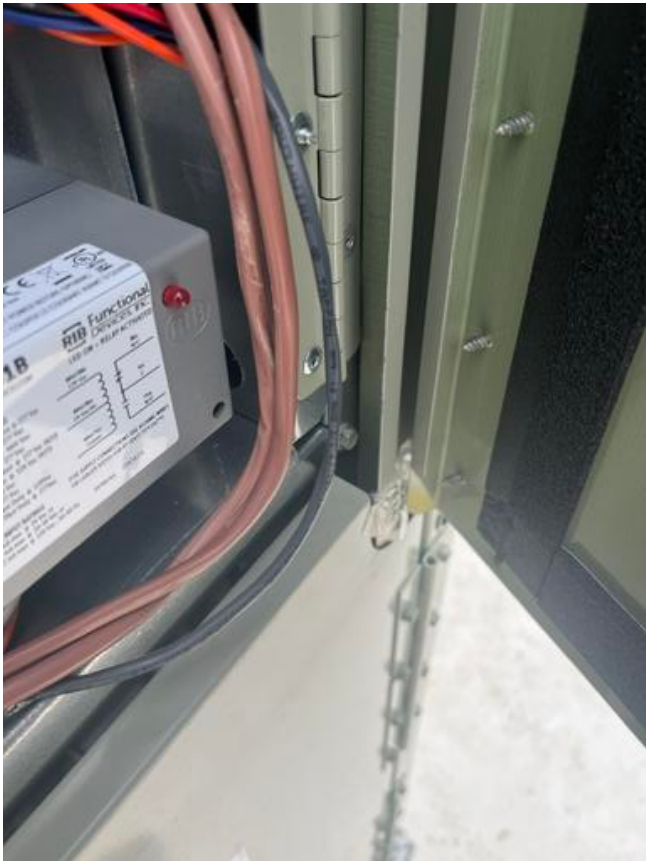
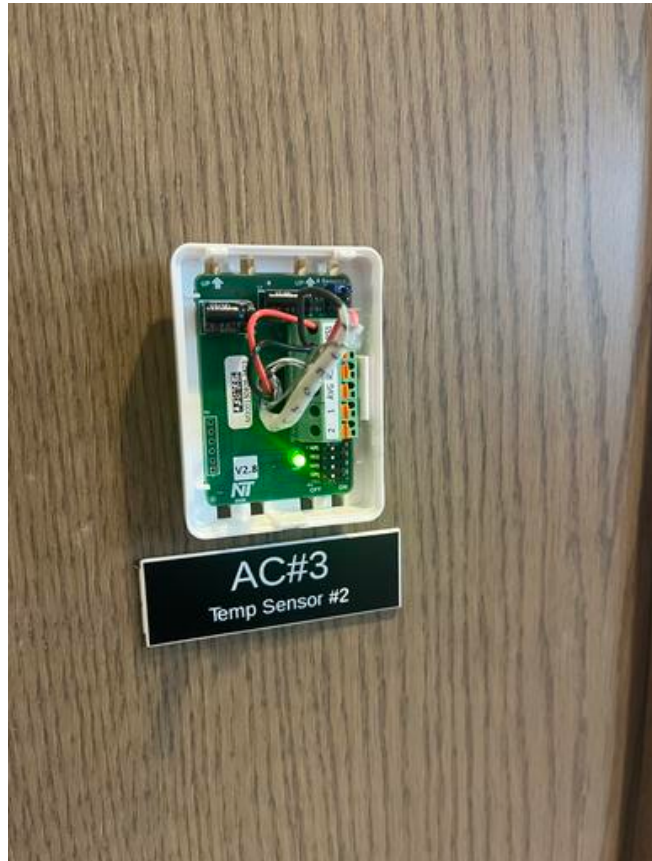
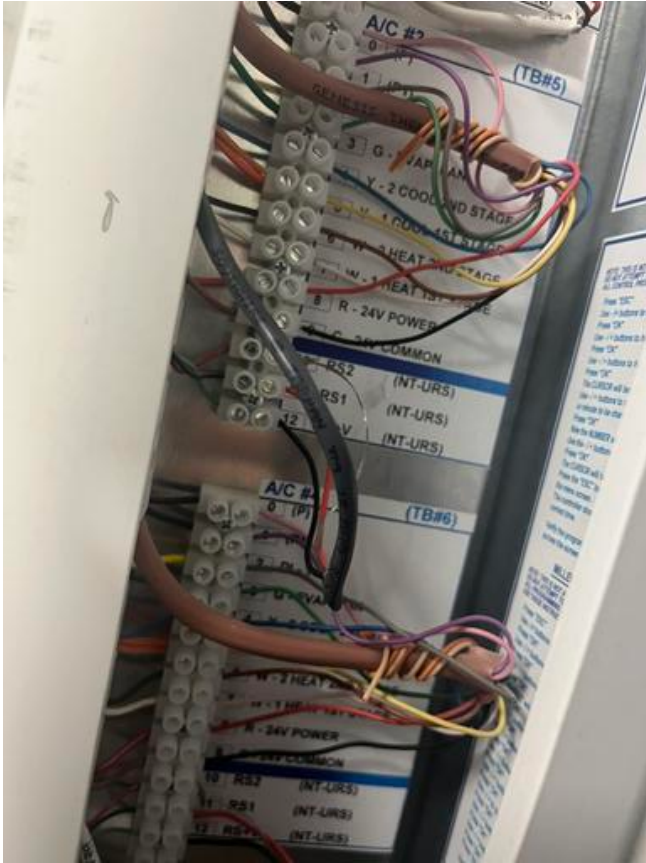
#39 [CNTL 003] [NEW] CRITICAL – Wiring specifications.

Temperature sensor is specified as CAT5/5E with no exceptions. Humidity sensor wiring to be single 18/2 sensor cable W221P-2003NT only. Must seek approval for change.

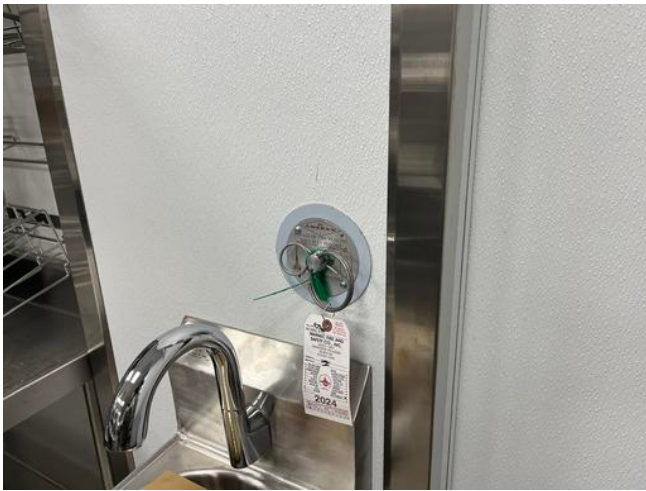
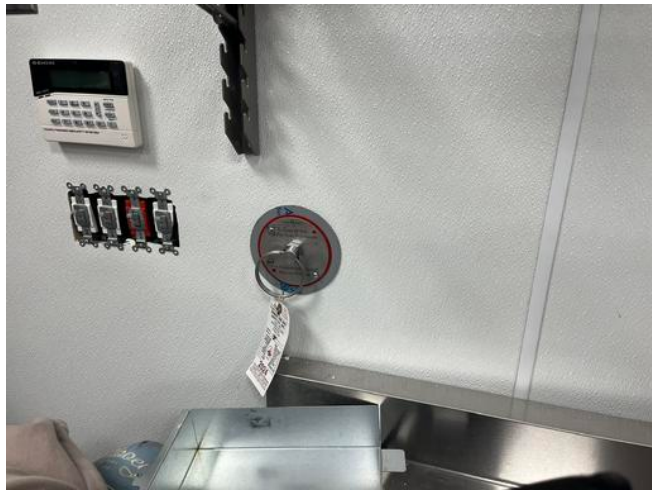
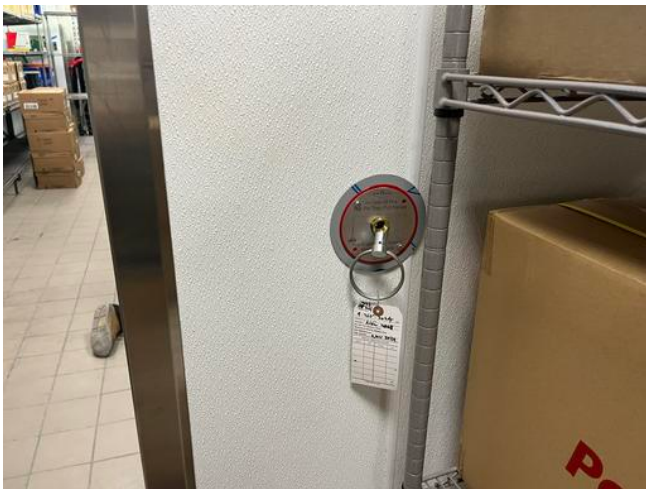
#35 [CNTL 509] [NEW] AMEREX pull labeling.

Label all amerex pull stations for which hoods they serve.

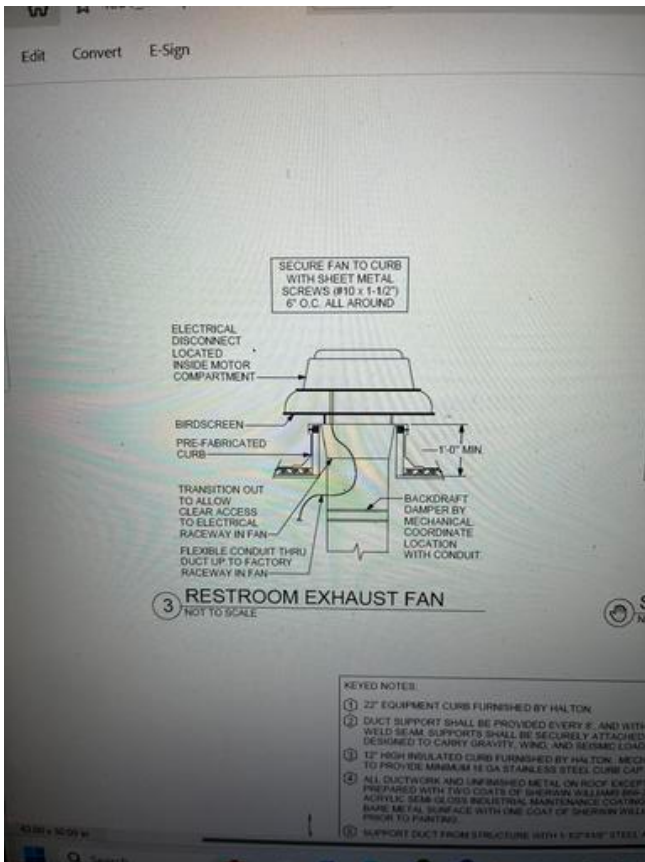
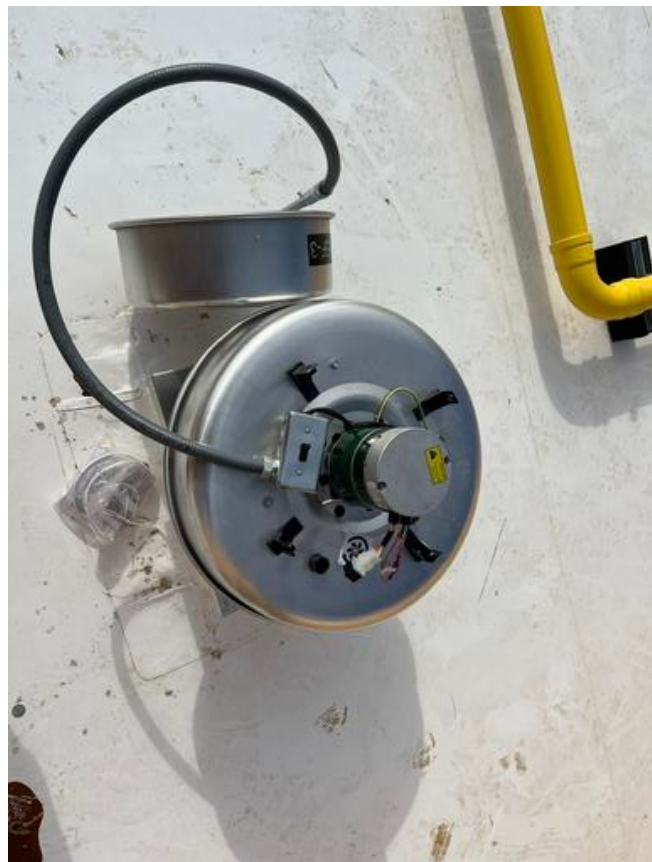
#32 [EXHA 513] [NEW] Exhaust fan electrical.

Exhaust fan electrical penetration is to be rigid through the roof membrane and/or local disconnect box is to be sealed from outside elements. Seek approval for current setup.

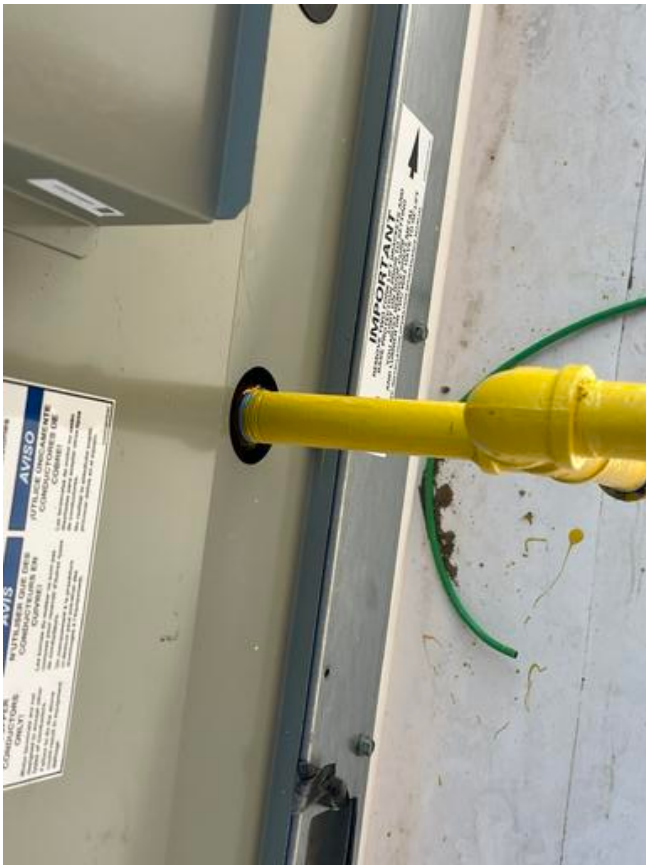
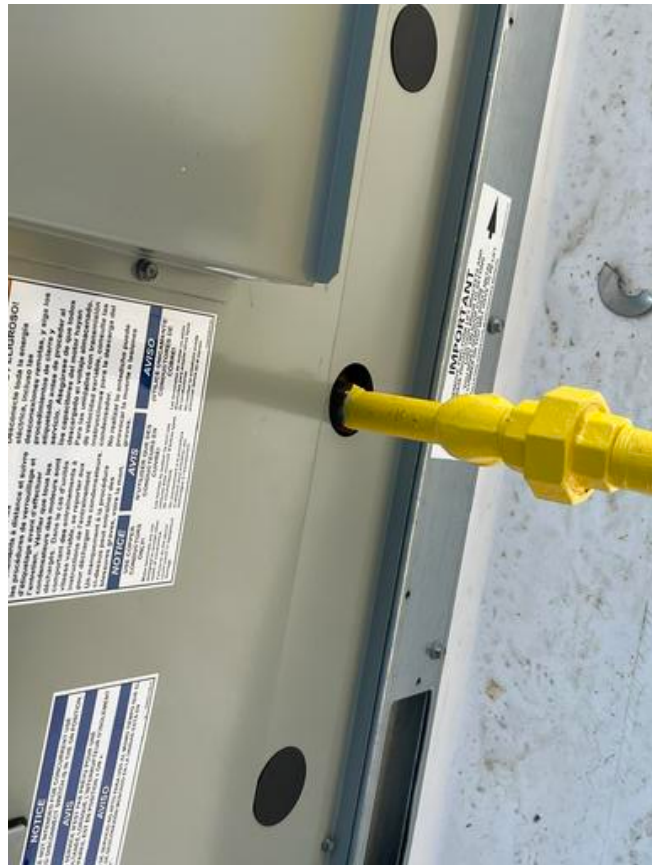
#30 [UNIT 510] [NEW] Gas inlet grommet.

AC gas inlet grommet is missing at the gas line/RTU penetration point. Missing on AC1, AC2, AC3.

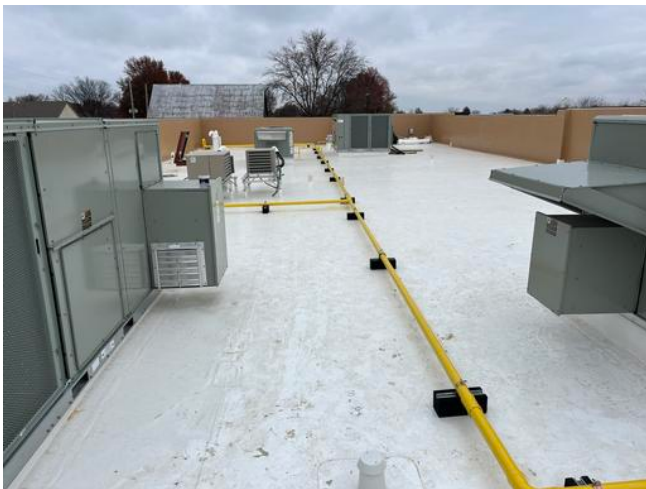
#29 [UNIT 517] [NEW] Condensate piping construction.

Equipment condensate piping or p-trap is not constructed per normal CFA specifications. Currently no condensate piping is constructed.

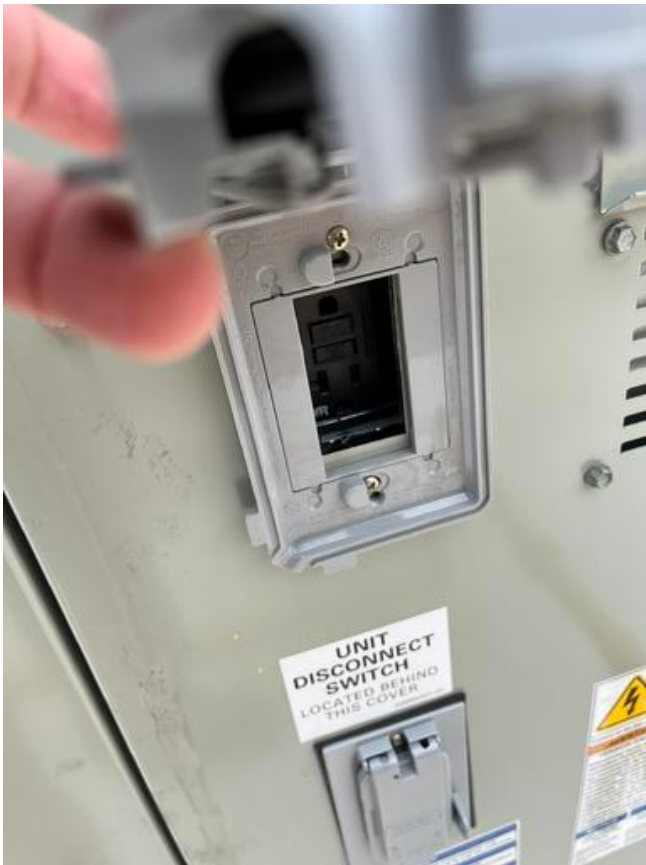
#28 [UNIT 506] [NEW] Equipment GFI outlets.

Equipment GFI outlet
missing components (GFI
itself, din rail with fuses) or
not terminated/operational.
