Report: TAB REPORT
Function: Test, Adjust, & Balance
Date: 07/24/2023

06-24-24 WALGREENS #1769 - DENVER, CO

Project: 06-24-24 WALGREENS #1769 - DENVER, CO

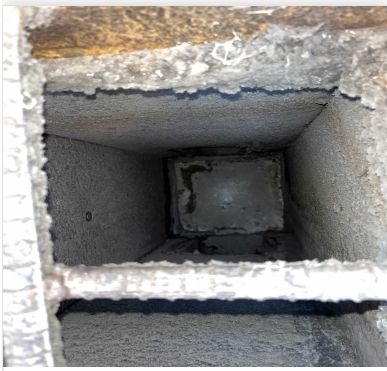
IMG_3249
06/17/2024

- **06/17/2024 National TAB - Stephen Tassinaro**
 - No damper installed.

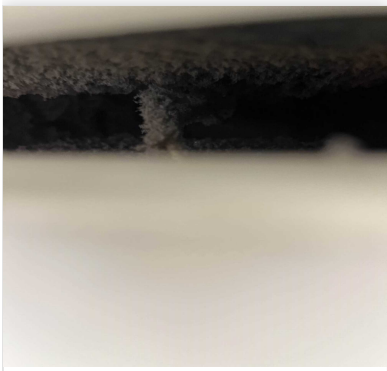
- **06/19/2024 National TAB - Stephen Tassinaro**
 - Airflow is now reduced to 0CFM, fan is still operating but flow hood is unable to detect any airflow. Fan is very dirty. It is possible a larger fan need be installed to overcome to rise to the rooftop from the basement, as well as thoroughly cleaning the duct.

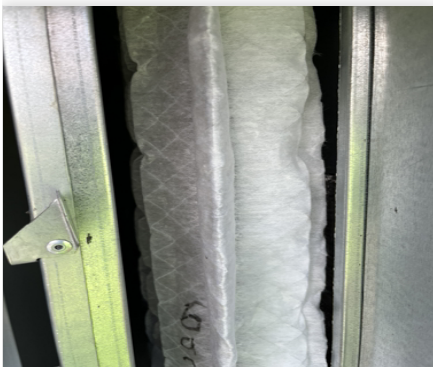
CurrentFilters
07/20/2023

Issue Name : RTU Final Filters
Description : Recommended to install the appropriate sized MERV 8 or better throwaway filters in the RTUs for improved filtration.
Created By : National TAB **Assigned To :** National TAB - Stephen Tassinaro
Status : Open
Priority : Medium **Asset Tag :**
Originated Date : 07/20/2023 - Stephen Tassinaro - National TAB
