**Report: TAB REPORT**  
**Function: Test, Adjust, & Balance**  
**Date: 06/26/2024**

## 06-24-24 WALGREENS #1769 - DENVER, CO

2000 E COLFAX AVE

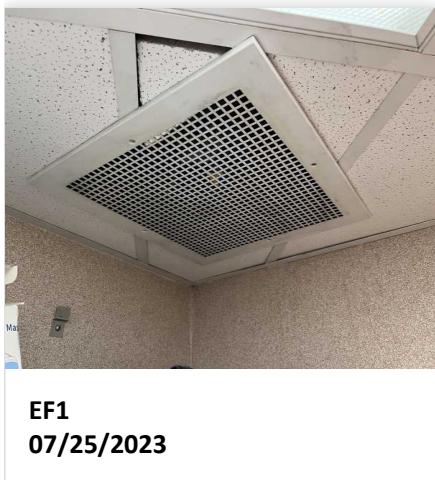
**Issue Name :** EF1 Not Functional  
**Description :** EF1 in the manager's office is not functional. The thermostat on the wall appears to be working as it sends 120V to the fan when needed, however the fan motor does not respond. Appears motor replacement is necessary, cleaning also recommended.

- **06/19/2024 National TAB - Stephen Tassinaro**
    - Fan is still not operational. NTi tech confirmed the thermostat switch is still working as intended. Fan is receiving 120v but does not function. NTi left fan unplugged.
1. [Open](#) EF1\_Issues.mp4  
06/19/2024

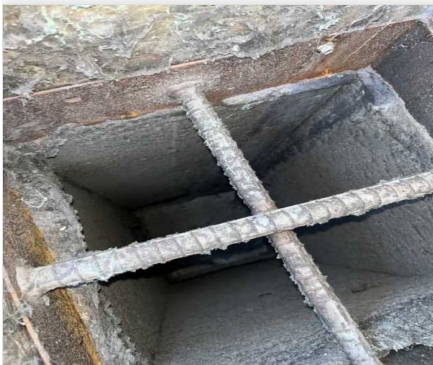
EF2\_DROP  
07/25/2023

**Issue Name :** EF2 No Backdraft Damper  
**Description :** No backdraft damper was found in the EF2 ductwork. Recommend installing to prevent drafting into the restrooms when the fan is not running.  
**Created By :** National TAB      **Assigned To :** National TAB - Stephen Tassinaro  
**Status :** Open  
**Priority :** Medium      **Asset Tag :**  
**Originated Date :** 07/25/2023 - Stephen Tassinaro - National TAB

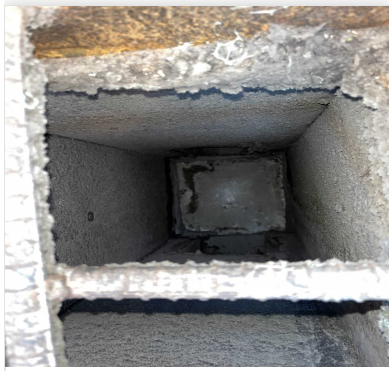
IMG\_3249  
06/17/2024

- **06/17/2024**      **National TAB - Stephen Tassinaro**
  - No damper installed.

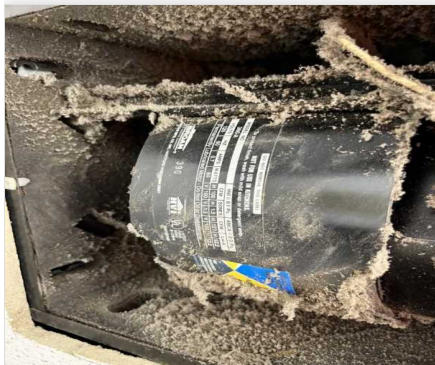
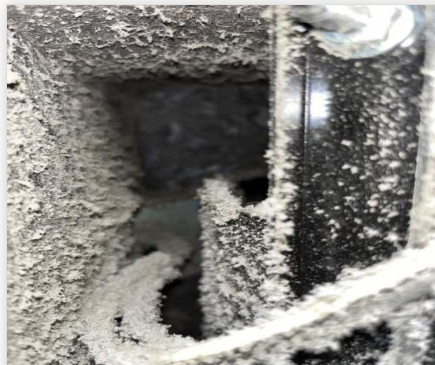
**Issue Name :** EF3 Dirty and Low Flow  
**Description :** EF3 in the employee room is exhausting 30CFM out of 100CFM design. Fan found to be functional but clogged with dirt and debris. Thorough cleaning recommended.  
**Created By :** National TAB  
**Assigned To :** National TAB - Stephen Tassinaro  
**Status :** Open  
**Priority :** Urgent  
**Asset Tag :**  
**Originated Date :** 07/24/2023 - Stephen Tassinaro - National TAB

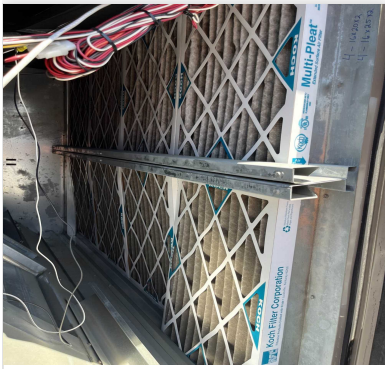
**Dirty\_Filters**  
**06/19/2024**

- **06/17/2024    National TAB - Stephen Tassinaro**
  - MERV 8 filters now installed in all units, but they are dirty and due for replacement.
